**REPORT September 2007**

**(after 6 years - 3 months of service)**

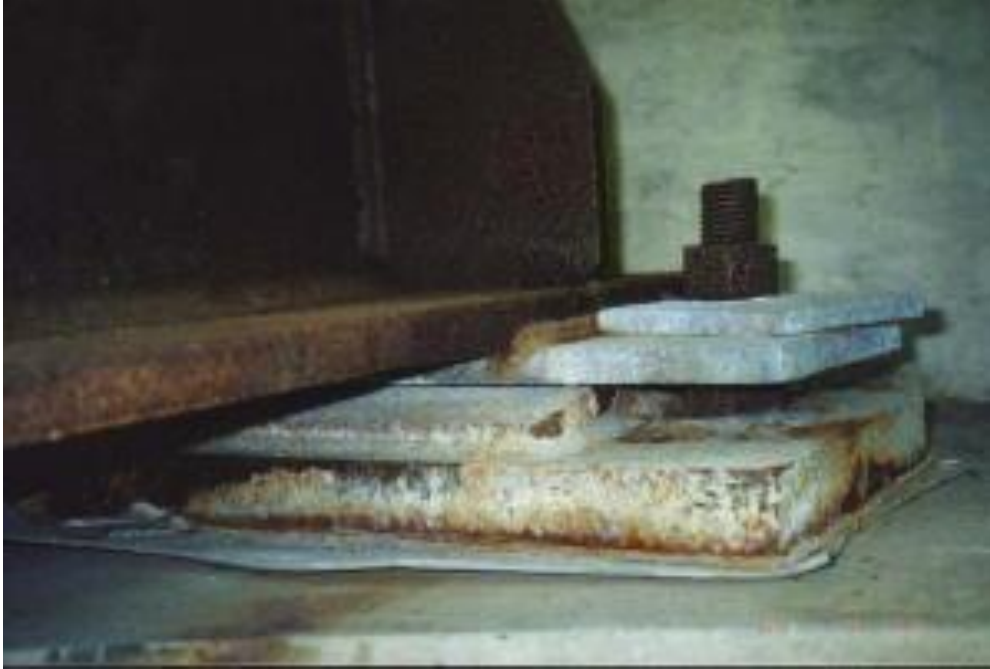
Photo 3 Existing condition of bearings in July 2001.

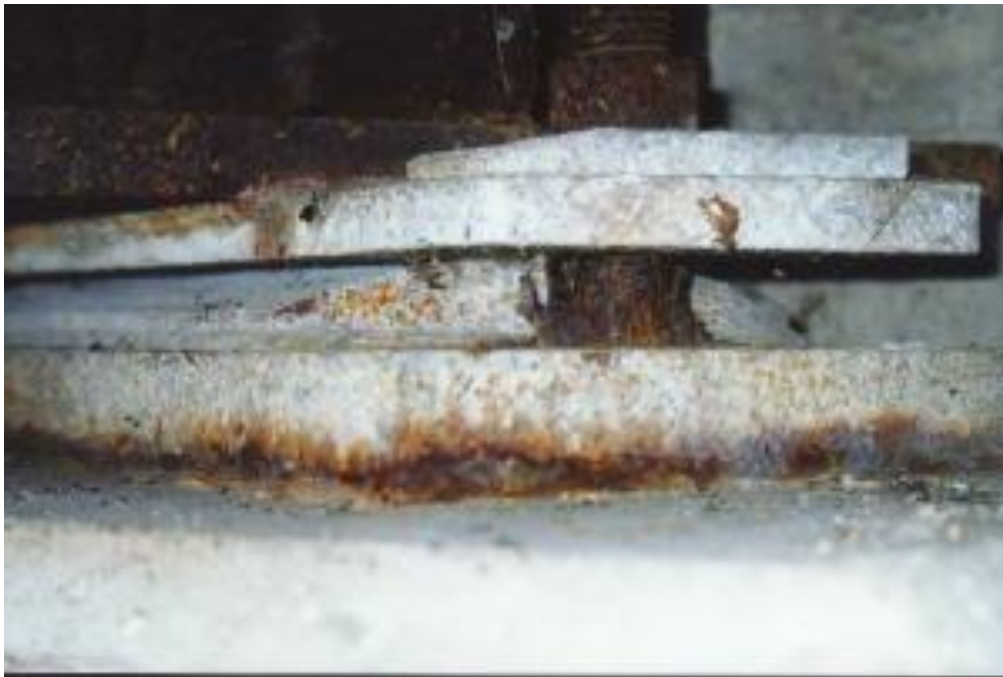
Photo 4 Existing condition of anchor bolt, note corrosion.

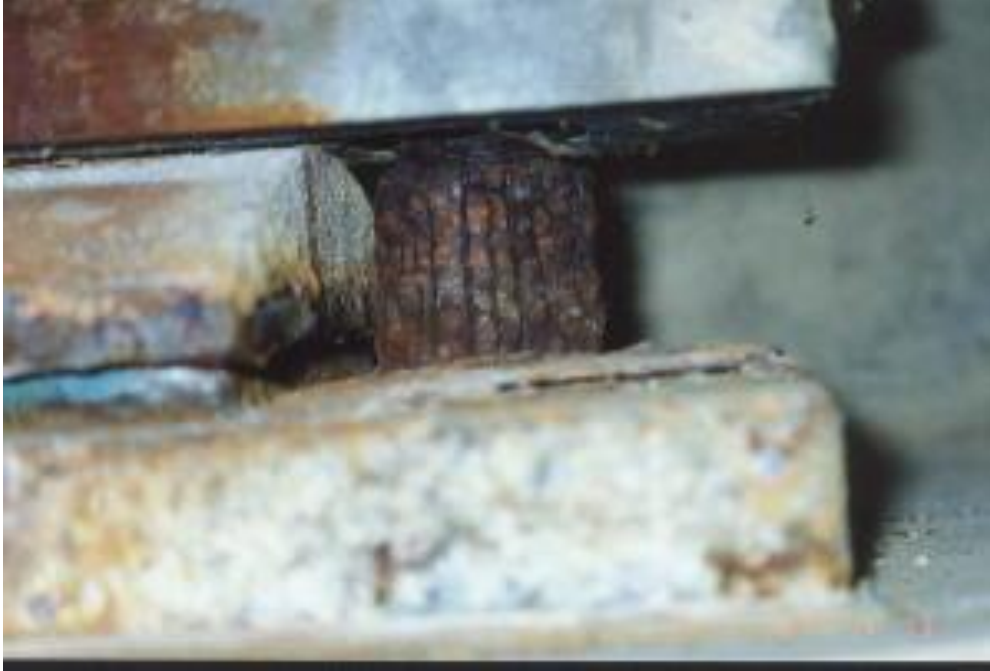
Photo 5 Existing condition of anchor bolts severe corrosion  
Corrosion ring/shell has expanded and cracked vertically  
but it has not yet fallen off (as seen in the next photo)

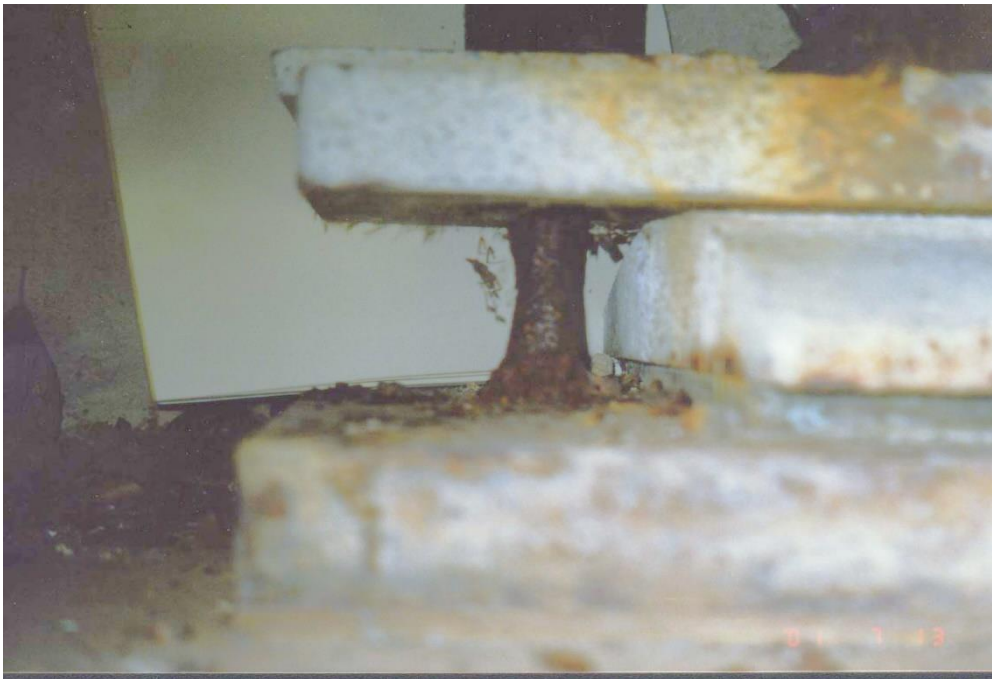
Photo 6 Corrosion ring/shell around anchor bolt has fallen off revealing substantial loss of cross sectional area of the bolt. (**Compare with Photos 11, 14 and 21**)

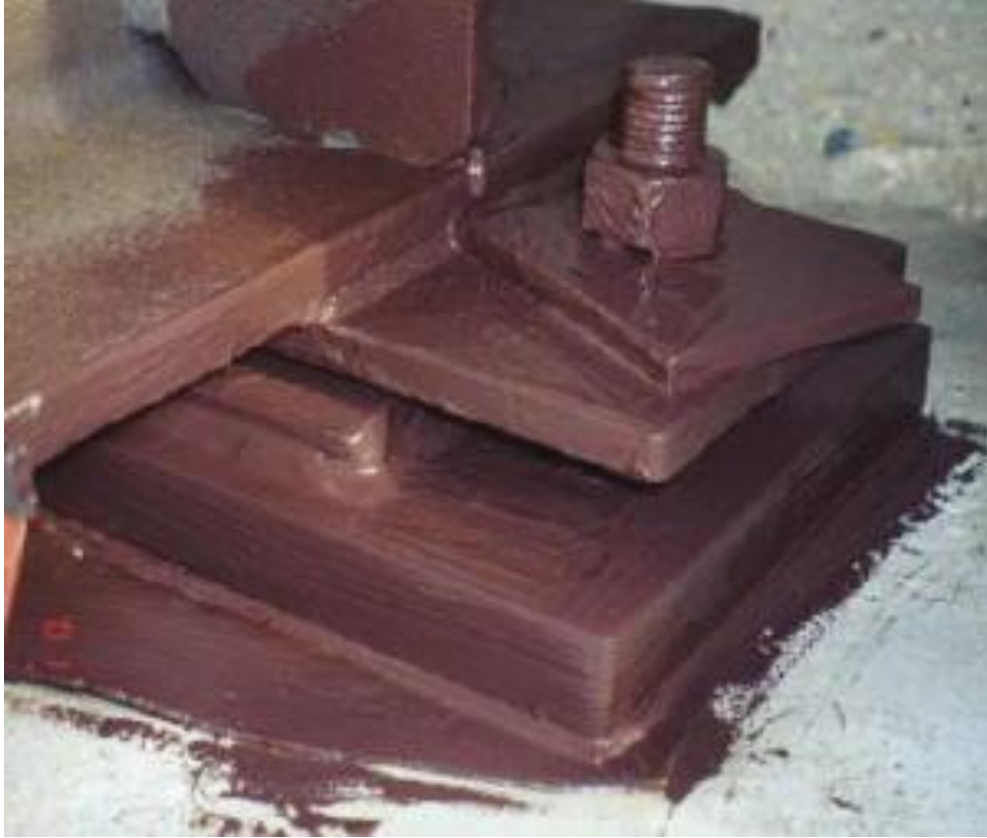
Photo 7 August 2001 after sandblasting and painting with Termarust.

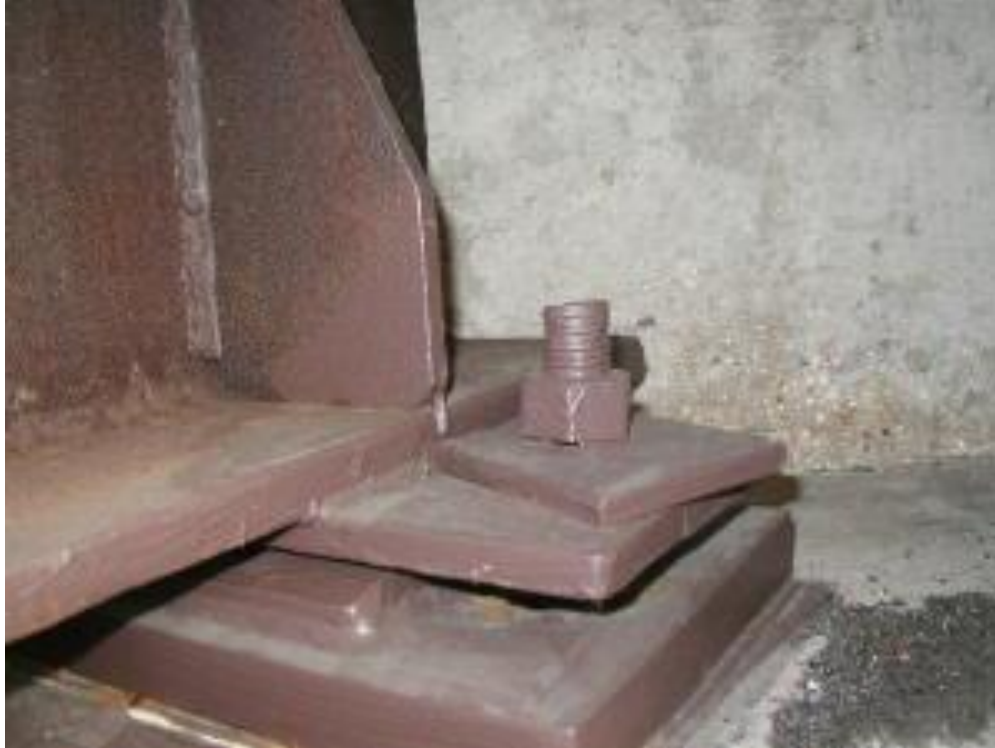
Photo 9 Condition, November 2003

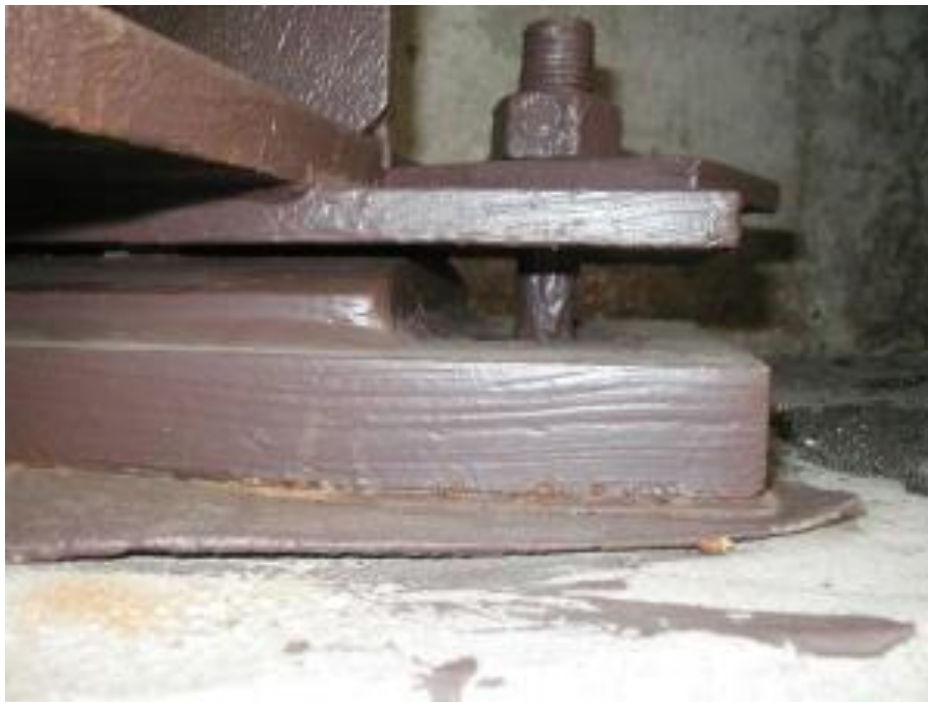
Photo 10 Condition in November 2003, no corrosion after 27 months.

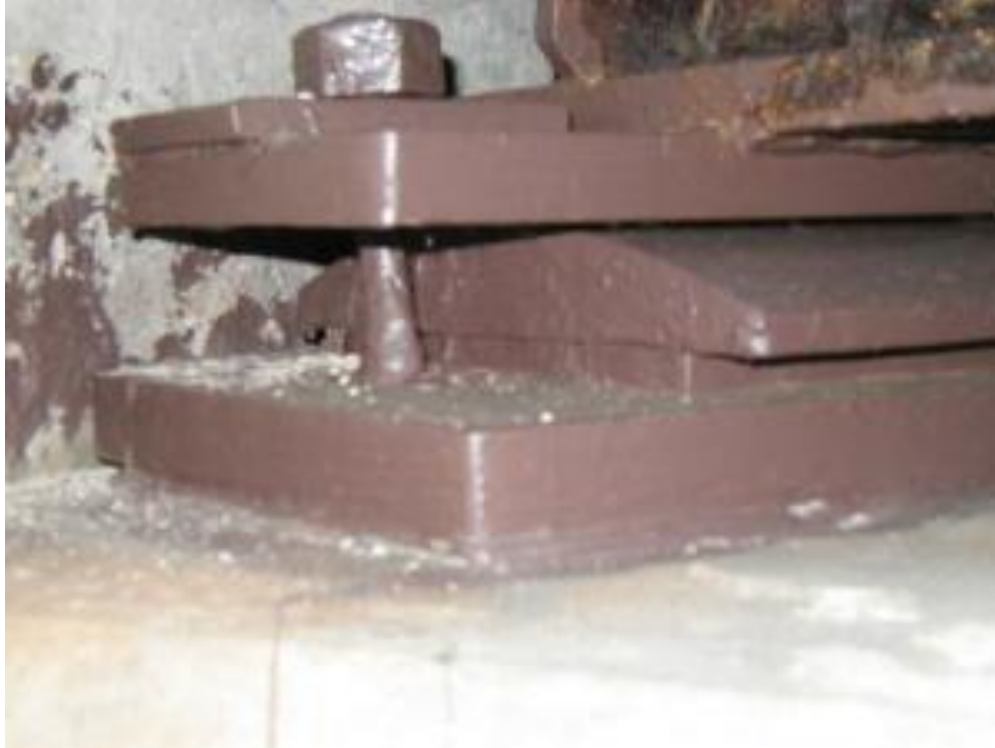
Photo 11 Condition in November 2003, after 27 months

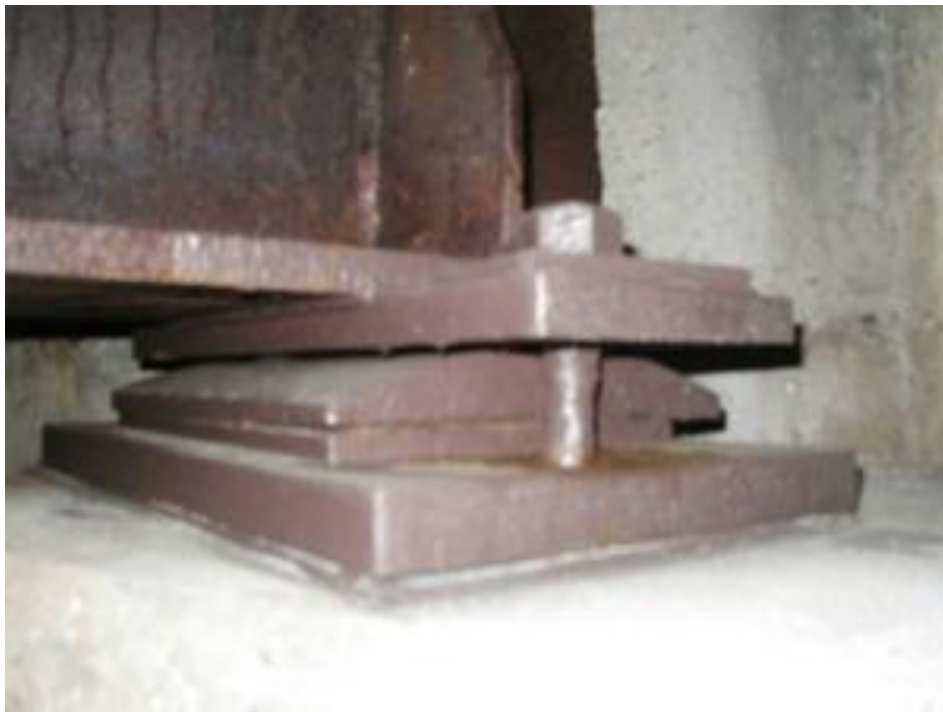
Photo 12 Condition in November 2003, no corrosion after 27 months.

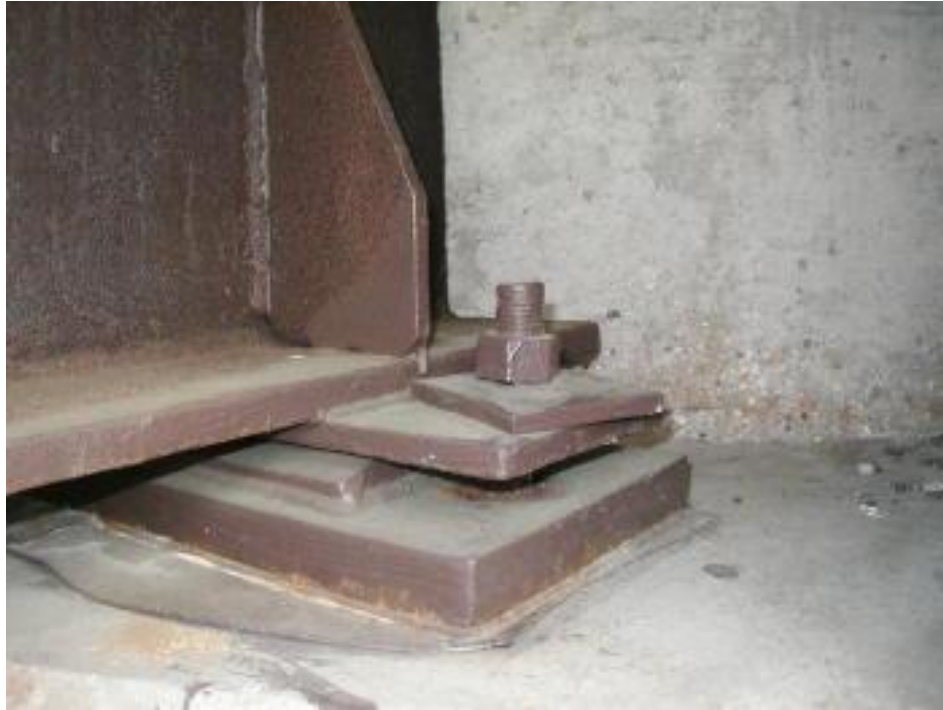
Photo 13 Condition in May 2005, no corrosion of the bearings or anchor bolts.

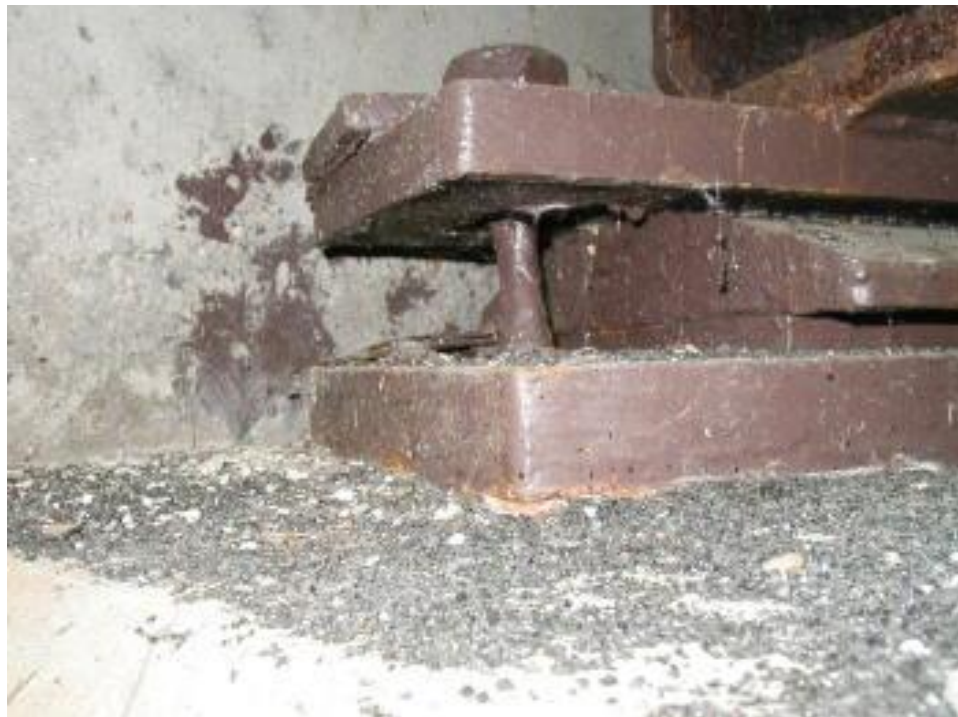
Photo 14 Condition in May 2005, no corrosion of the bearings or anchor bolts.

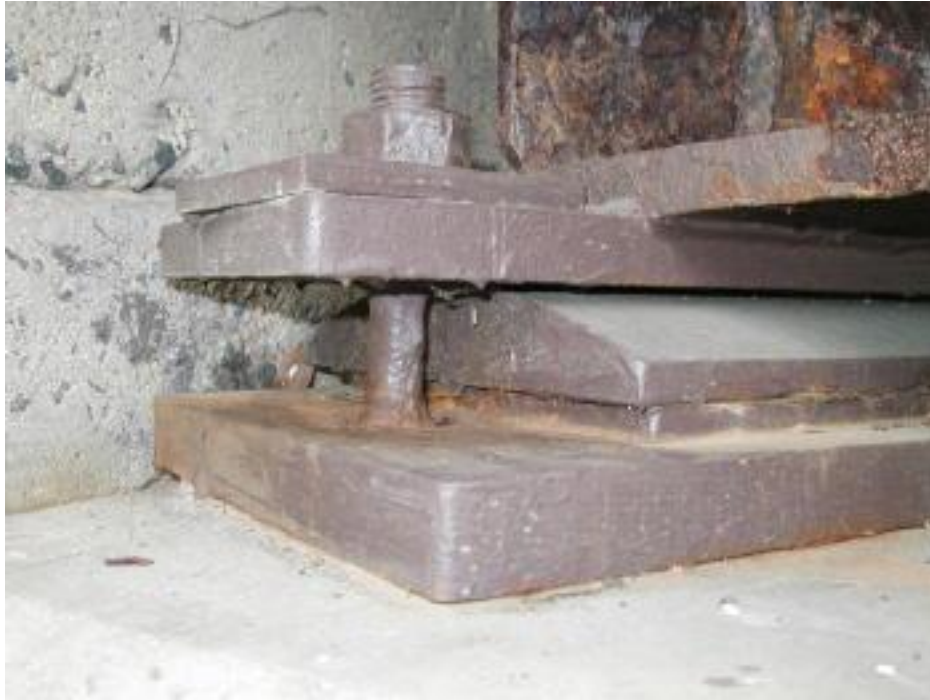
Photo 15 Condition in May 2005, no corrosion of the bearings or anchor bolts.  
(Rust staining is from inside of hole in upper bearing plate)

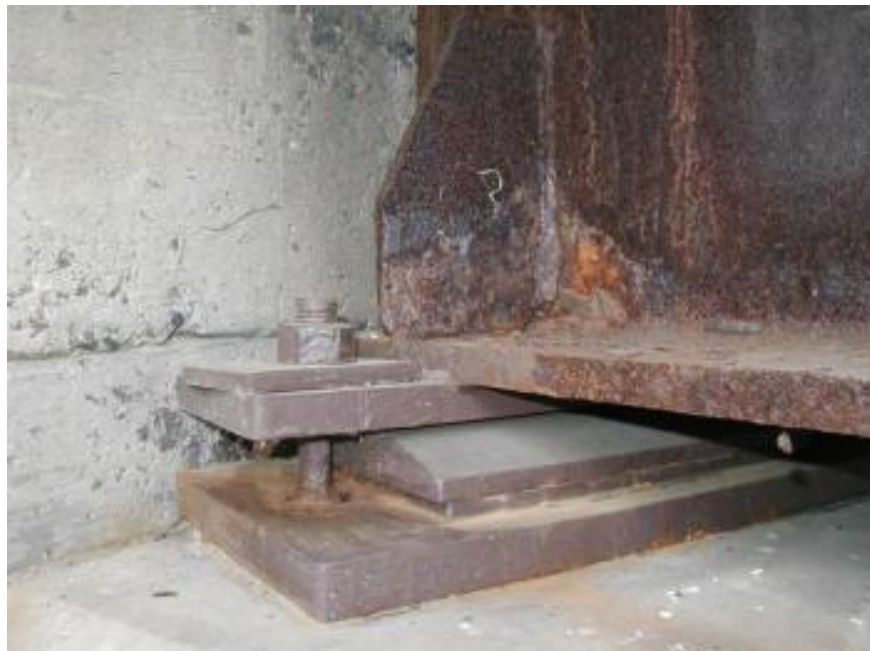
Photo 16 Condition in May 2005, no corrosion of the bearings or anchor bolts.  
(Rust staining is from the underside of the top bearing plate and inside of holes in plates)

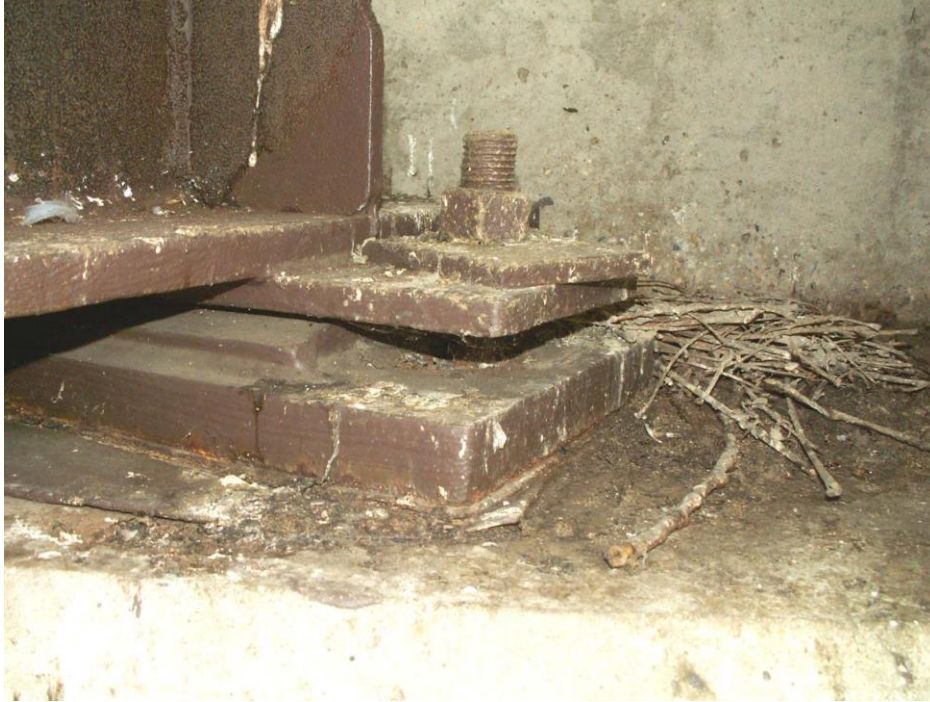
Photo 17 Condition of an exterior bearing in September 2007, after 6 years  
(No corrosion or rust staining)

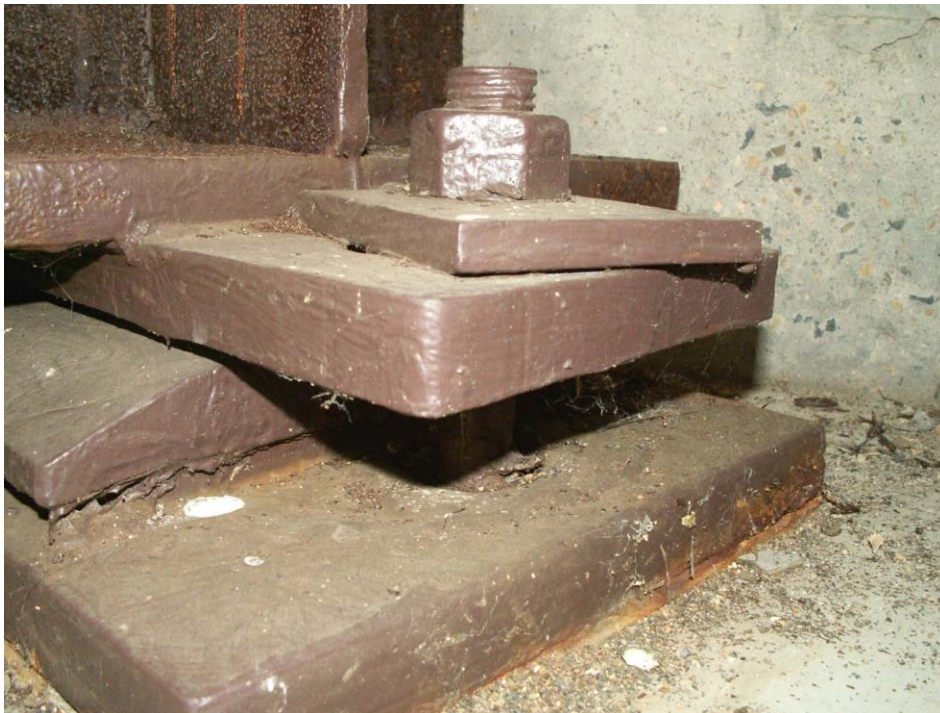
Photo 18 Condition in September 2007 after 6 years (Rust staining is from the underside of the top bearing plate, inside of holes in plates and under base plate)

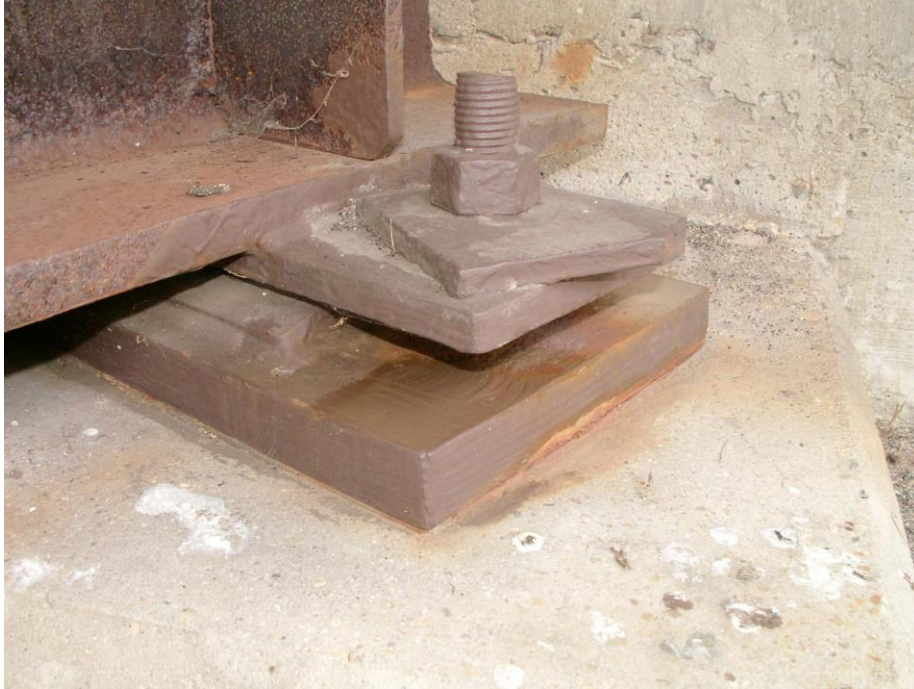
Photo 19 Condition in September 2007 after 6 years (Note that rust staining on top of the front corner of the base plate has been washed off paint under it is in excellent condition)

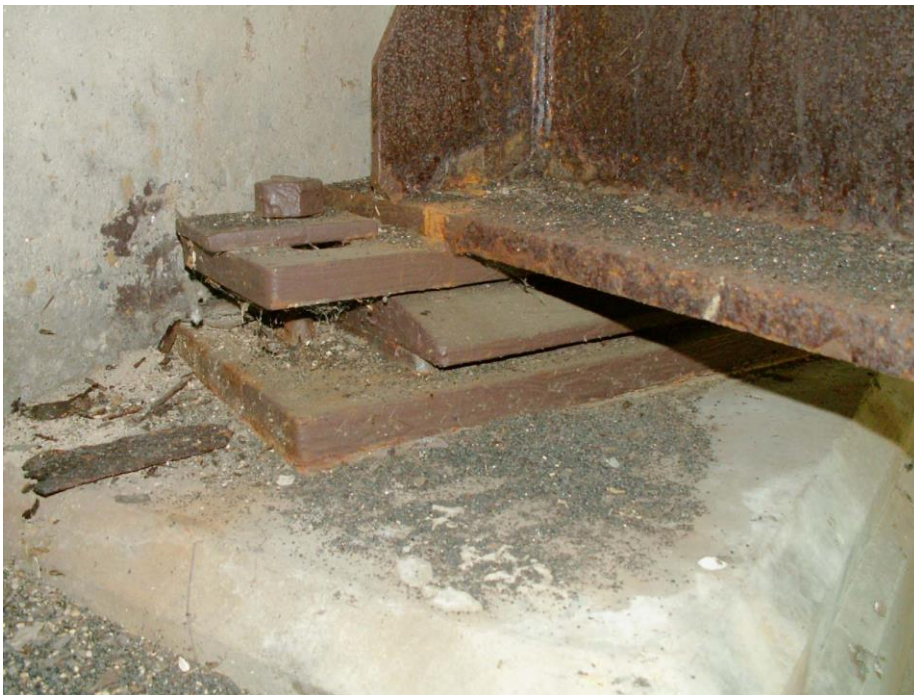
Photo 20 Condition in September 2007 after 6 years (Rust staining is from the underside of the top bearing plate and inside of the holes and rusting of the unpainted A-588 steel beam)

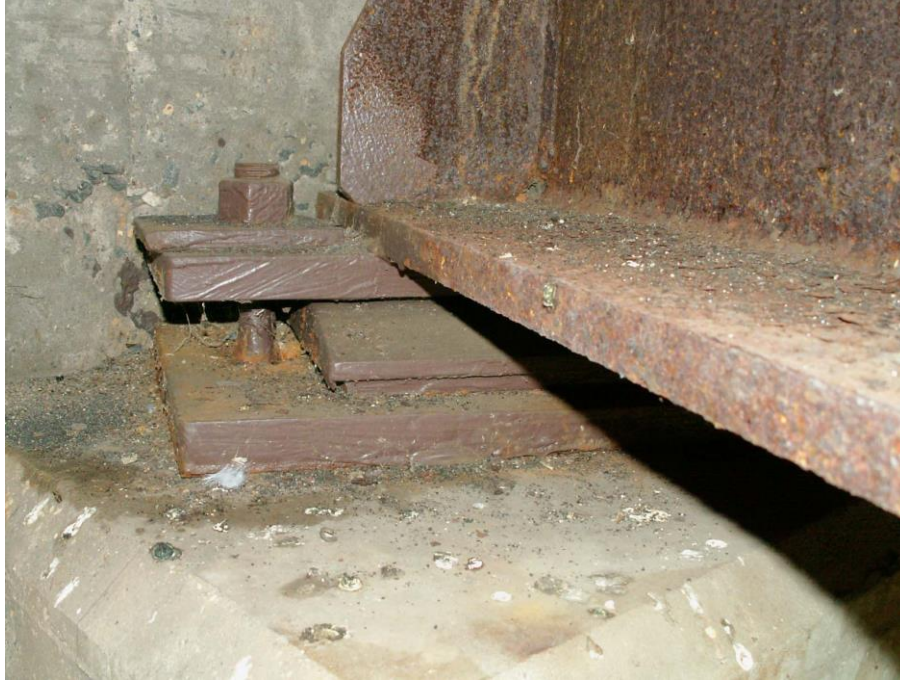
Photo 21 Condition in September 2007 after 6 years (Rust staining is from under underside of plates and inside of holes and the A-588 beam (Compare to Photos 6, 11 and 14))

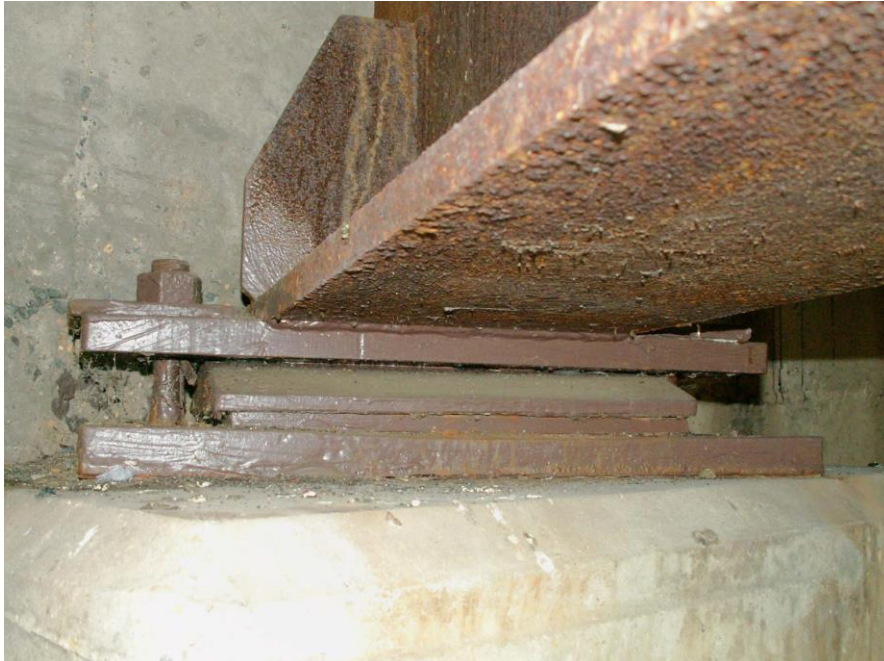
Photo 22 Condition in September 2007 after 6 years (Rust staining is from unpainted A-588 steel beam)
