**INITIAL REPORT**

**STOPPING ACTIVE CREVICE CORROSION**

**On a Lancaster County Pennsylvania Truss Bridge  
“Big Conestoga #9” (Rock Hill Road) bridge  
By High Pressure (5,000 psi) Water Wash Cleaning (with C\*R)  
and Overcoating with the Termarust  
high ratio co-polymerized calcium sulfonate coating system**

**For Lancaster County Pennsylvania  
Lancaster, Pennsylvania**

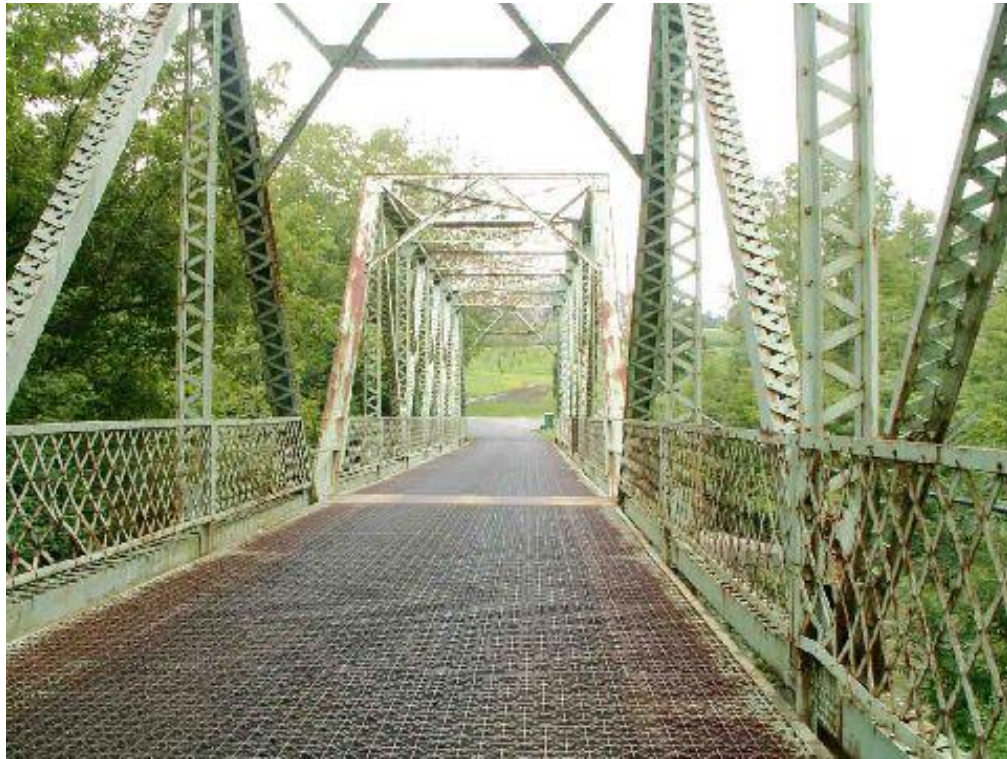
Photo 1 – Bridge before cleaning and coating with the Termarust system.

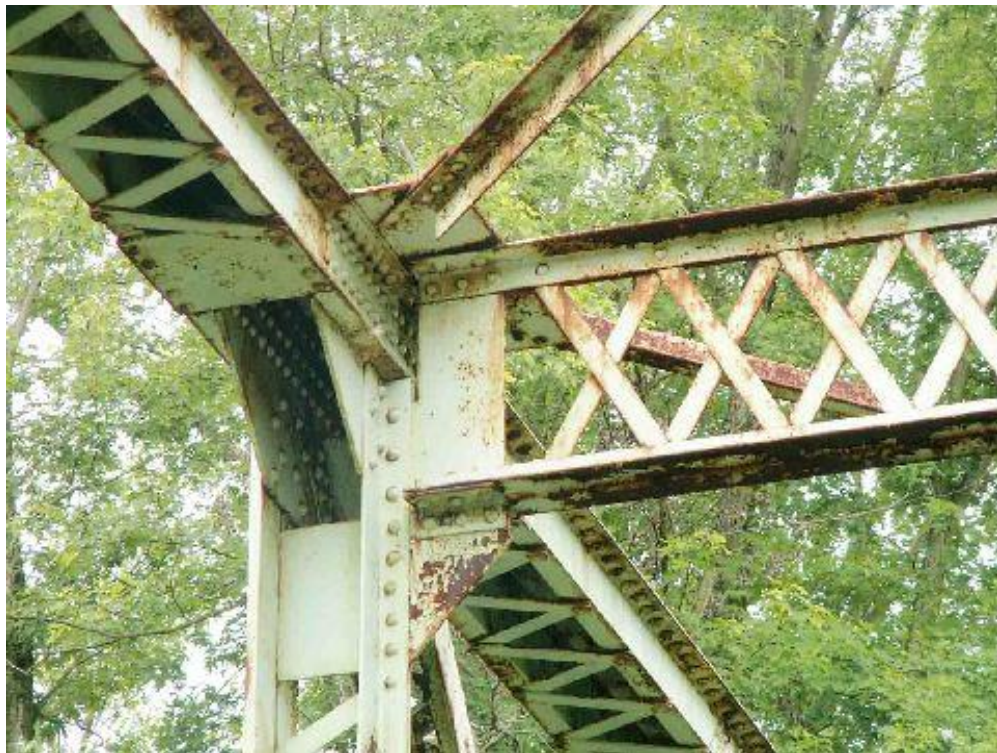
Photo 2 – Upper portion of the truss – showing corrosion and some pack rust.

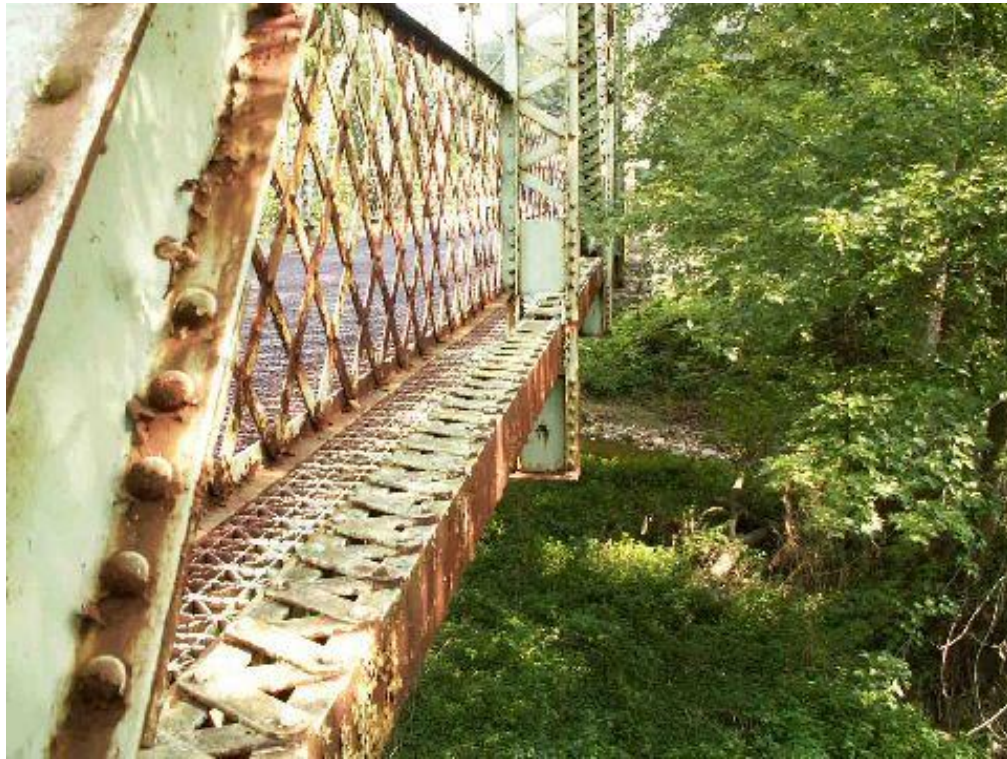
Photo 3 – View of outside of the truss, before cleaning and coating with Termarust

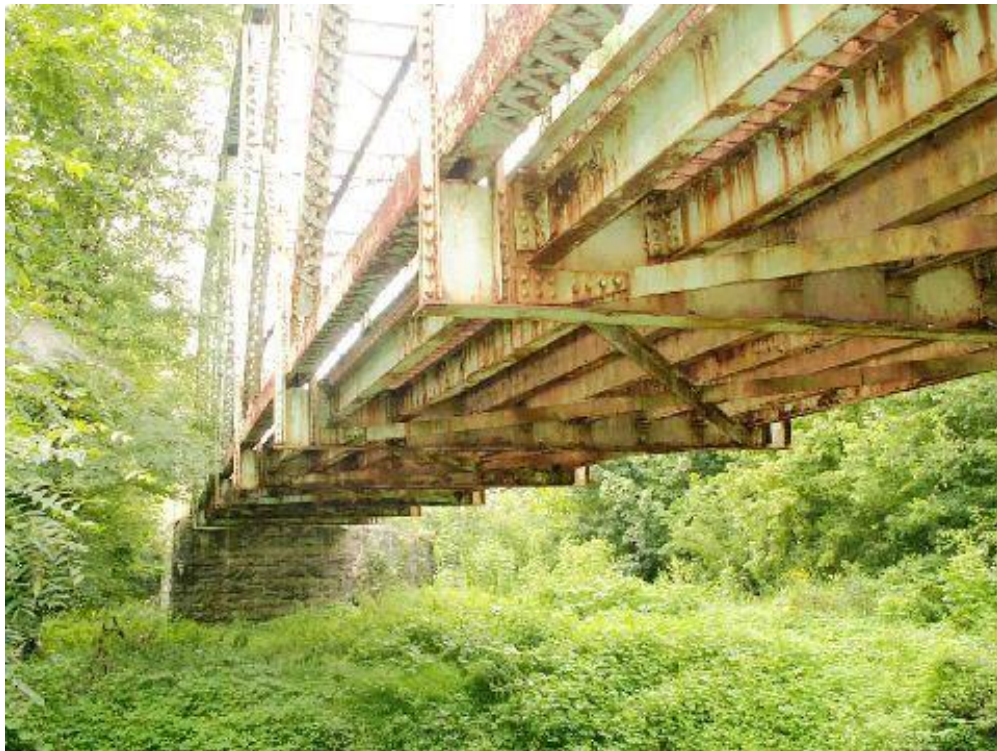
Photo 4 – The underside of one span of the truss, before cleaning and coating with Termarust.

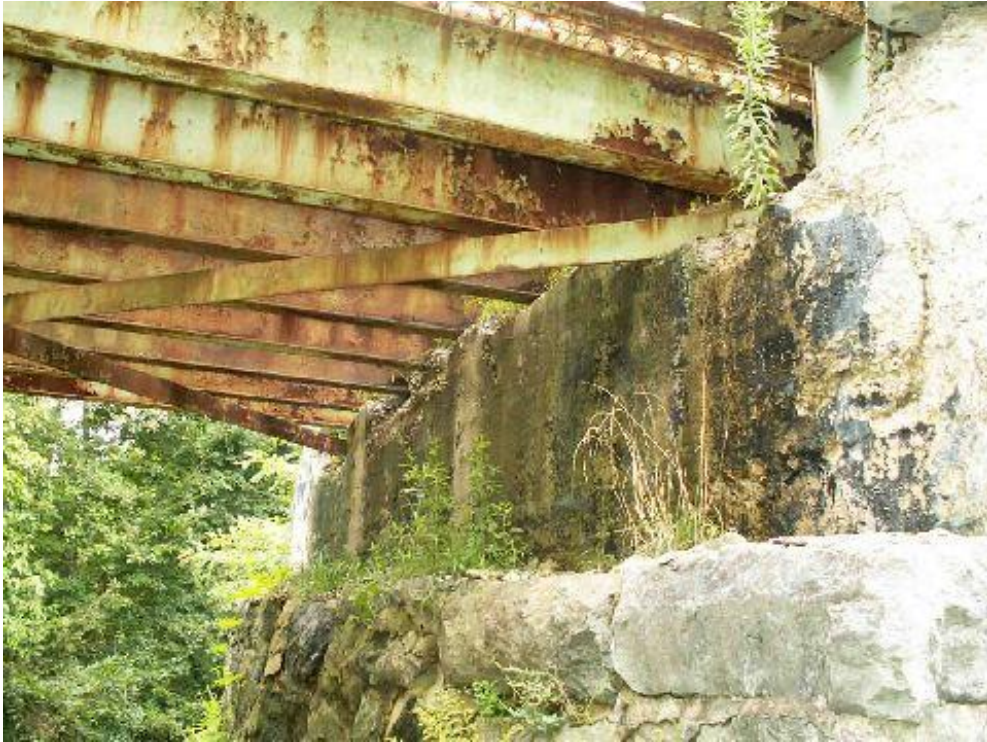
Photo 5 – Underside of the deck, at the pier. The ends of four of the longitudinal beams had corrosion-caused holes in the webs. The webs were strengthened by welding plates to both sides.

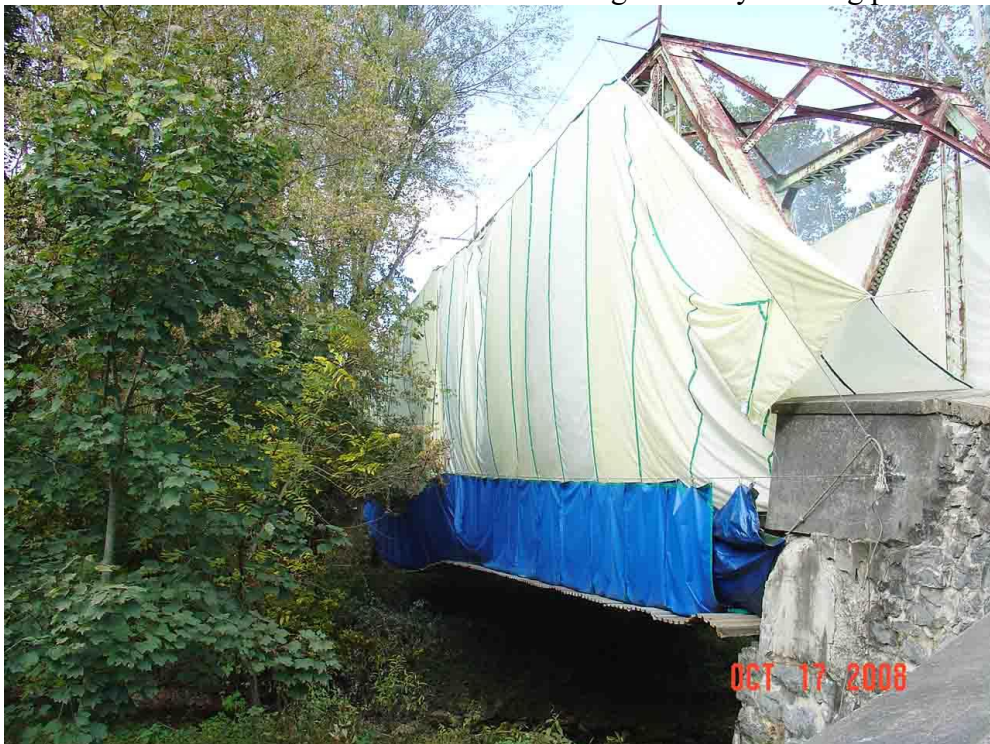
Photo 6 – Containment for pressure wash cleaning and collection of lead paint containing chips of paint and corrosion debris

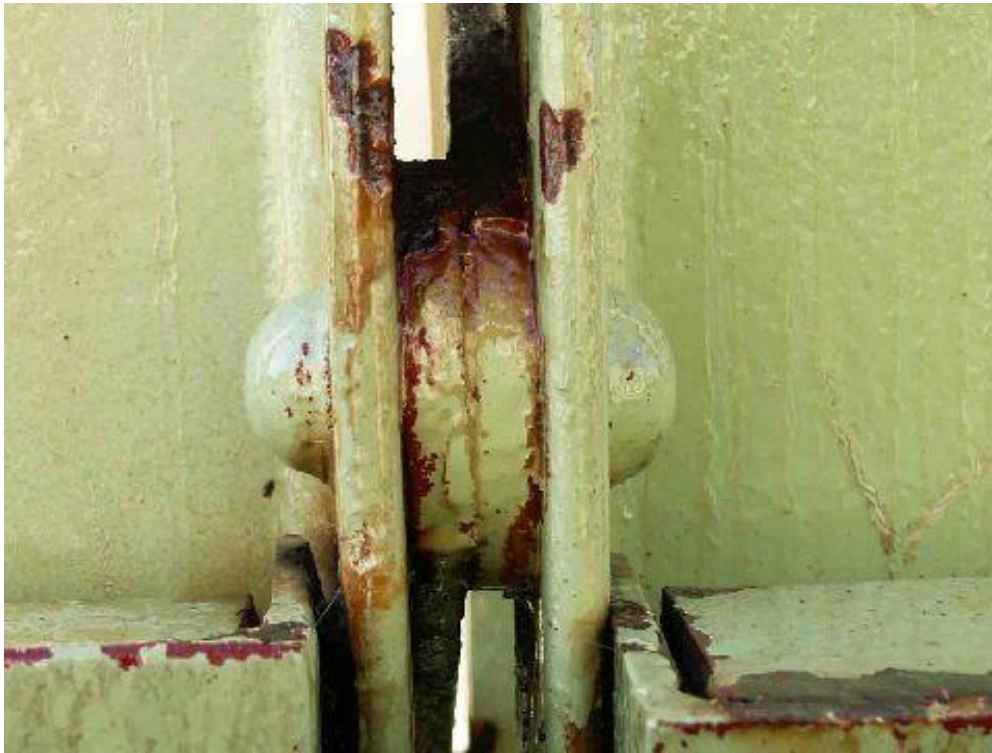
Photo 7 – After pressure washing – loose paint and loose corrosion debris has been removed.

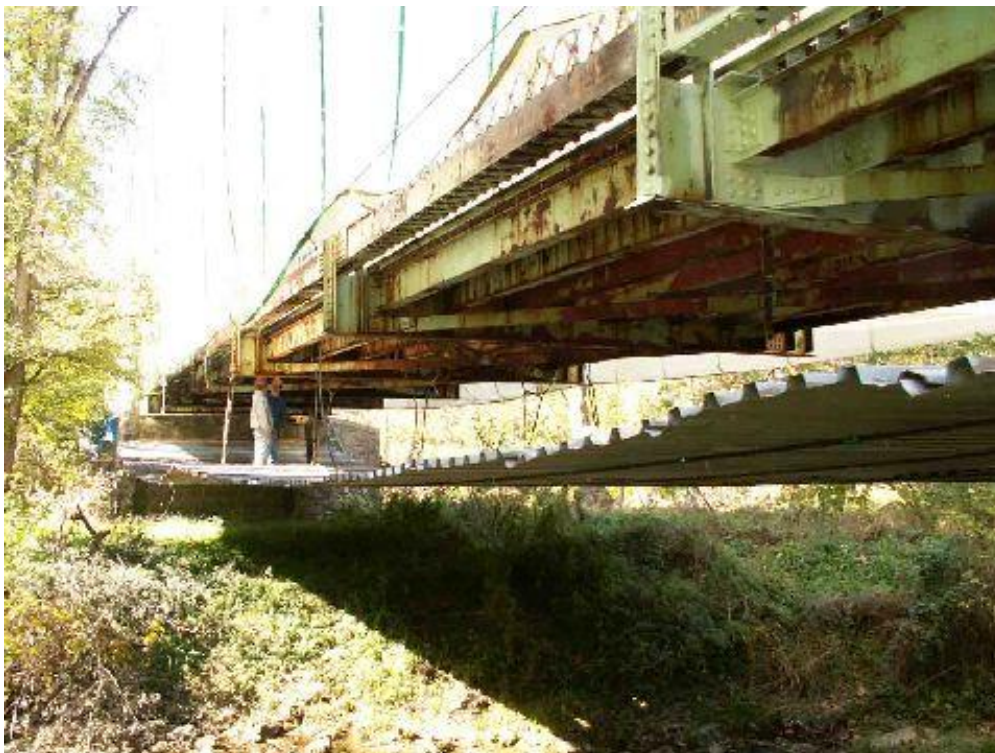
Photo 8 – Work platform – Containment tarps were removed after pressure washing.

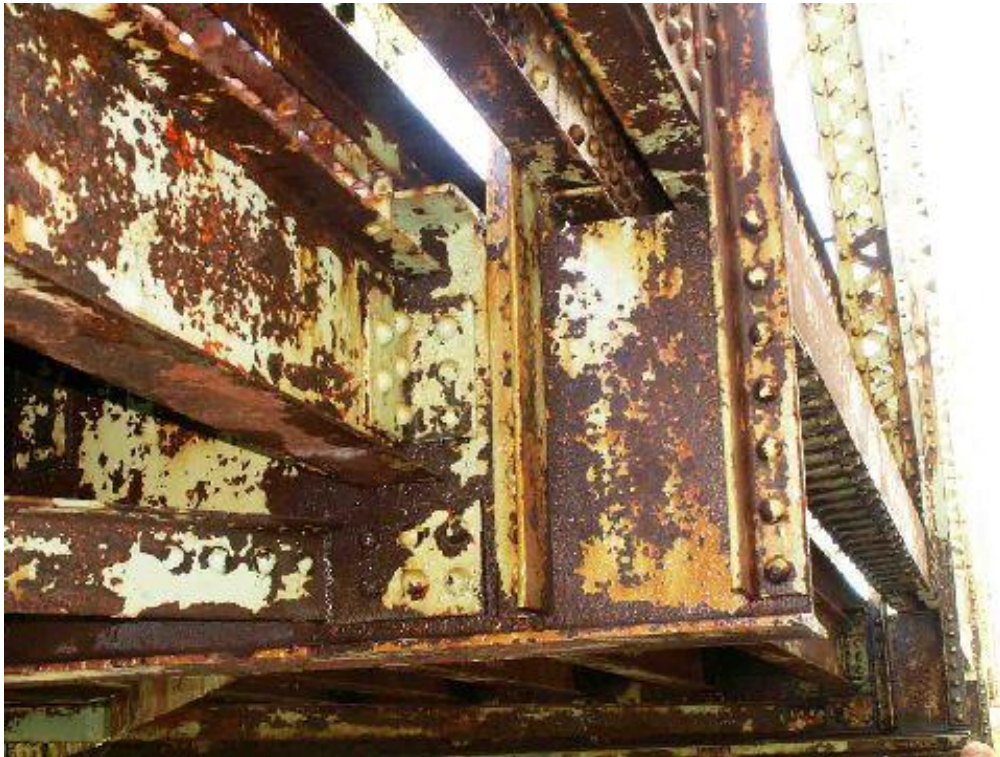
Photo 9 – After pressure washing only tight paint and tight clean rust remains

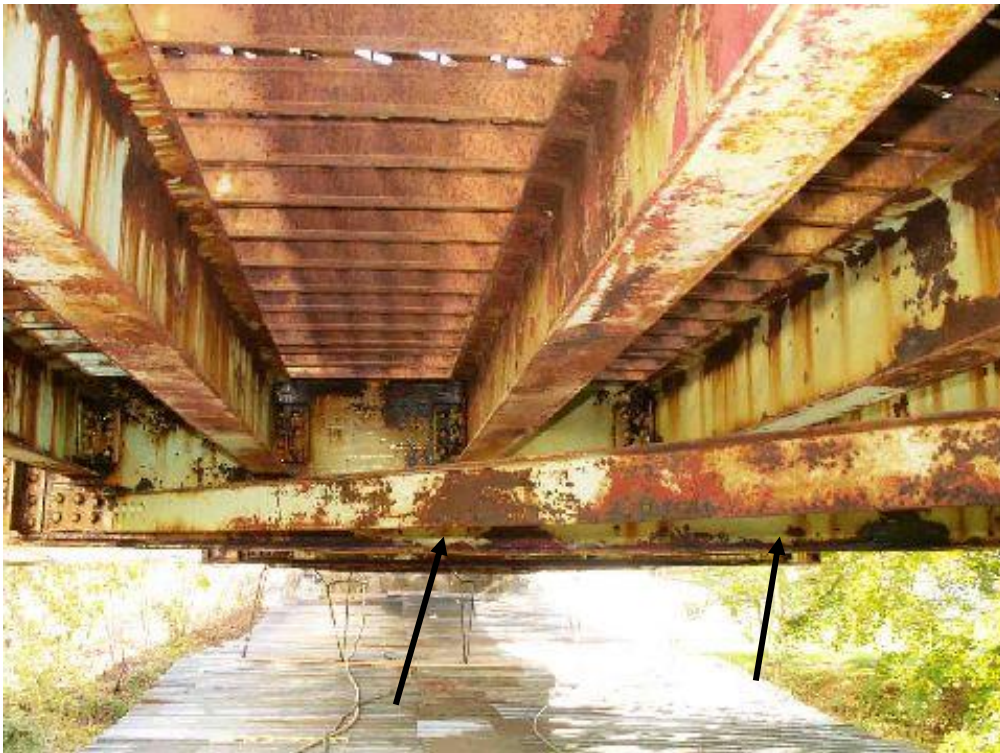
Photo 10 – After pressure washing – some scale rust remains on some members under the deck, which must be mechanically removed, because there is active corrosion under it.

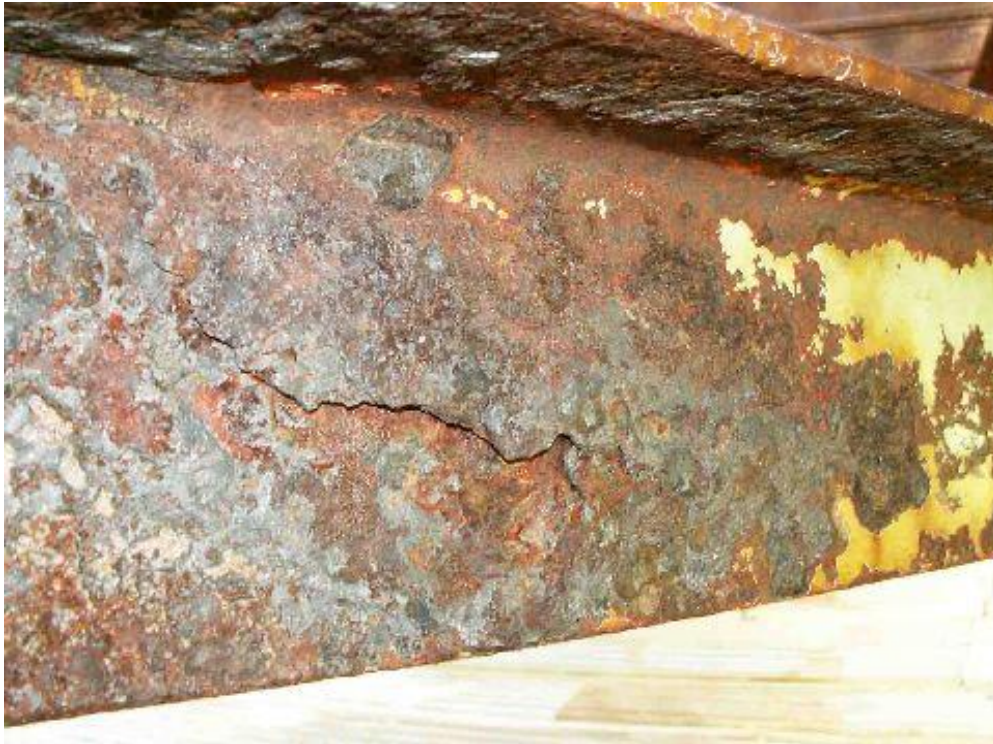
Photo 11 – Example of scale rust that remained after pressure washing; and which was removed.

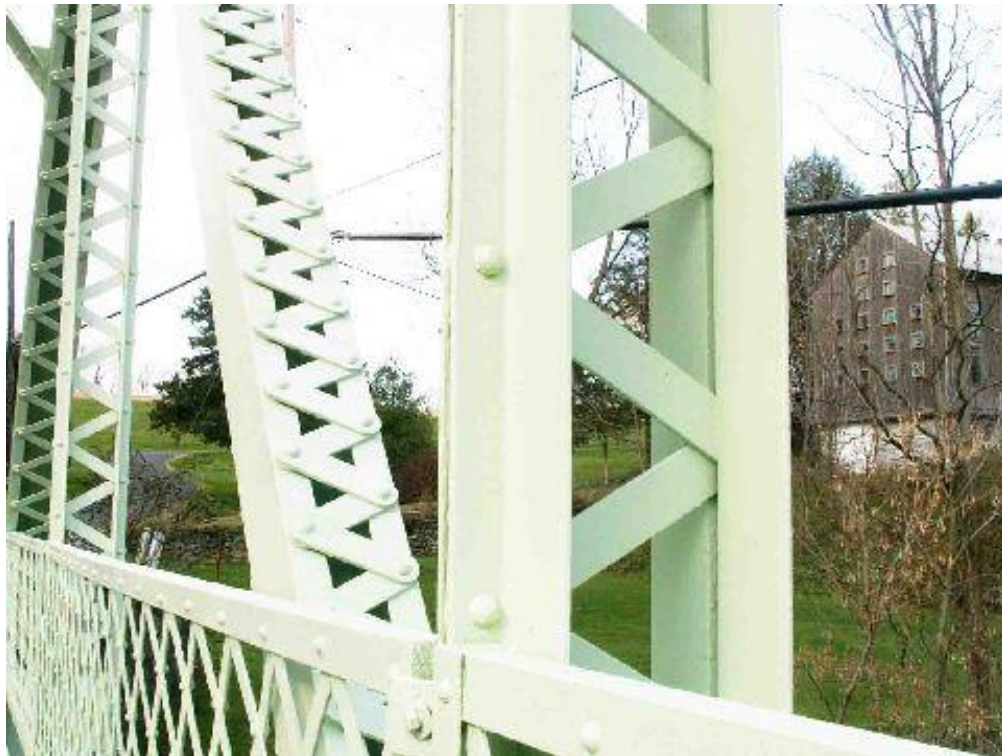
Photo 12 – Bridge members have been coated with the Termarust system

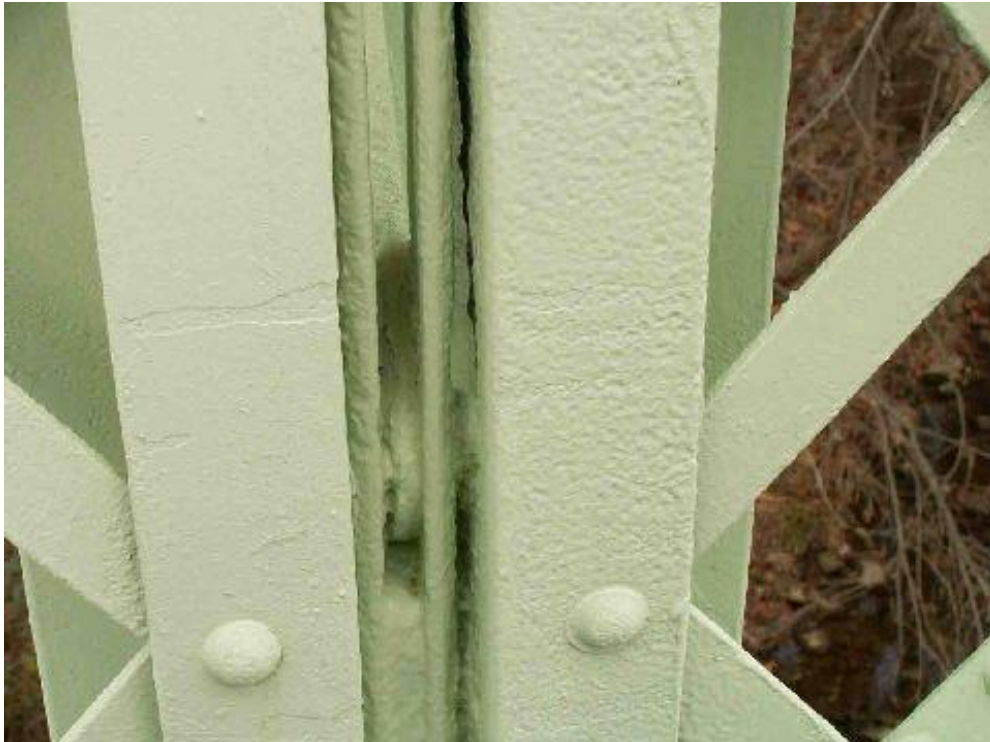
Photo 13 – Close-up of a complex connection (See Photo 7)

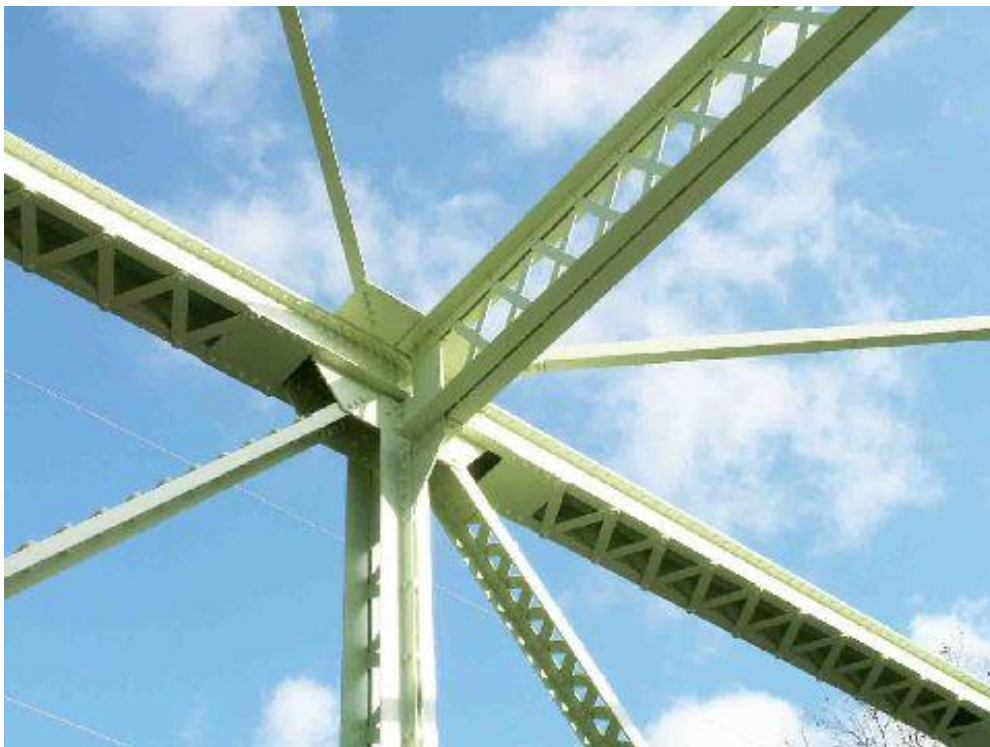
Photo 14 – Coating has been completed (See Photo 2)

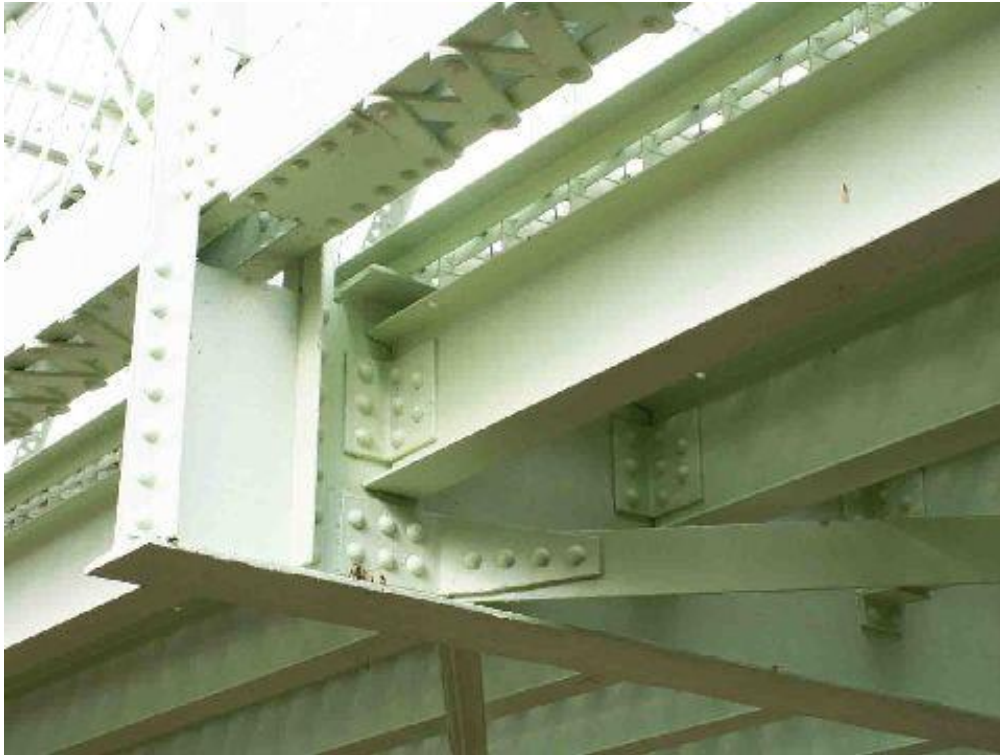
Photo 15 – Coating has been completed (See Photos 8 and 9)

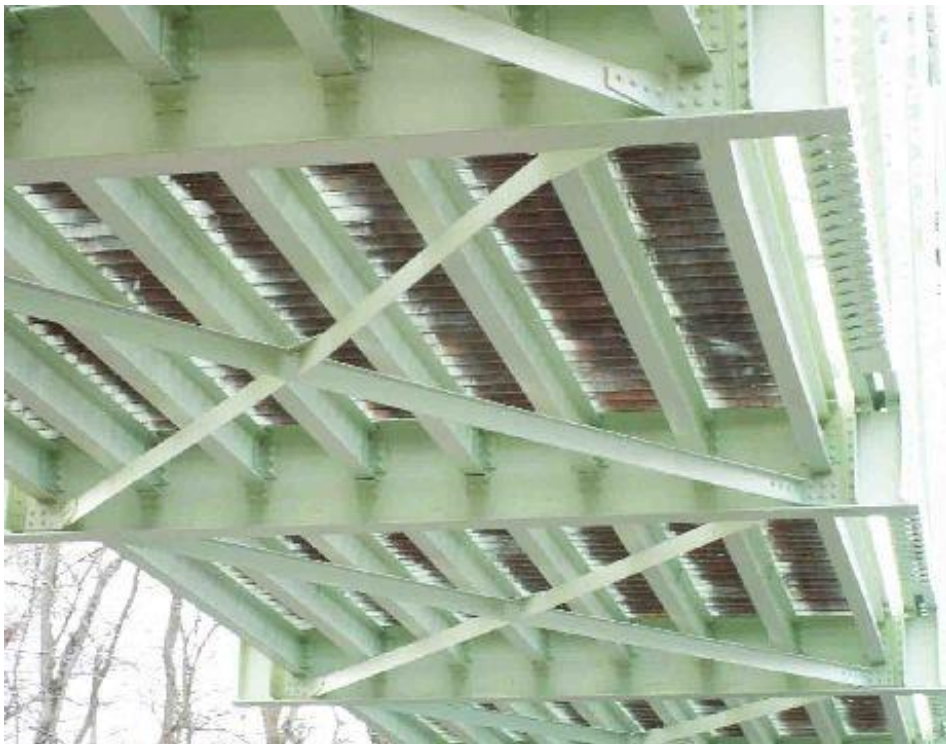
Photo 16 – Coating has been completed and corrosion stopped. (See Photos 4, 5 and 10)
