**UPDATE REPORT 12 YEARS OF SERVICE TERMARUST HRCSA OVERCOATING**

**High Pressure (5,000 psi) Water Cleaning  
and Overcoating of a Historic (1915) truss bridge on Route  
778 over the Middle River in Augusta County, Virginia With  
the Termarust HRCSA High Ratio Co-Polymerized Calcium  
Sulfonate Coating System**

**For the Staunton District Virginia DOT**

# UPDATE REPORT 12 YEARS AFTER TERMARUST HRCSA OVERCOAT

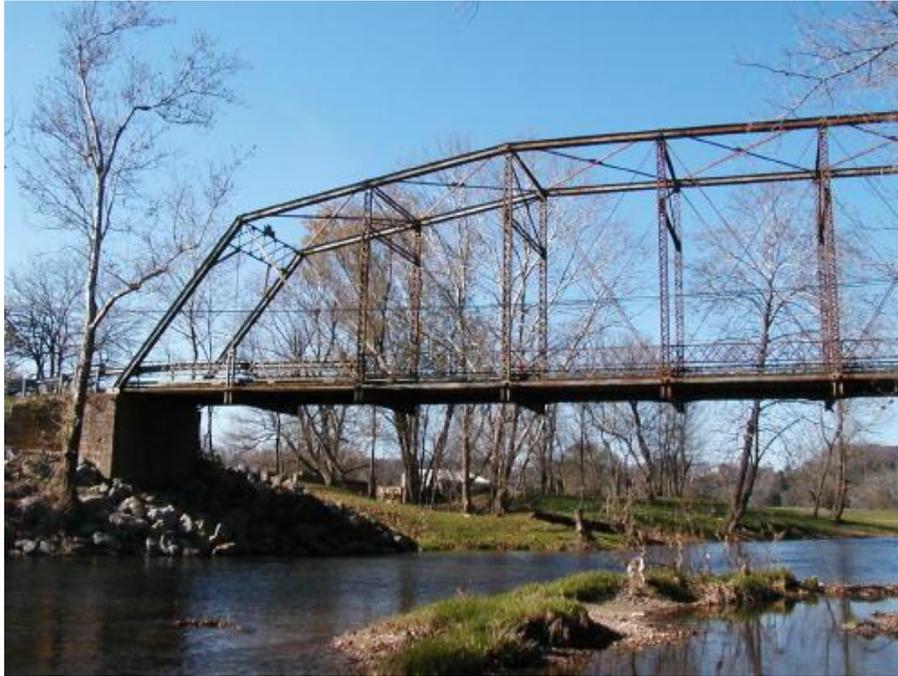
Photo 1 Bridge in 2004, before painting.

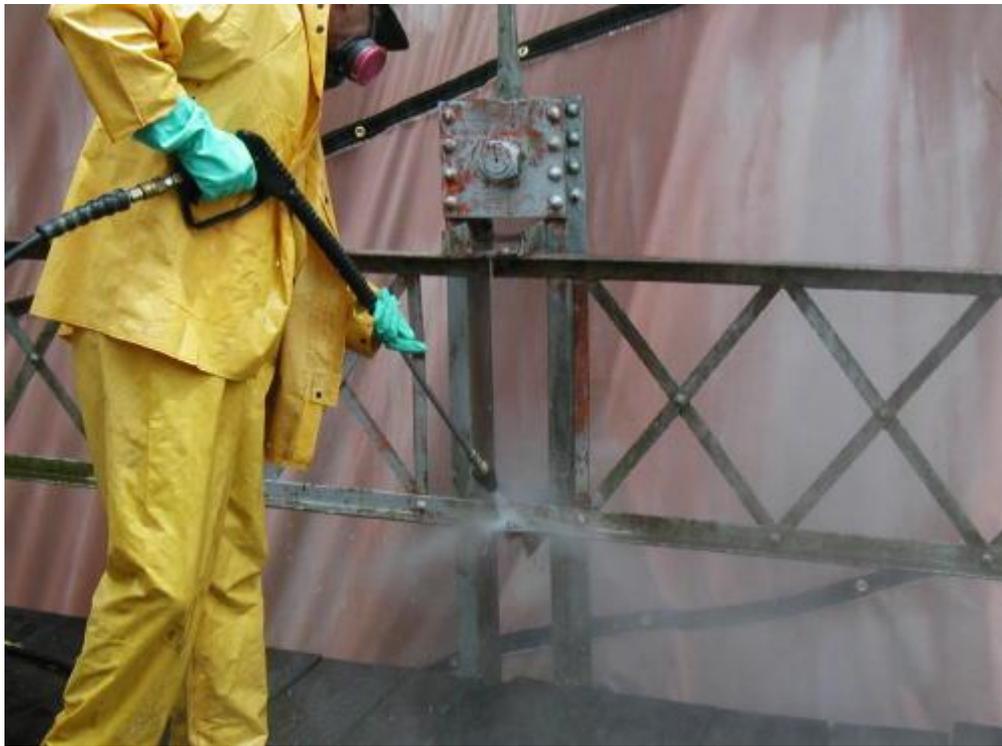
Photo 8 5,000 psi pressure washing, standoff distance less than 4 inches.

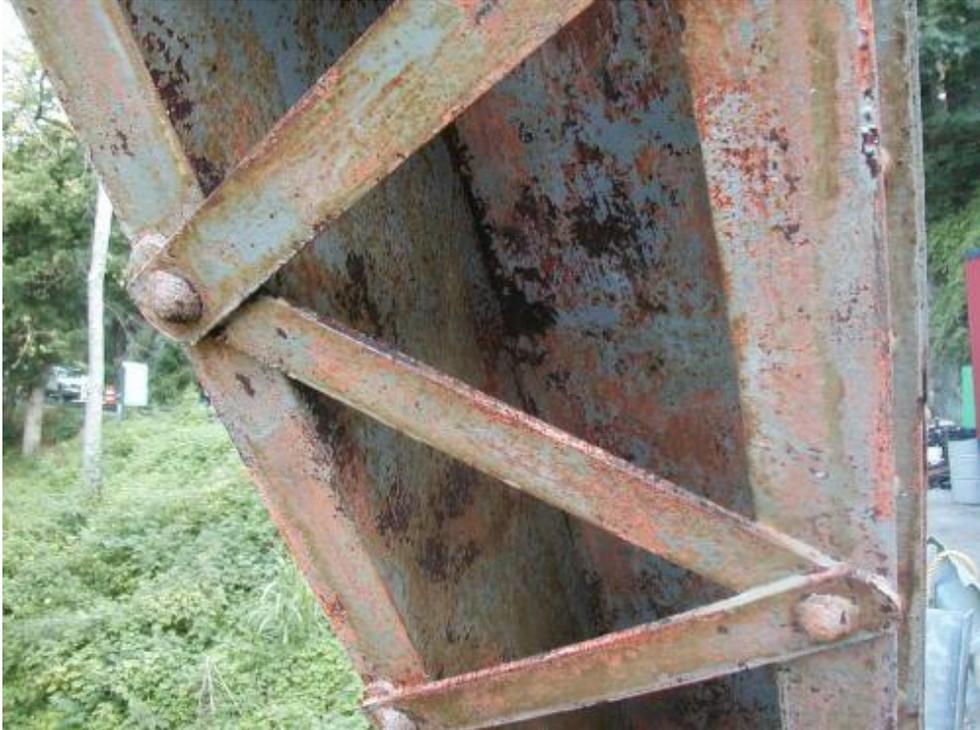
Photo 9 Truss member cleaned by pressure washing, ready for painting.

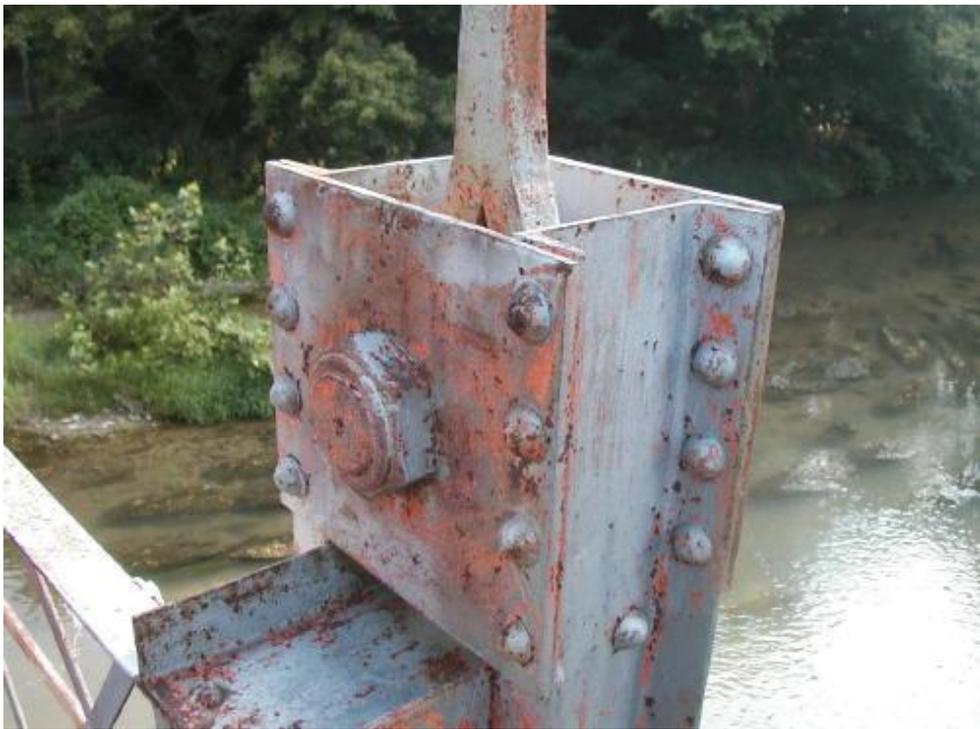
Photo 10 Bottom of tie rod assembly cleaned and ready for painting. (see Photo 25)

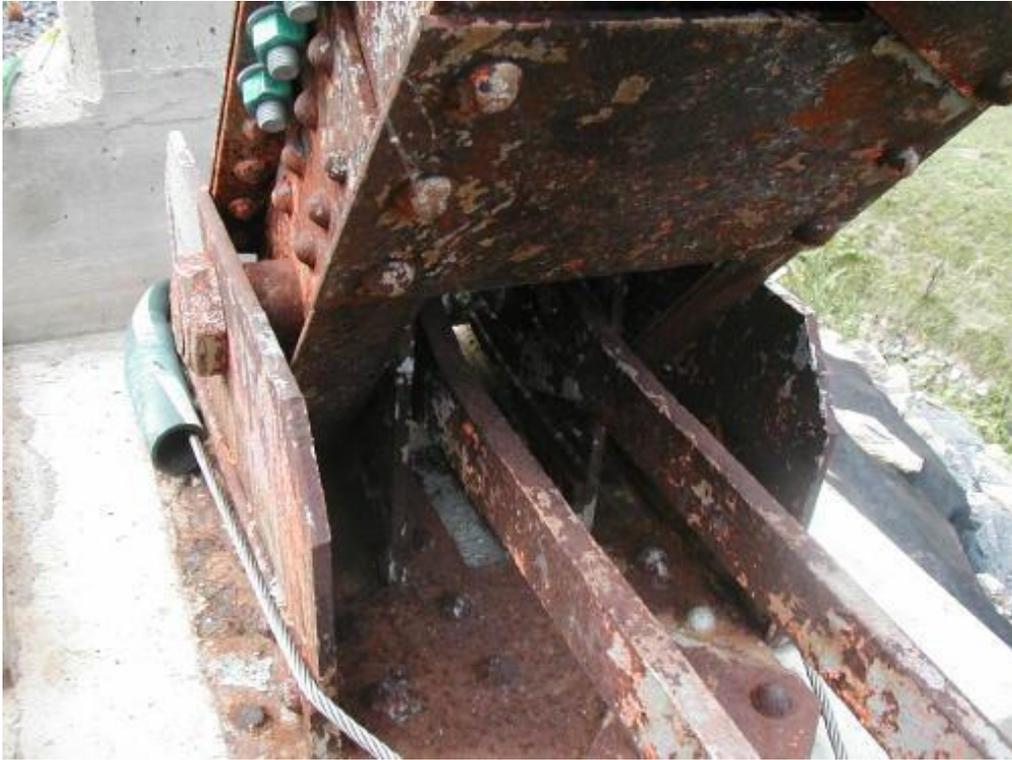
Photo 11 Pin/truss assembly cleaned and ready for painting.

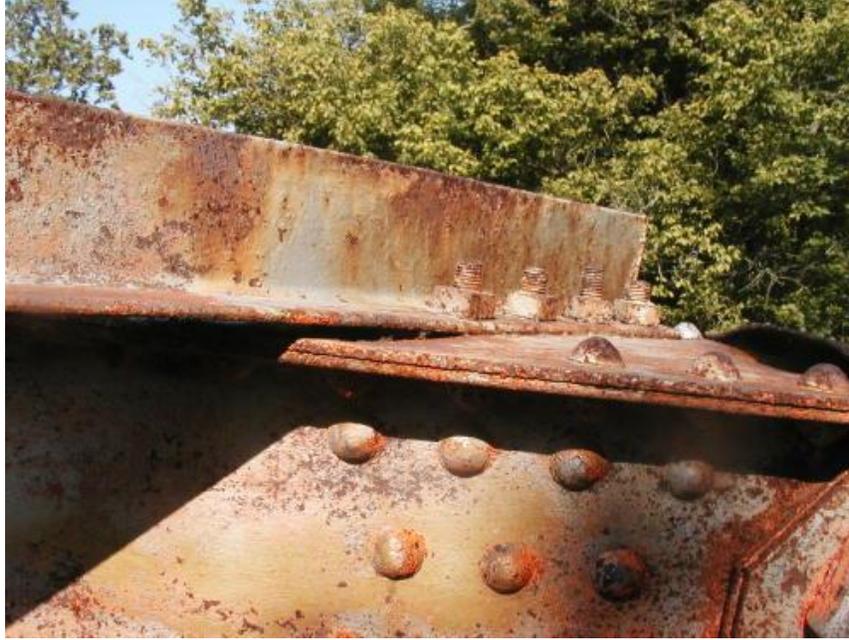
Photo 13 Top of portal frame cleaned and ready for painting

Note: most of pack rust under longitudinal member has been removed by pressure washing.

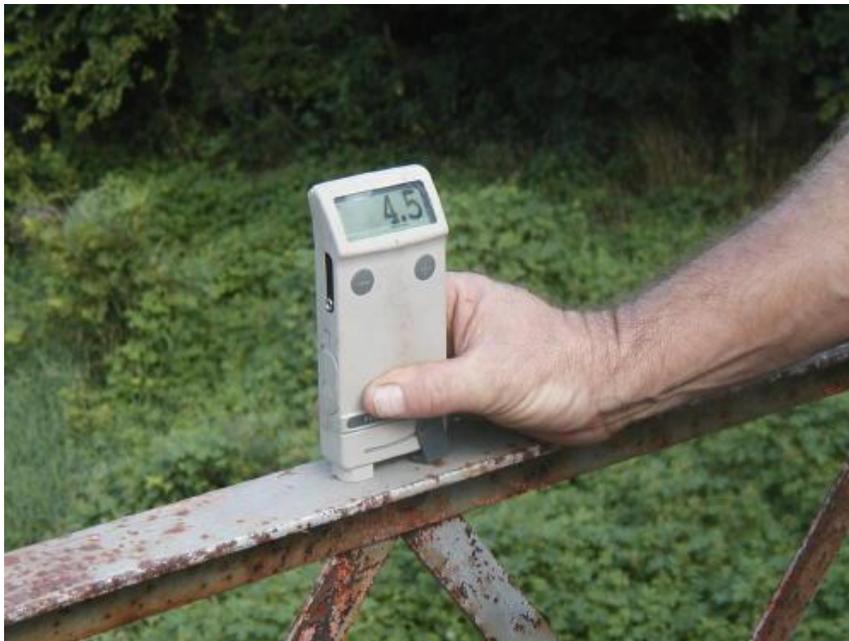
Photo 14 Film thickness gage shows 4.5 mils of existing tightly adhered lead-based paint.

(At least 85% of the bridge had 2.0 to 25 mils of tightly adhered paint, after pressure washing)

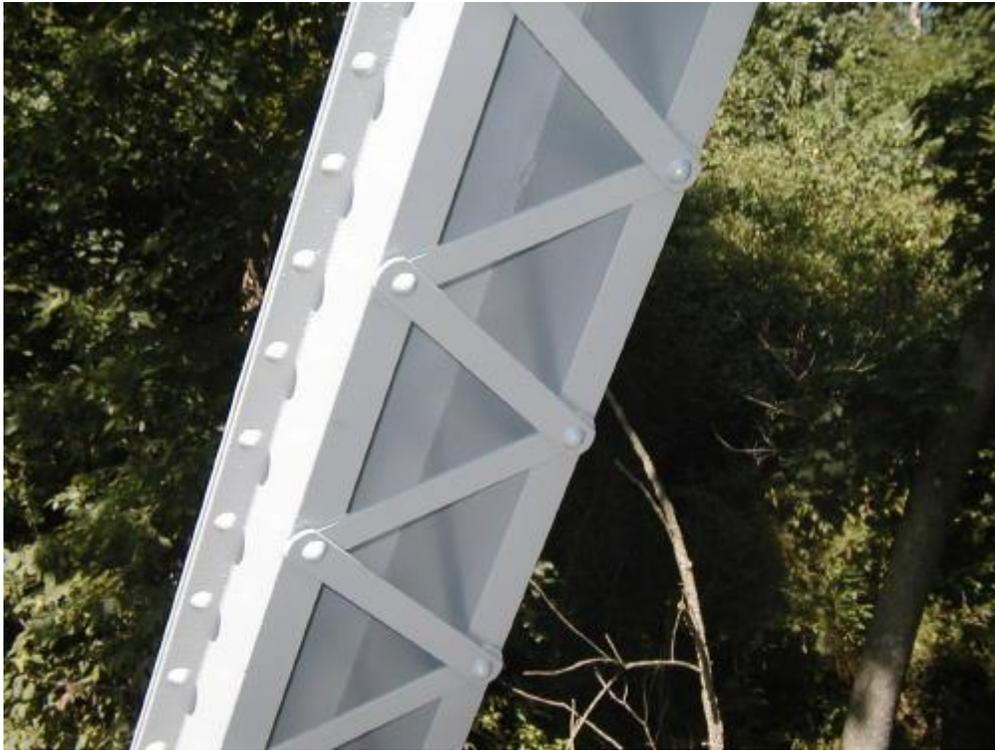
Photo 18 Painting completed. (see Photo 21)

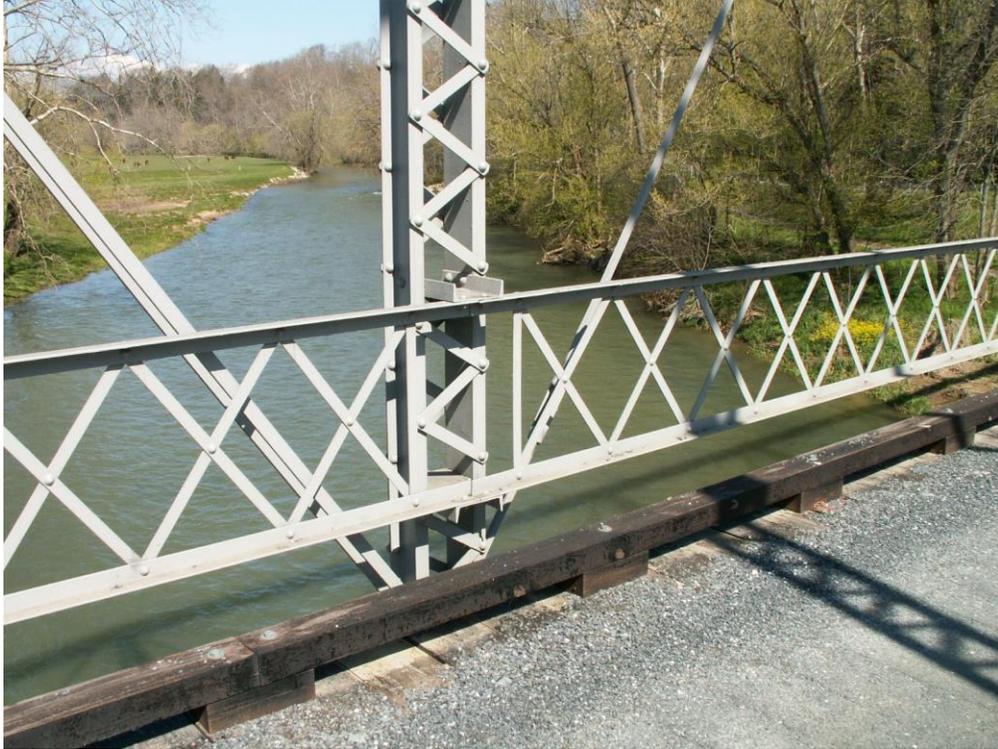
1. The Termarust HRCSA coating appears to be in excellent condition.
2. seen that the color of the Termarust HRCSA Coating has not faded in color.
3. It was observed that there are a few small areas of dark colored stains on small portions of a few connection, for example see Photo 24.

Photo 19 coating has been in service for 12 years . (see Photo 16)

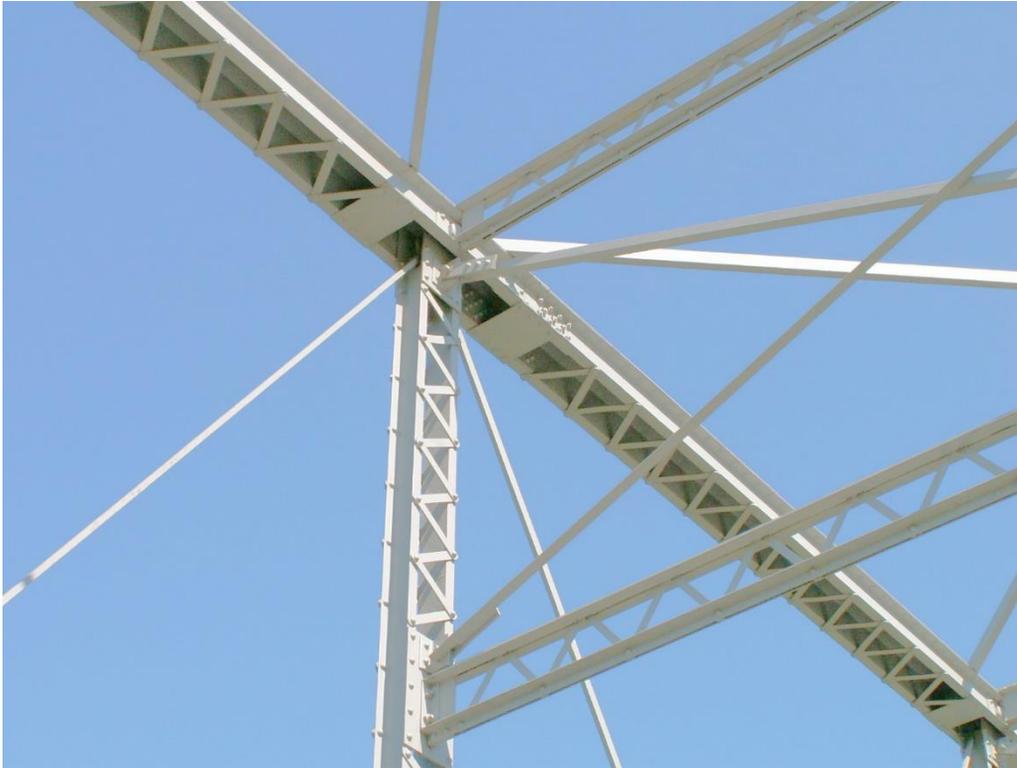
Photo 20 coating has been in service for 12 years . (see Photo 3)

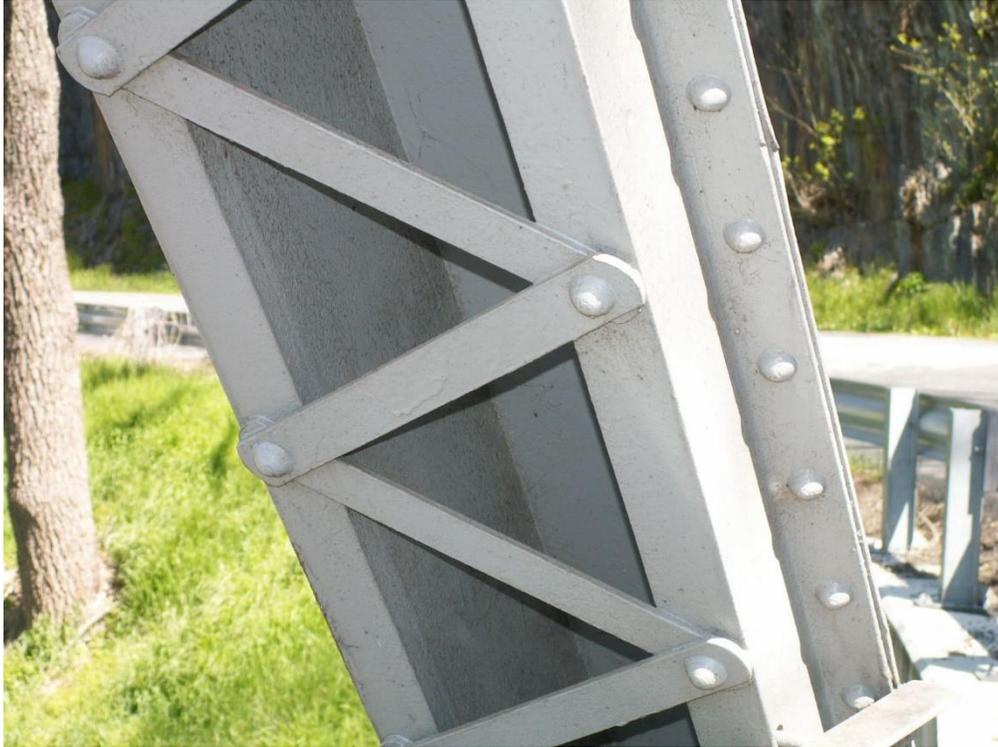
Photo 21 coating has been in service for 12 years .. (see Photos 9 and 18).

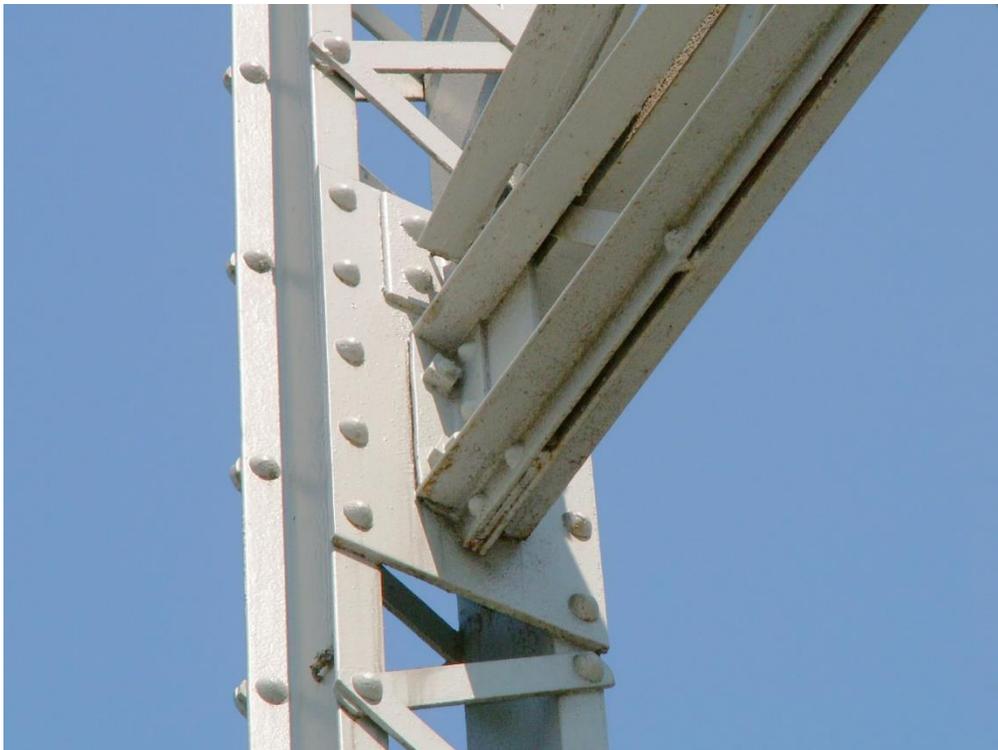
Photo 22 coating has been in service for 12 years . (see Photos 3 and 20)

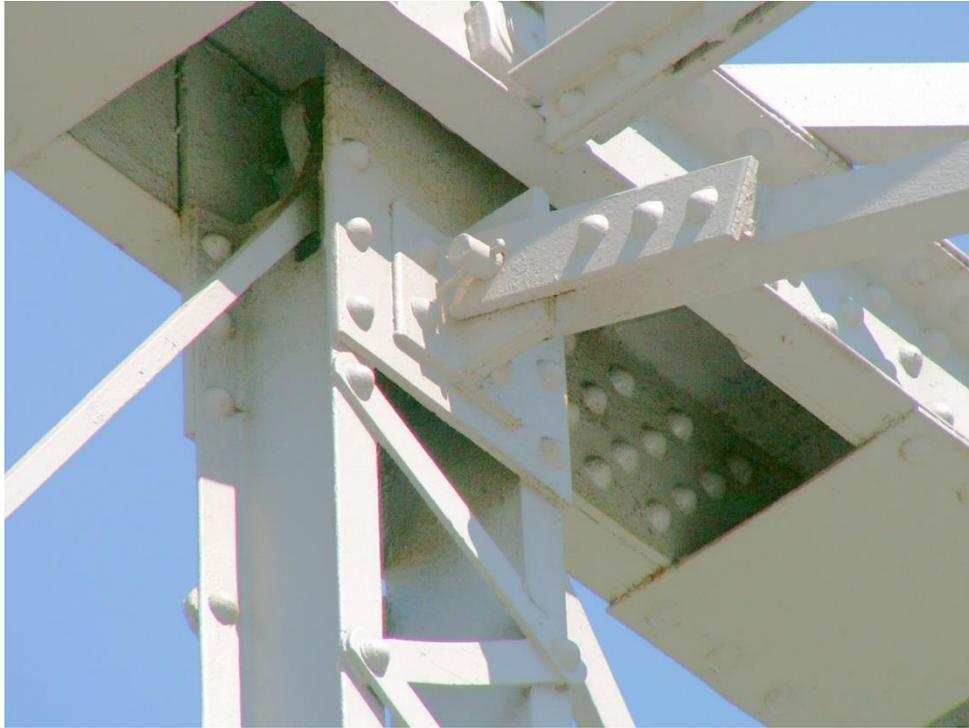
Photo 23 coating has been in service for 12 years . (see Photos 3 and 20)

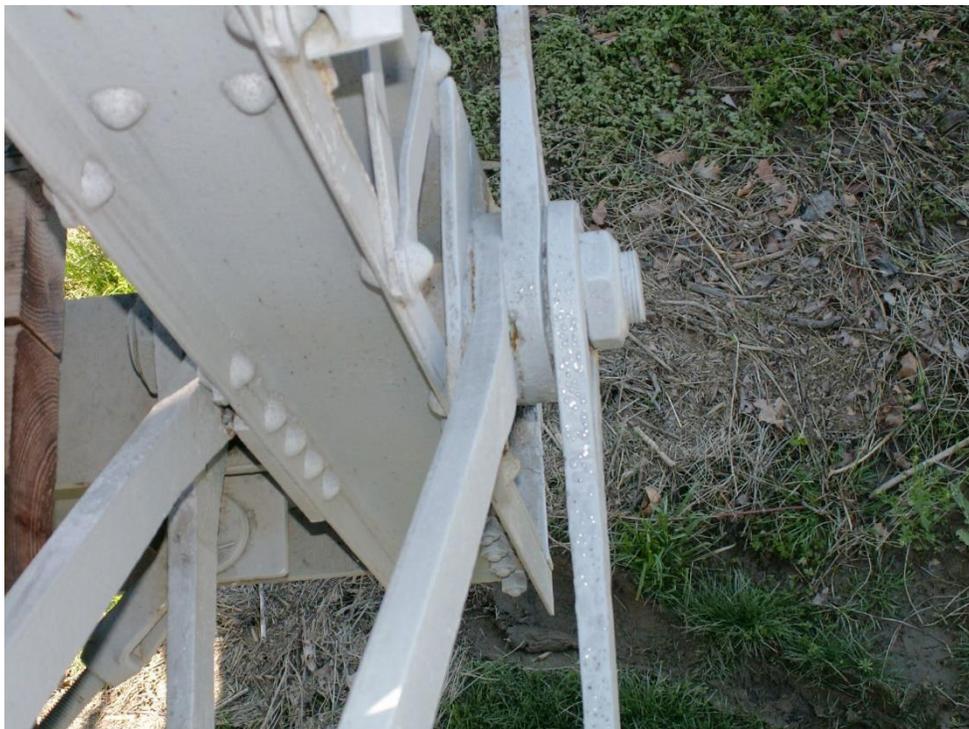
These areas are believed to be where the water (from pressure washing) was not completely blown out during the high pressure air blow-down of the connections with the result that the Termarust HRCSA TR2200HS Penetrant/Sealer and the TR2100 Primer/Topcoat (which have a polar attraction to steel) have pushed the rusty water out of the connections and onto the surface of the connection and then they wetted the steel and chemically stopped further corrosion.

The fact that these areas have a dark color (rather than bright red) indicates that the active corrosion in the connections has been stopped. Also, it has been found on other projects that this dark stain is just on the surface of the adjacent areas and it can usually be wiped off.

Photo 24 coating has been in service for 12 years (see Note 3 on Page 3)

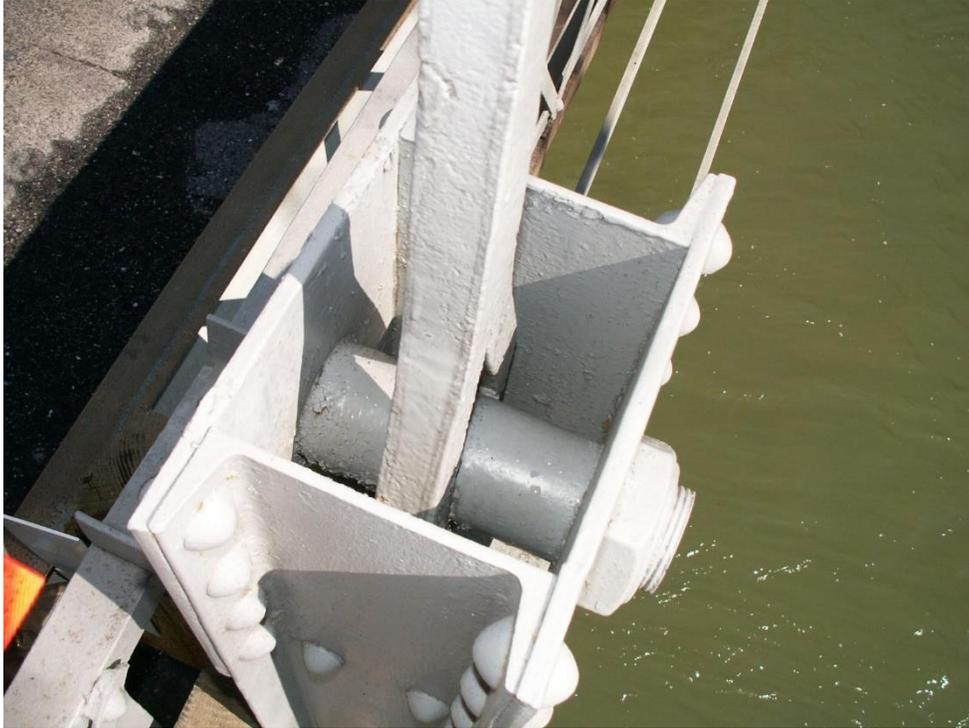
Photo 25 coating has been in service for 12 years .. (See Photos 4 and 10)

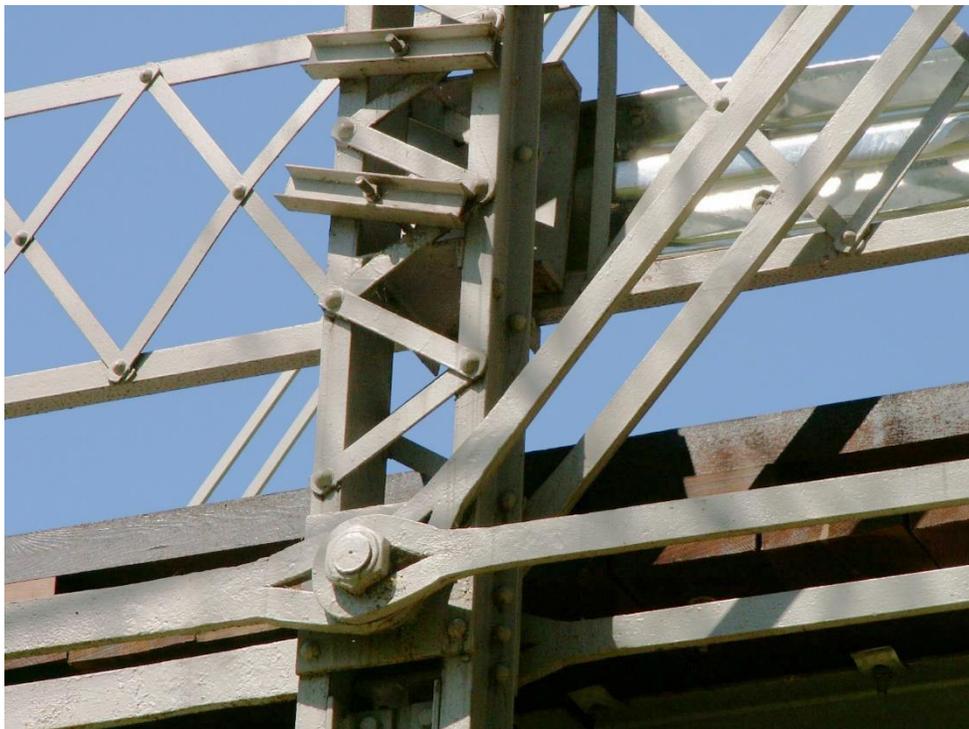
Photo 26 coating has been in service for 12 years . (see Photo 2)
