**UPDATE REPORT – 20 MONTHS AFTER TERMARUST OVERCOATING**

**High Pressure (5,000 psi) Water Wash Cleaning And Overcoating of a Historic (1915) truss bridge on Route 778 over the Middle River - in Augusta County, Virginia With the Termarust High Ratio Co-Polymerized Calcium Sulfonate coating system**

**For the Staunton District – Virginia DOT  
Cleaning & Coating by Structural Coatings, Inc.  
Clayton, North Carolina  
Coating Materials from  
Termarust Technologies, Vienna, Virginia**

**Project Painting Date: August, 2005**

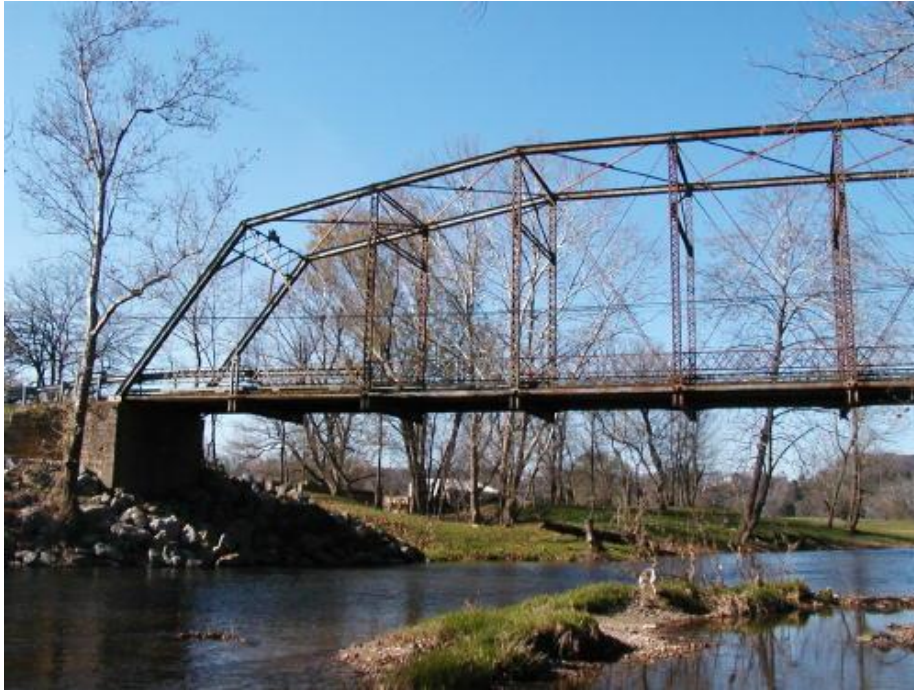
Photo 1 – Bridge in 2004, before painting.

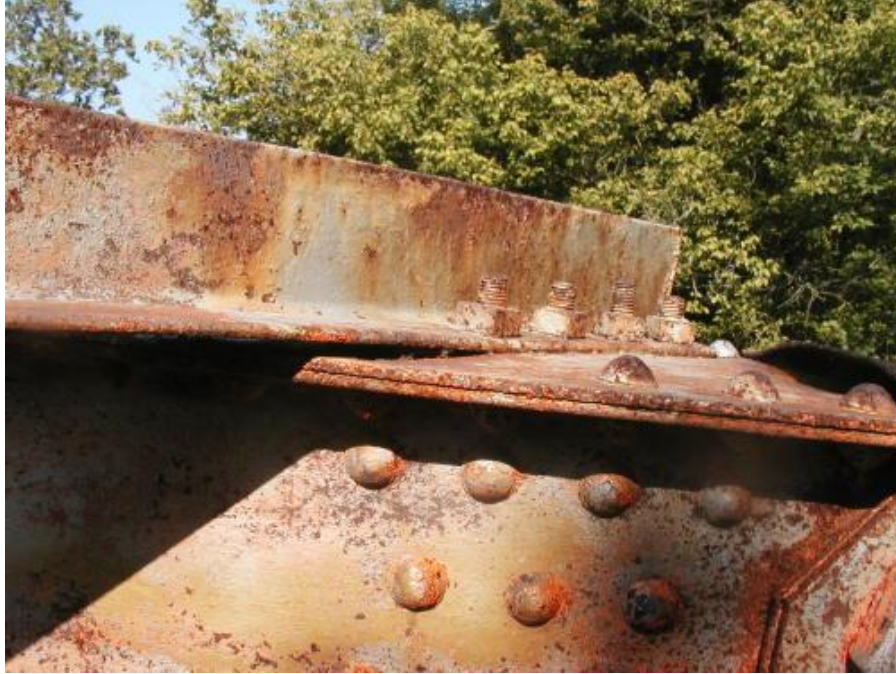
Photo 13 – Top of portal frame cleaned and ready for painting

Note: most of pack rust under longitudinal member has been removed by pressure washing.

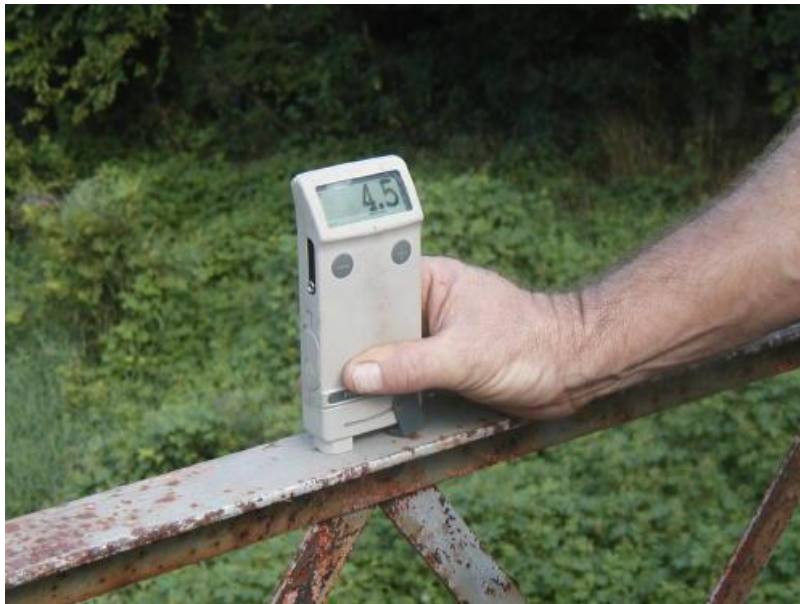
Photo 14 – Film thickness gage shows 4.5 mils of existing tightly adhered lead-based paint.

(At least 85% of the bridge had 2.0 to 25 mils of tightly adhered paint, after pressure washing)

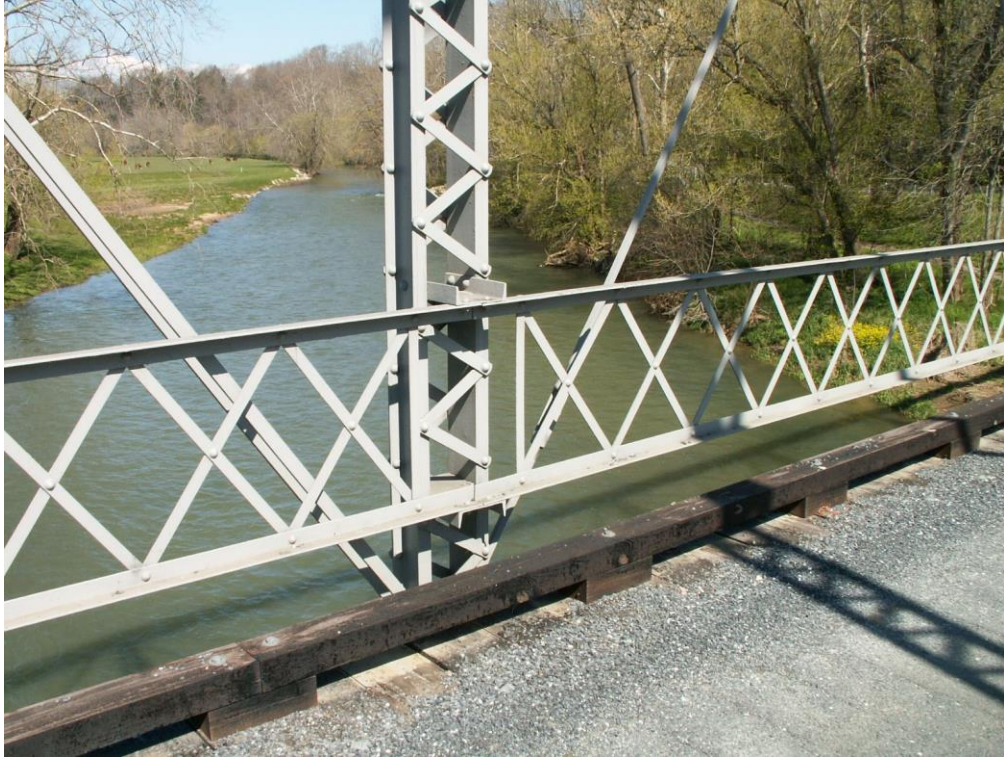
Photo 19 – 20 Months after painting. (see Photo 16)

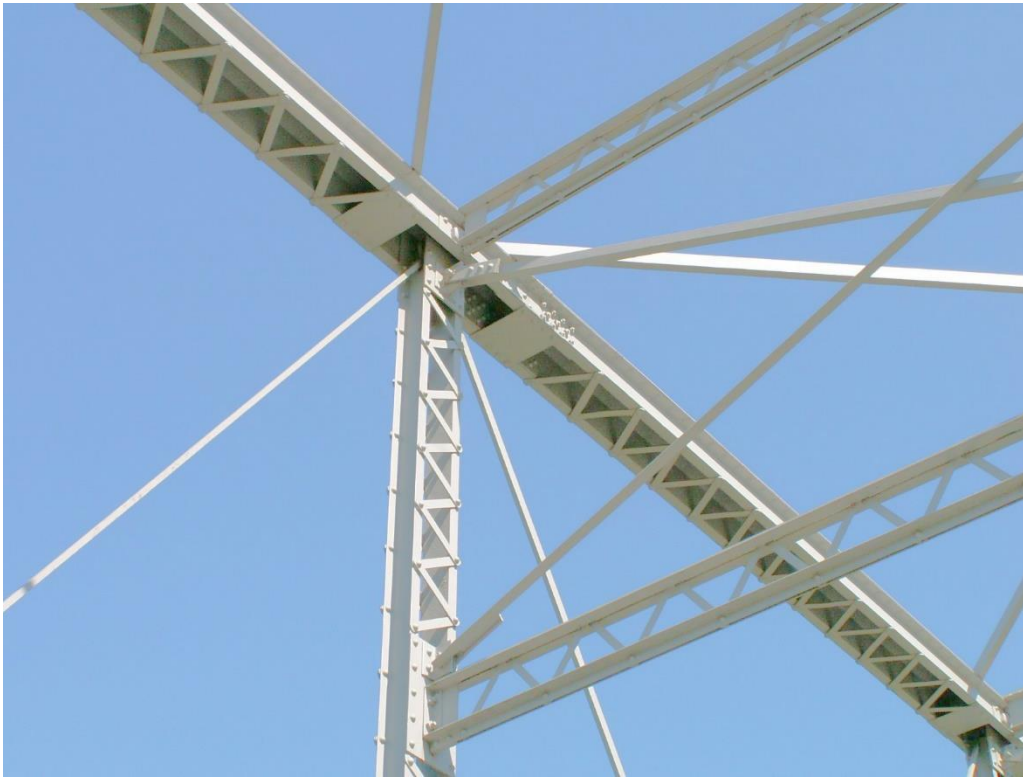
Photo 20 – 20 Months after painting. (see Photo 3)

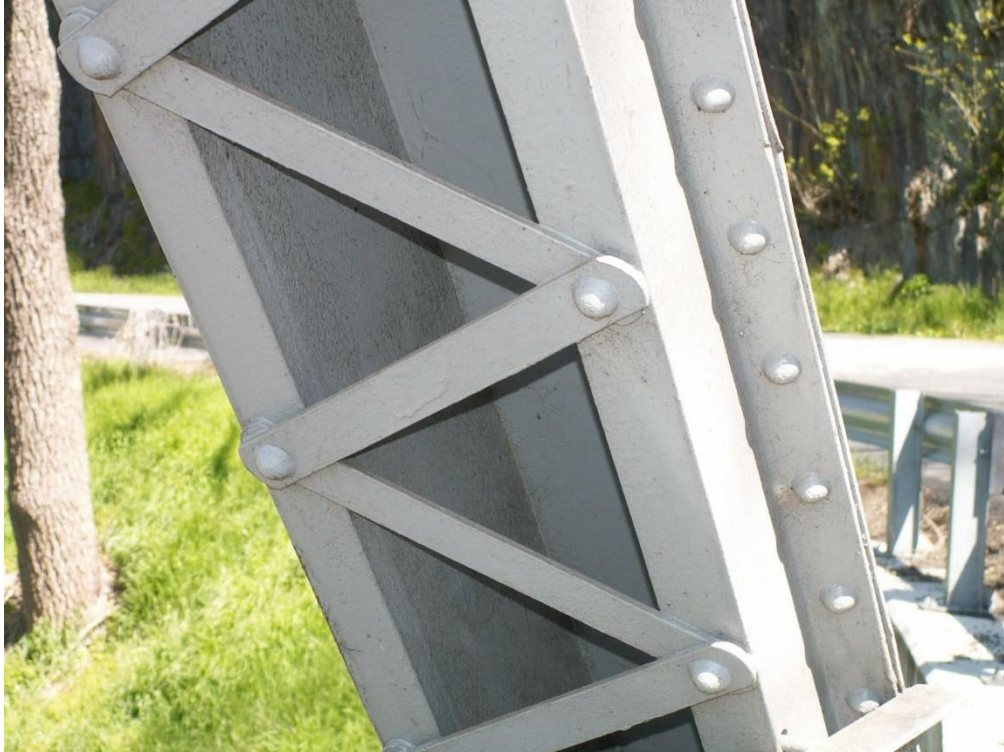
Photo 21 – 20 Months after painting. (see Photos 9 and 18).

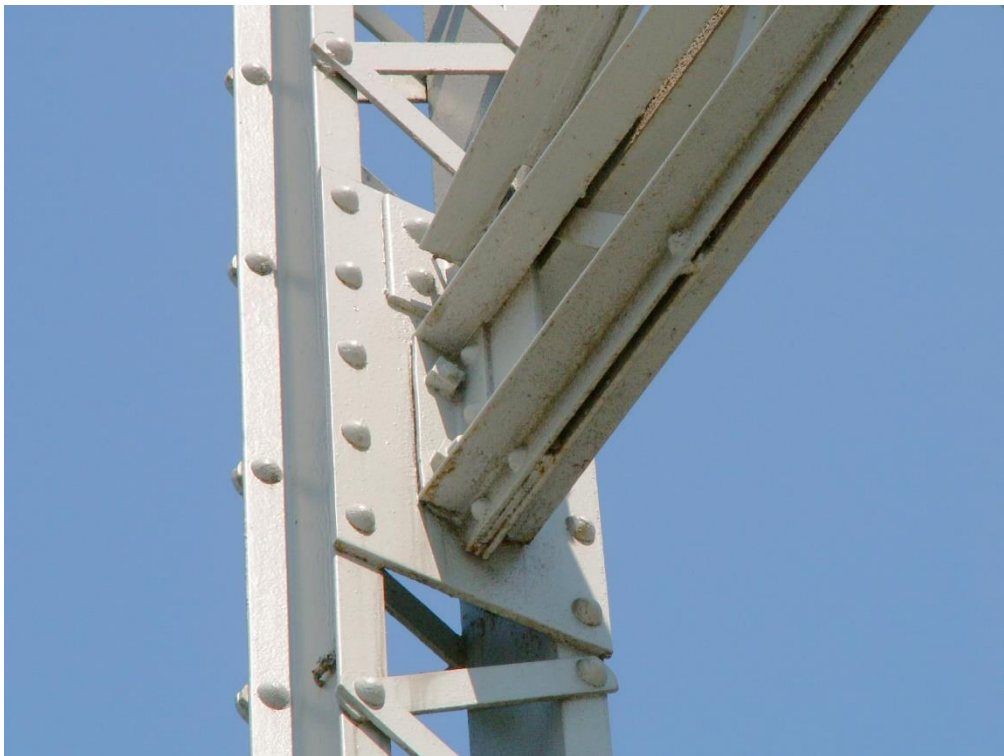
Photo 22 – 20 Months after painting. (see Photos 3 and 20)

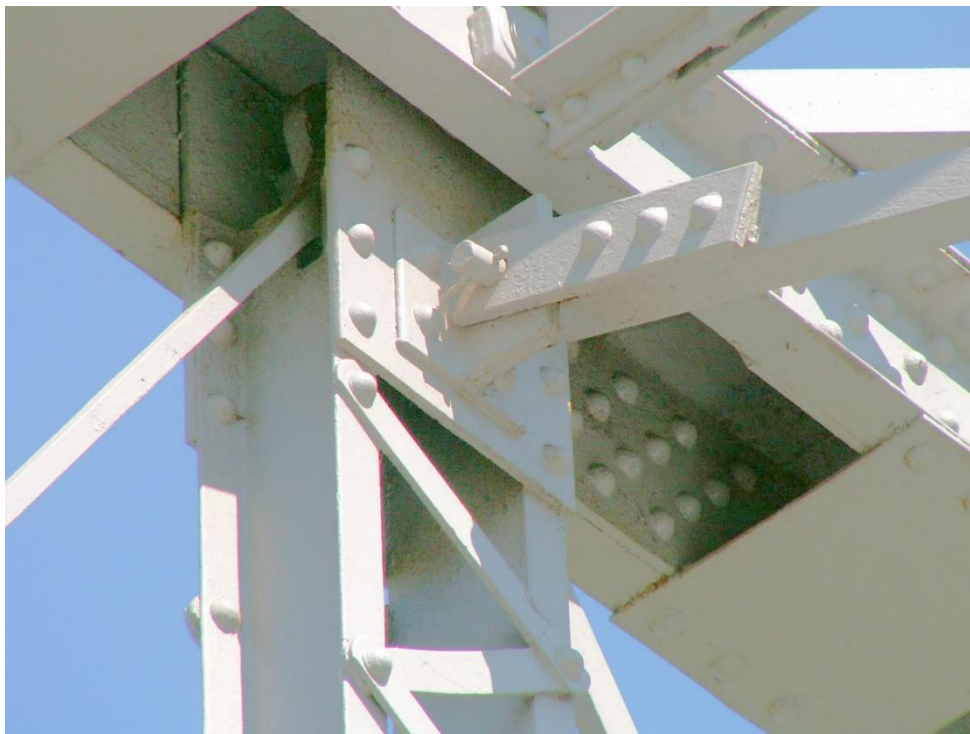
Photo 23 – 20 months after painting. (see Photos 3 and 20)

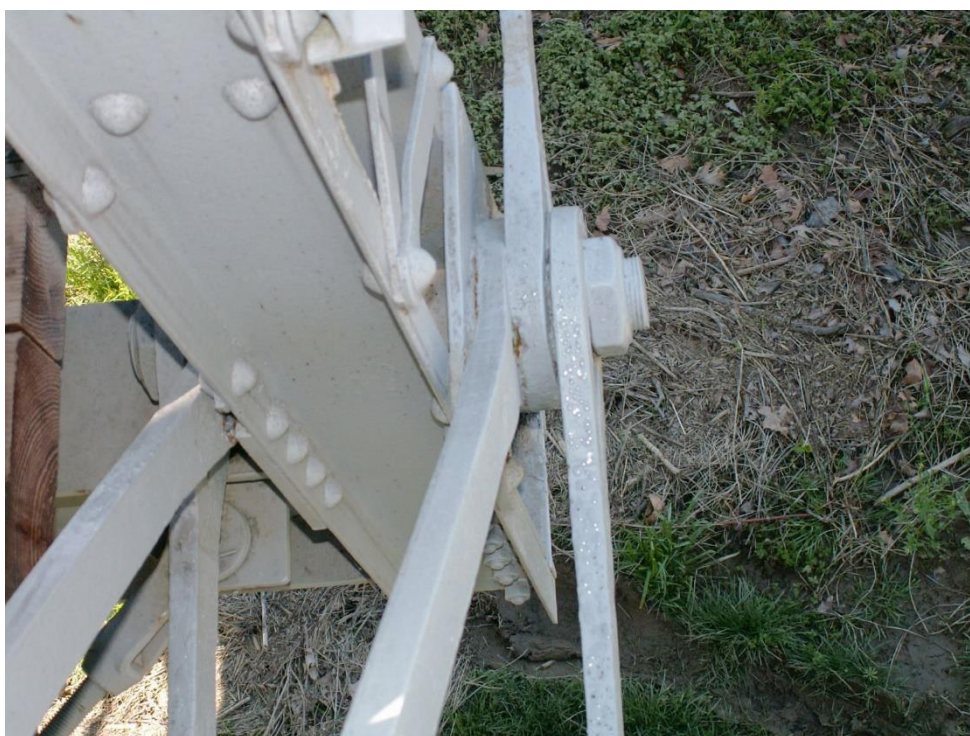
1. The Termarust coating appears to be in excellent condition.
2. It may be seen that the color of the Termarust coating has not faded in color.
3. It was observed that there are a few small areas of dark colored stains on small portions of a few connection, for example see Photo 24.

These areas are believed to be where the water (from pressure washing) was not completely removed during the air pressure 'blow-down' of the connections – with the result that the Termarust TR2200 Penetrant and the TR2100 Topcoats (which have a polar attraction to steel) have pushed the 'rusty water' out of the connections and onto the surface of the connection – and then they 'wetted' the steel and chemically stopped further corrosion.

The fact that these areas have a 'dark' color (rather than bright red) indicates that the active corrosion in the connections has been stopped. Also, it has been found on other projects that this dark stain is just on the surface of the adjacent areas – and it can usually be wiped off.

Photo 24 – 20 Months after painting – corrosion in connection has been stopped.

(see Note 3 on Page 3)

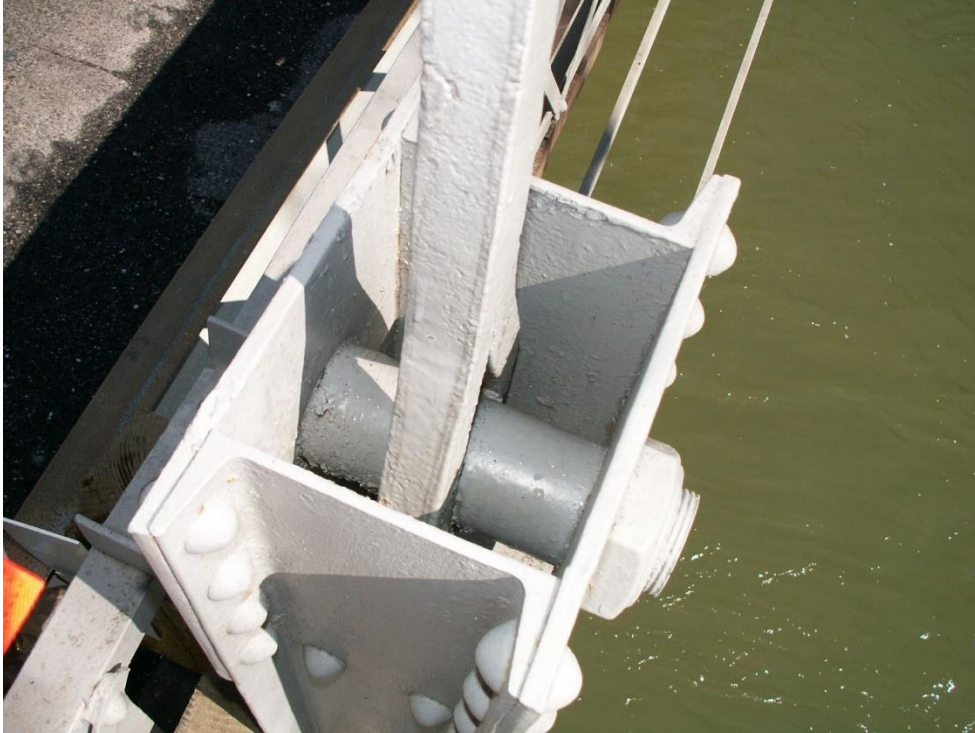
Photo 25 – 20 Months after painting. (See Photos 4 and 10)

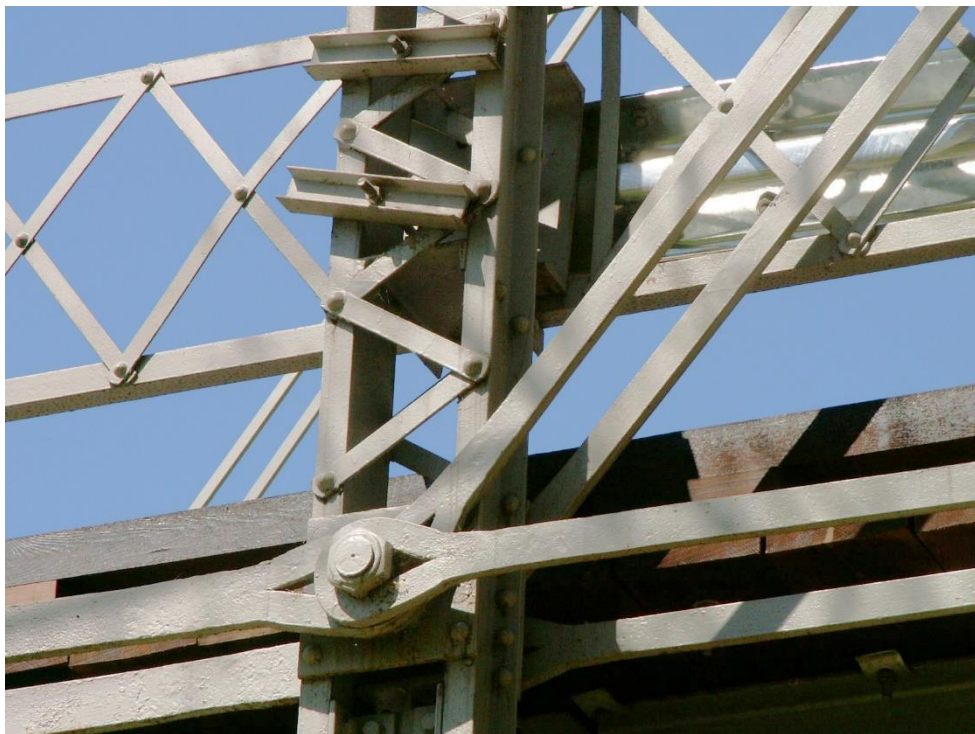
Photo 26 – 20 Months after painting. (see Photo 2)
