UPDATE REPORT AFTER 3 YEARS

STOPPING CREVICE CORROSION

High Pressure (5,000 psi) Water Wash Cleaning And Overcoating of a Historic (1879) Bollman Bridge over the C&O Canal, in Williamsport, Maryland with the Termarust HRCSA High Ratio Co-Polymerized Calcium Sulfonate Coating System

Project Painting Date: January, 2006

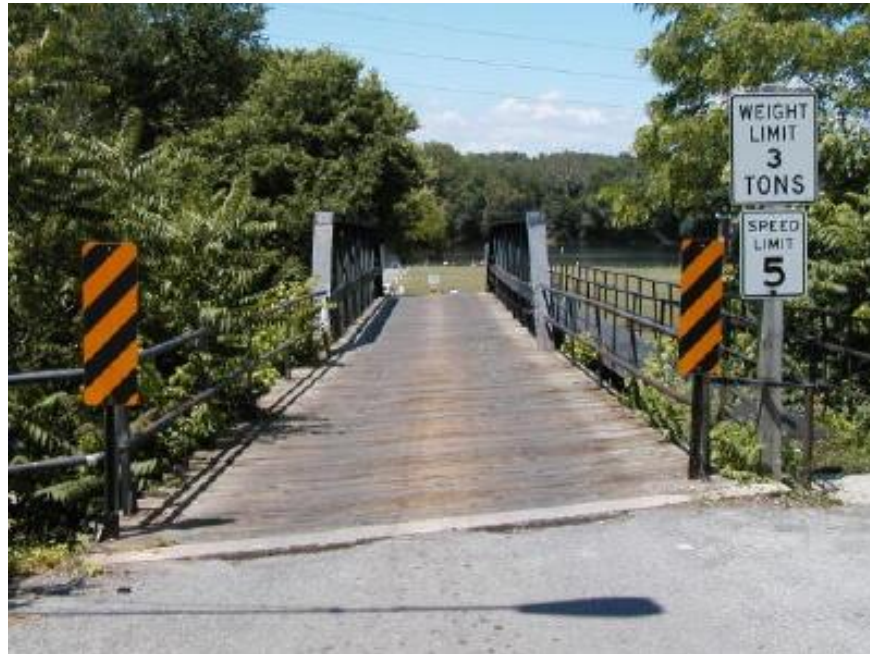
Photo 1 Bridge, and approach span, in 2005, before painting.

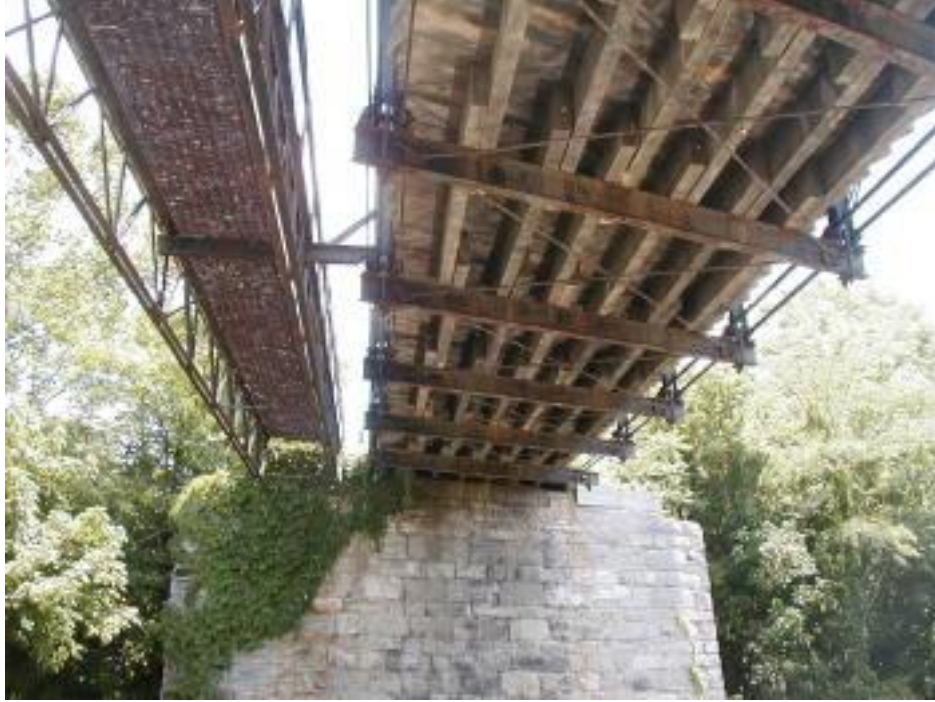
Photo 3 Underside of the bridge showing transverse floor beams and longitudinal timber beams

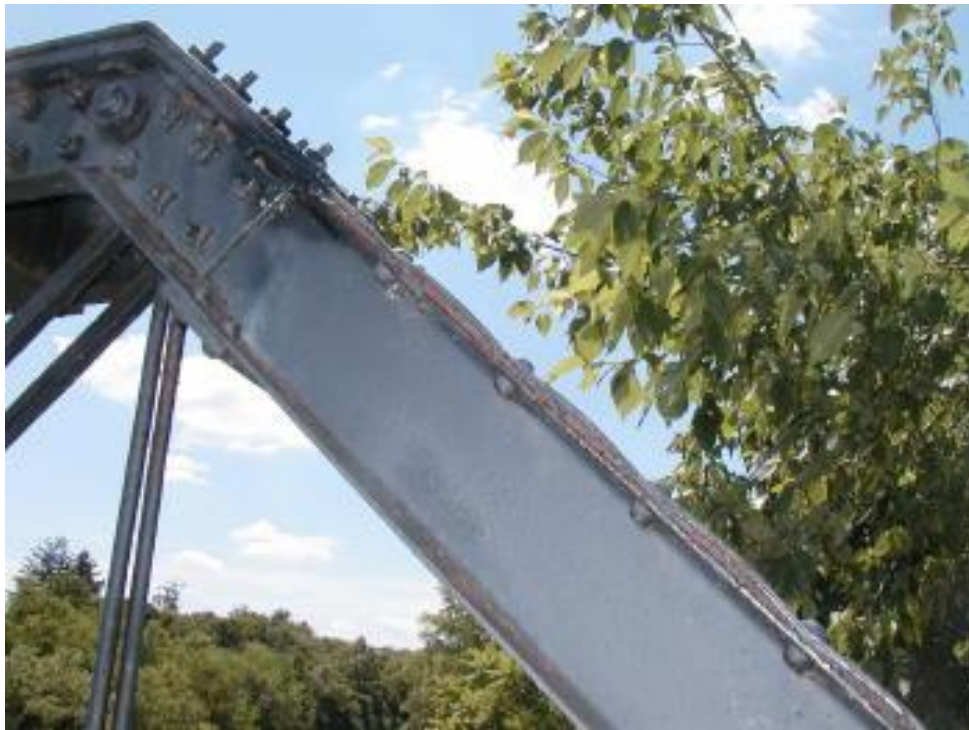
Photo 4 Edge of front truss member with crevice corrosion and pack rust that has bent the cover plate and stressed the rivets.

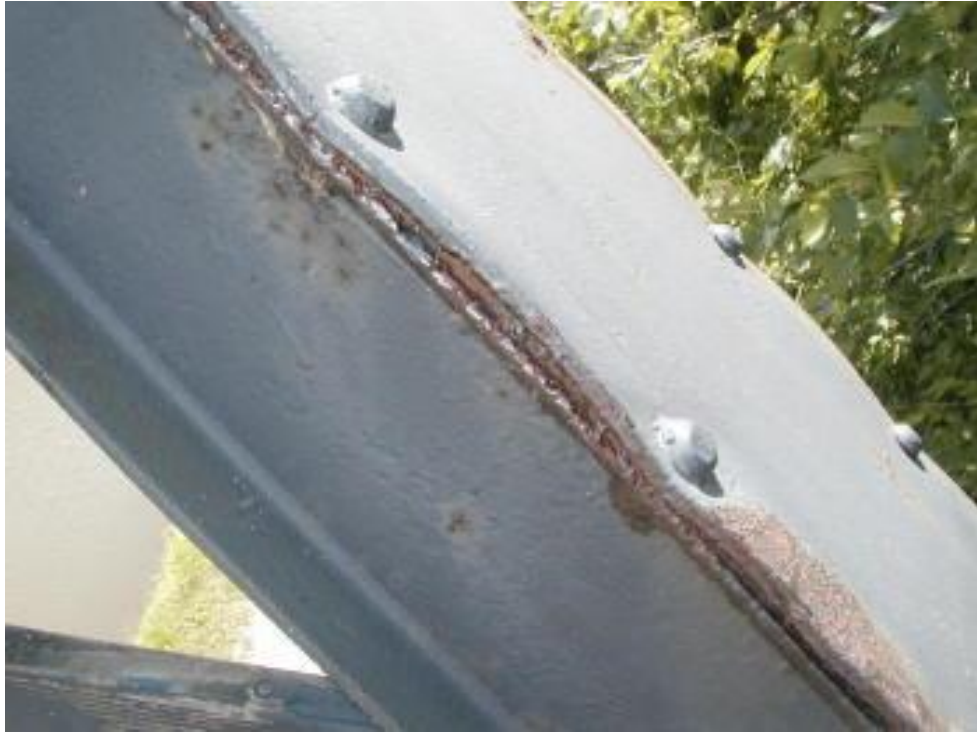
Photo 5 Close-up of pack rust that has bent the cover plate.

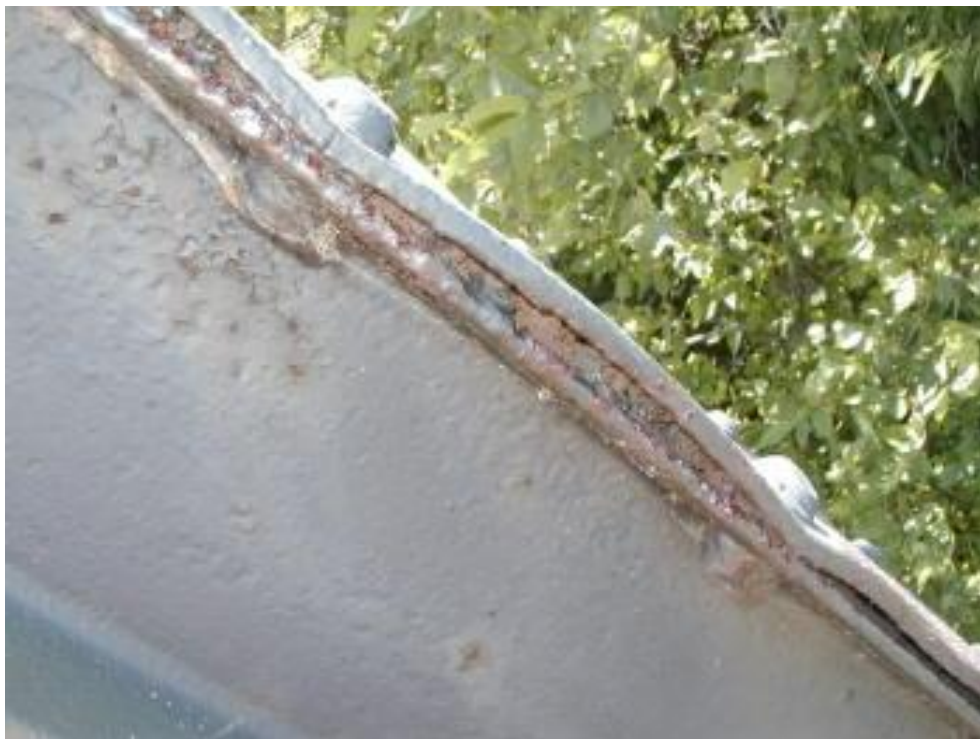
Photo 6 Closer view of the pack rusted connections.

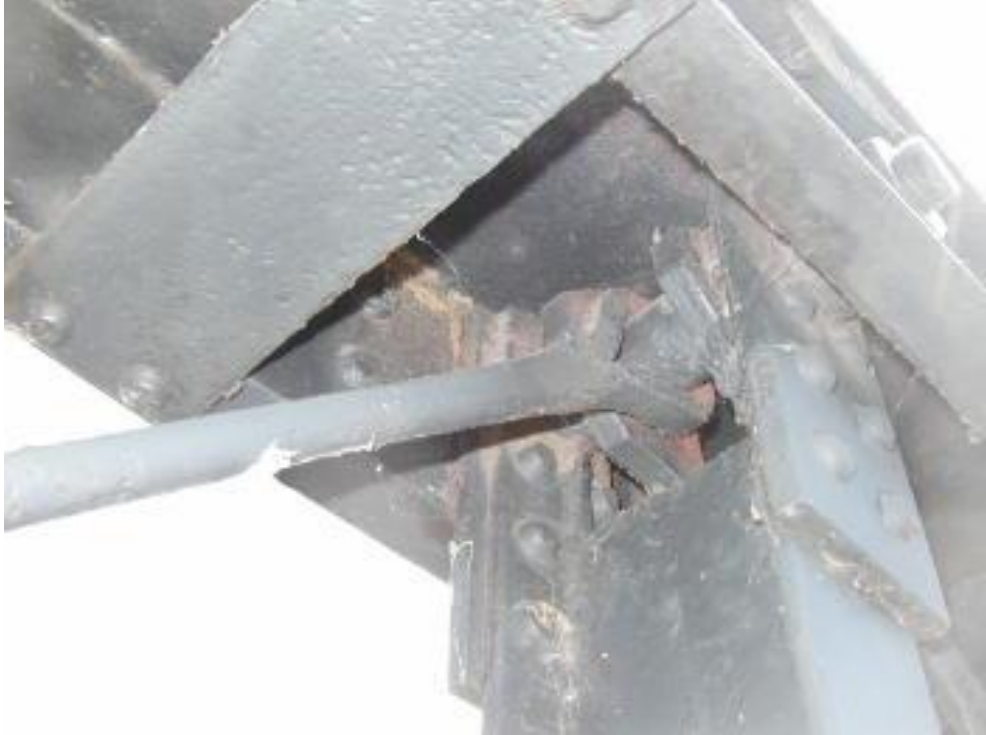
Photo 7 Upper tie-rod and truss connection.

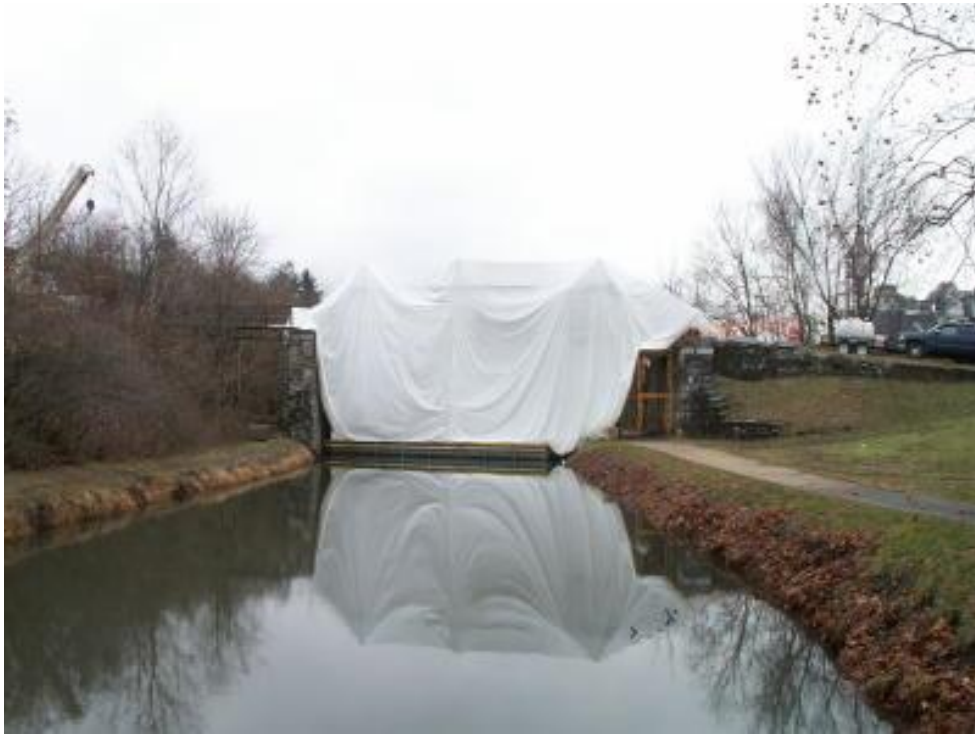
Photo 8 Bridge is covered with a tarp, for cleaning and painting

Note: A barge in the Canal provides a working platform and containment.

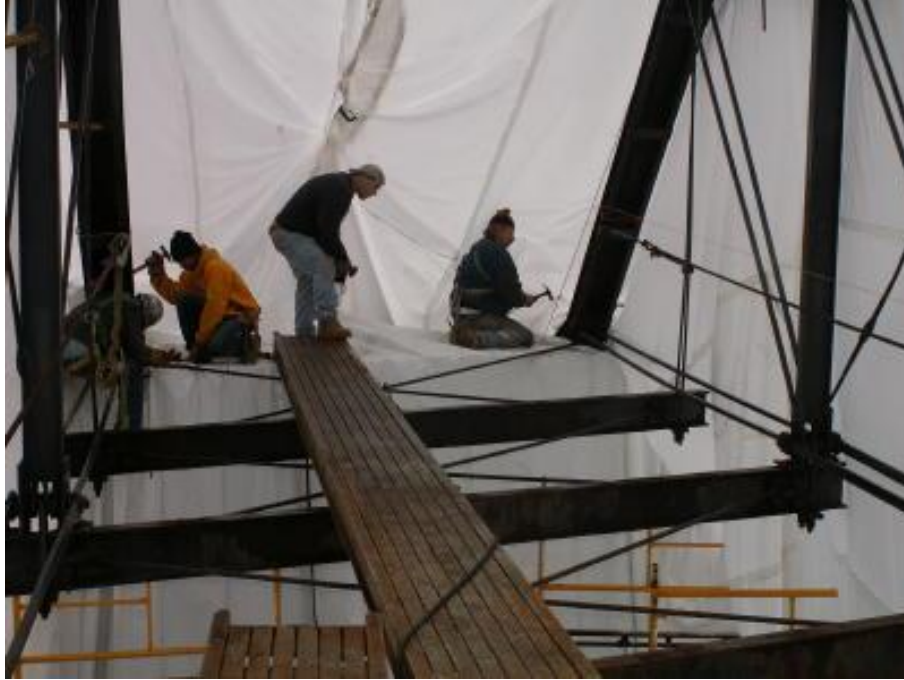
Photo 9 Removing scale rust before pressure washing

Note. Scale removal was started with hammers and later with small air tools.

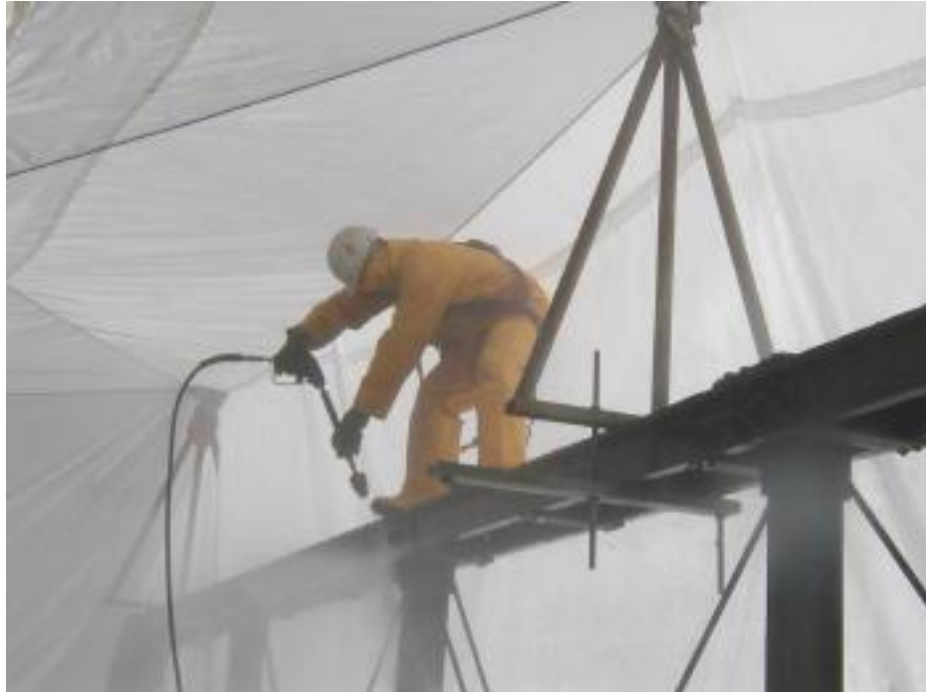
Photo 10 5,000 psi pressure washing of the truss, with Chlor*Rid in the final rinse water.

1. Pressure wash clean the bridge with a 5,000 psi pressure washer (at a 6 standoff distance) with clean water with an additive of Chlor*Rid to remove non-visible salts; e.g. chlorides. (For more information on Chlor*Rid see www.chlor-rid.com)
2. With dry compressed air blow dry all connections (and cross-over points on built-up lattice members. (almost all superstructure members)
3. Apply Termarust TR2200 Penetrant into all open connections
4. Apply a caulk (or stripe) coat of Termarust TR2100 into/onto edges of connections
5. Spot prime areas of bare steel and tightly adhered rust with 5 mils DFT of Termarust TR2100
6. Overcoat the entire area with another 5 mils DFT of TR2100.

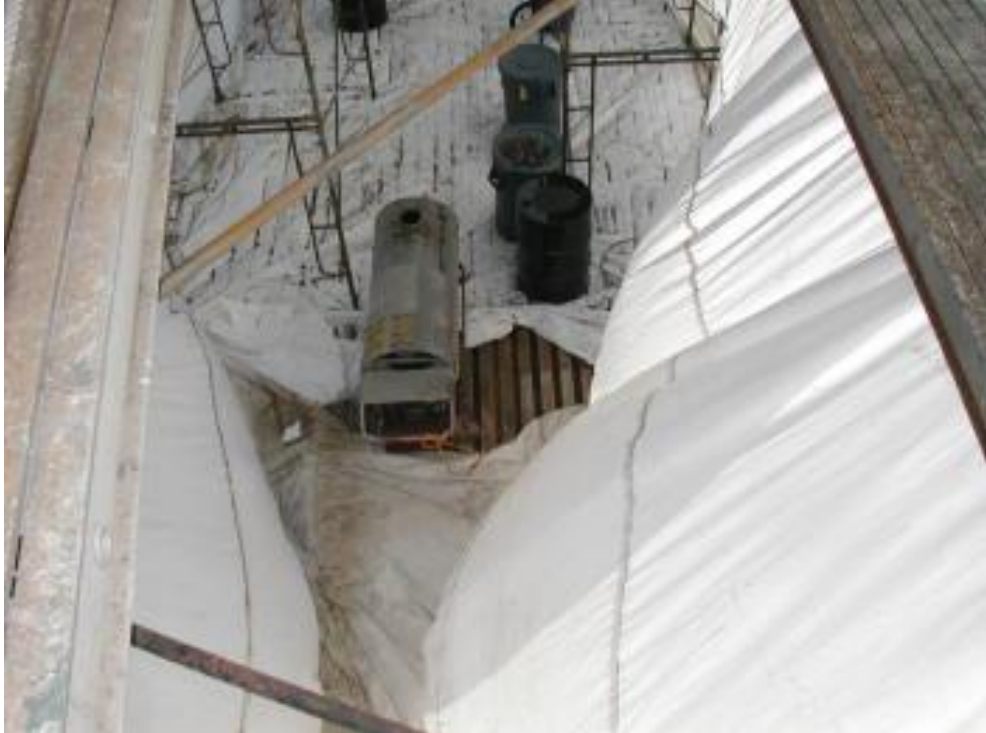
Photo 11 A large heater was used to maintain a minimum 50°F steel temperature for painting.

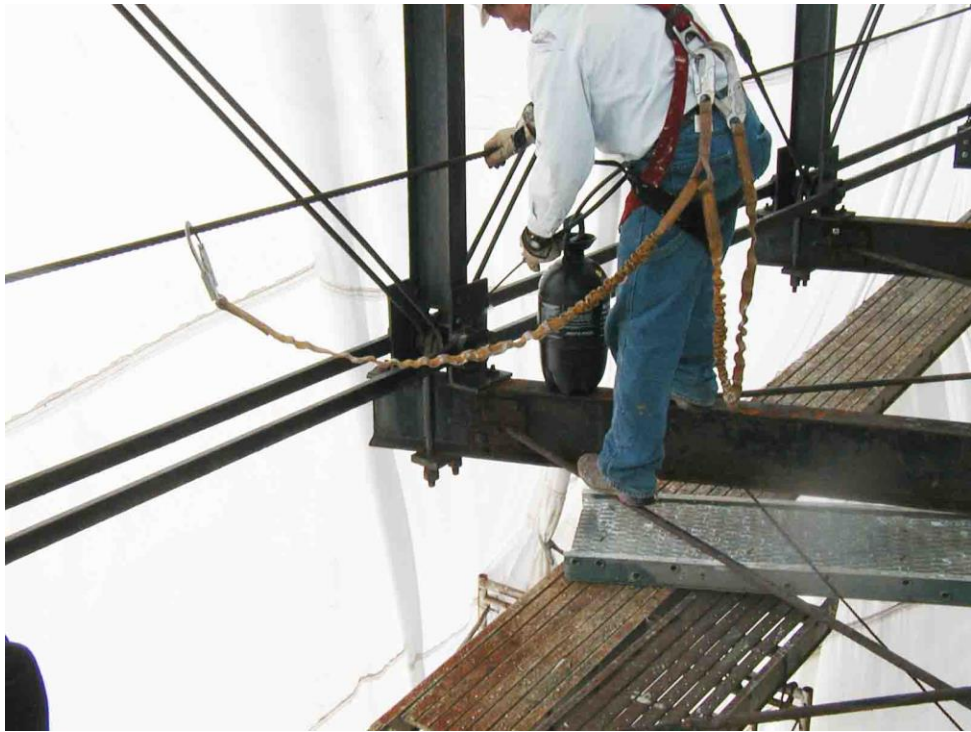
Photo 12 Applying the TR2200 Penetrant into connections.

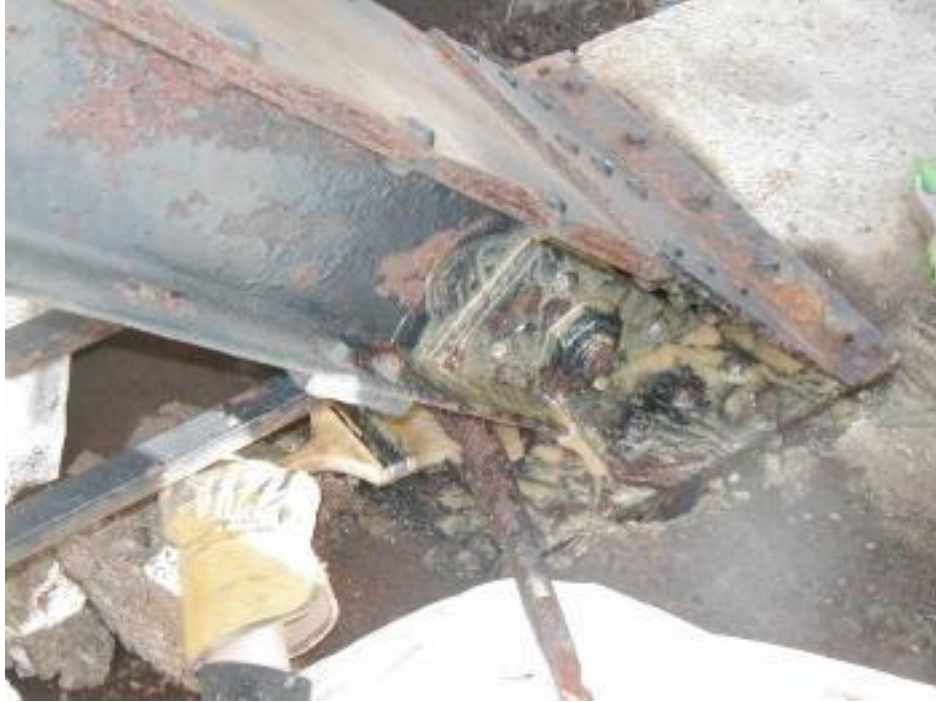
Photo 13 TR2200 Penetrant has been applied to front bearing connection.

(Excess Penetrant was then removed by brush)

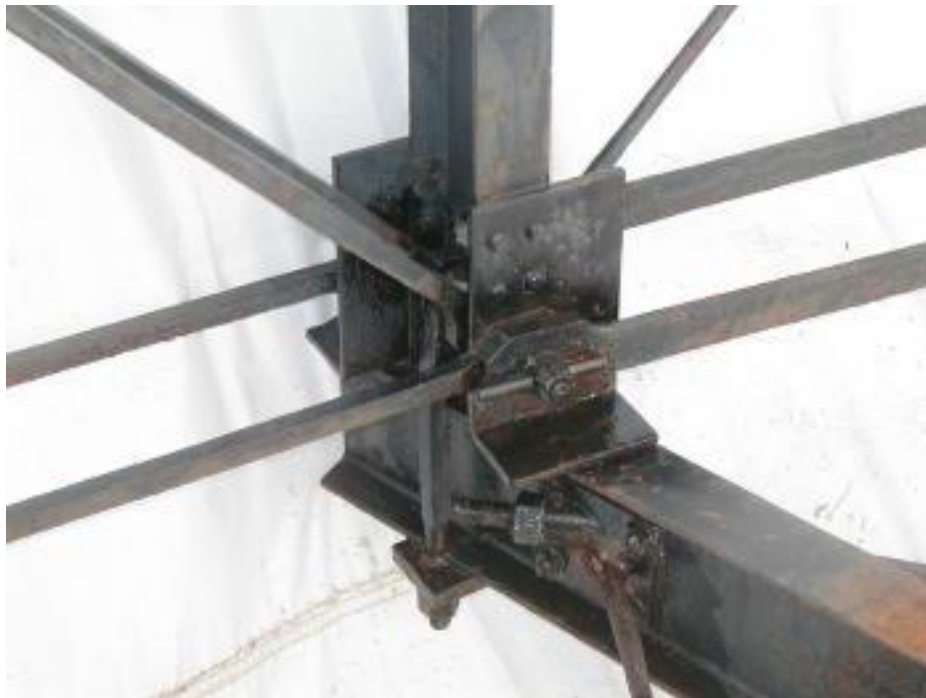
Photo 14 TR2200 Penetrant has been applied to the connection,
before application of the TR2100 Topcoat.

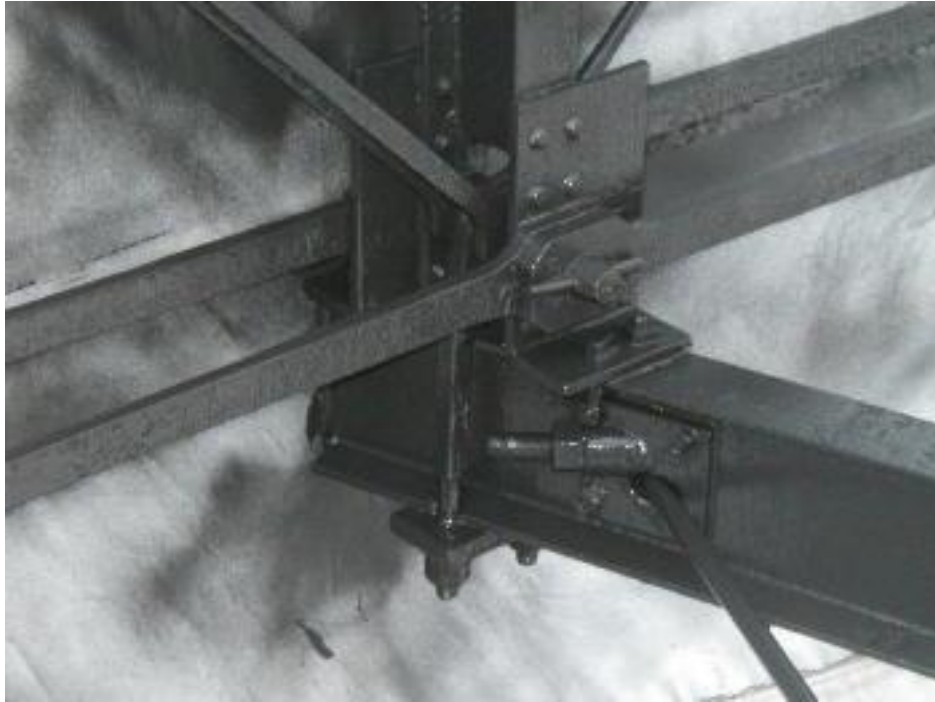
Photo 15 The connection has been coated with the TR2100 Topcoat.

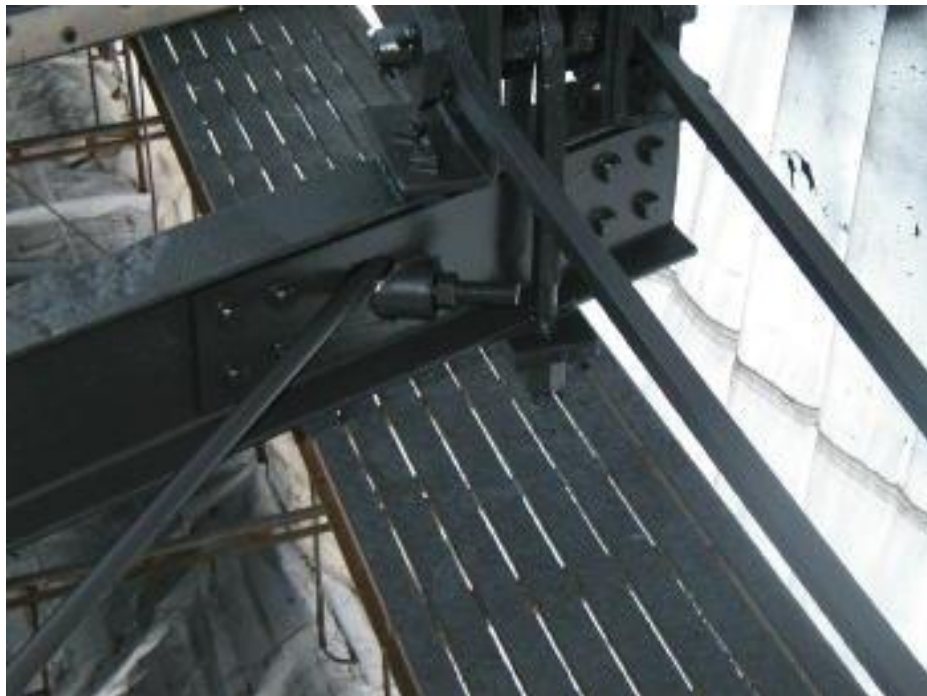
Photo 16 ◆ TR2200 and TR2100 has been applied to the connection ◆ after it was strengthened,

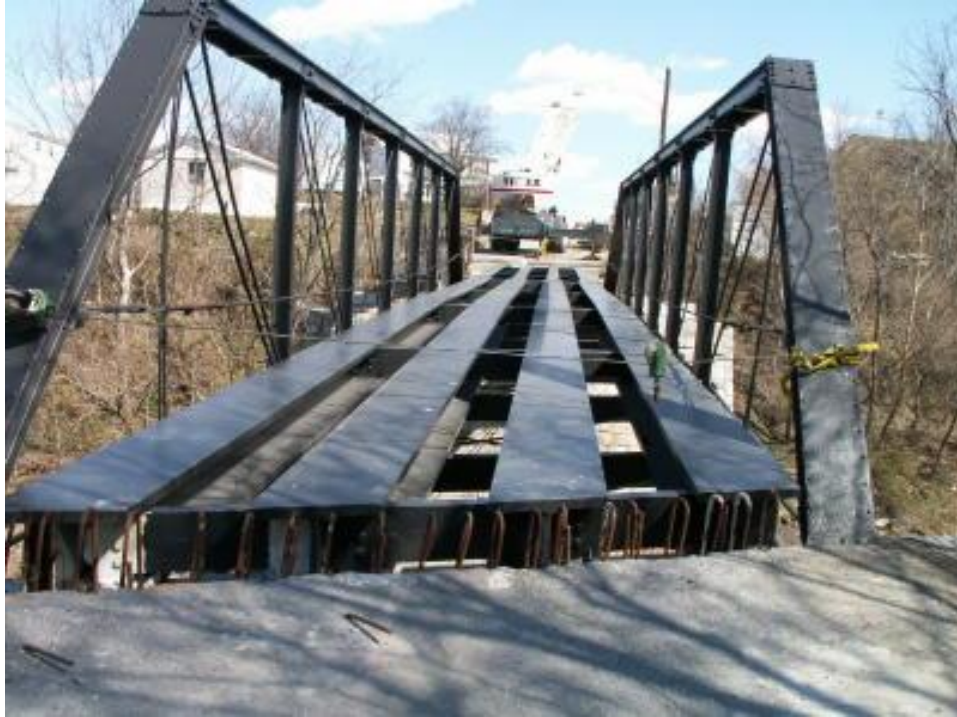
Photo 17 The truss has been painted and the new longitudinal beams have been installed.

A new timber deck will now be installed

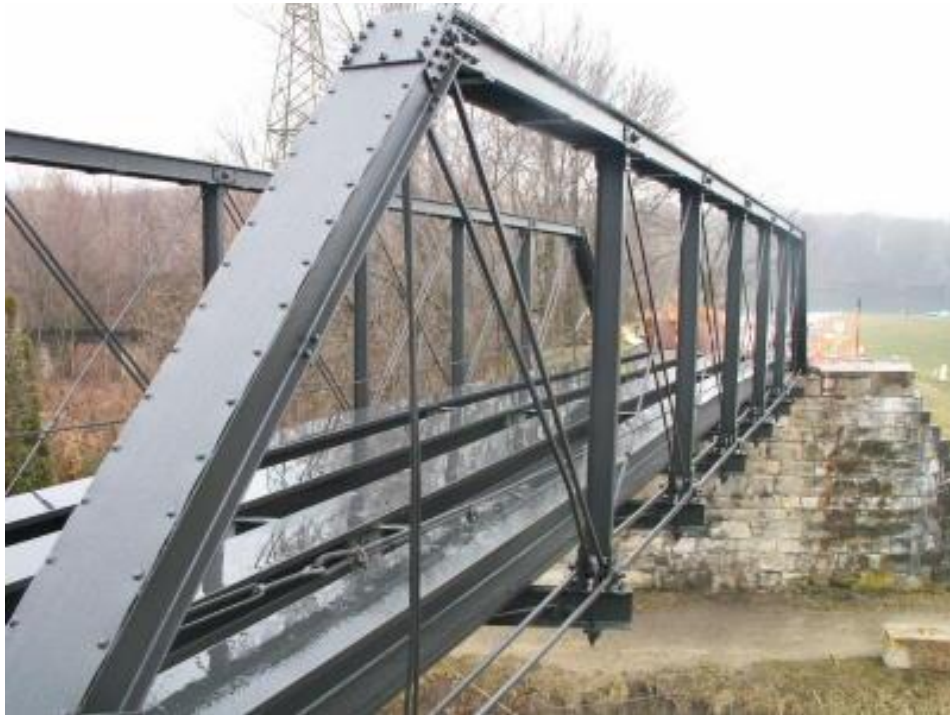
Photo 18 ♦ Painting completed.

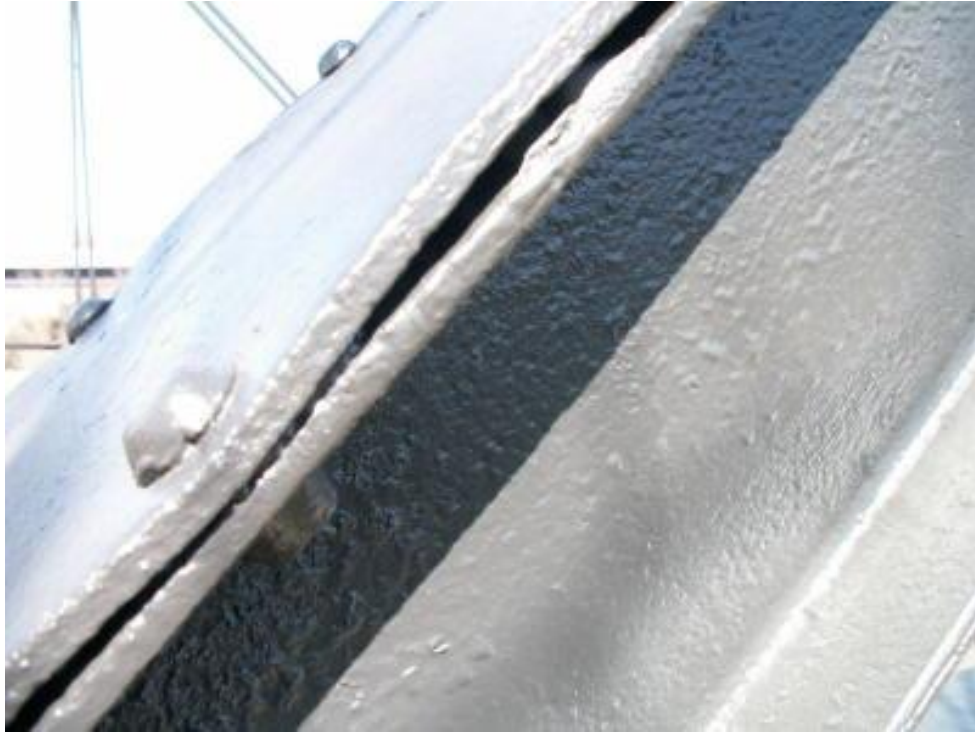
Photo 19 Close-up of connection with most of the pack rust removed before painting.

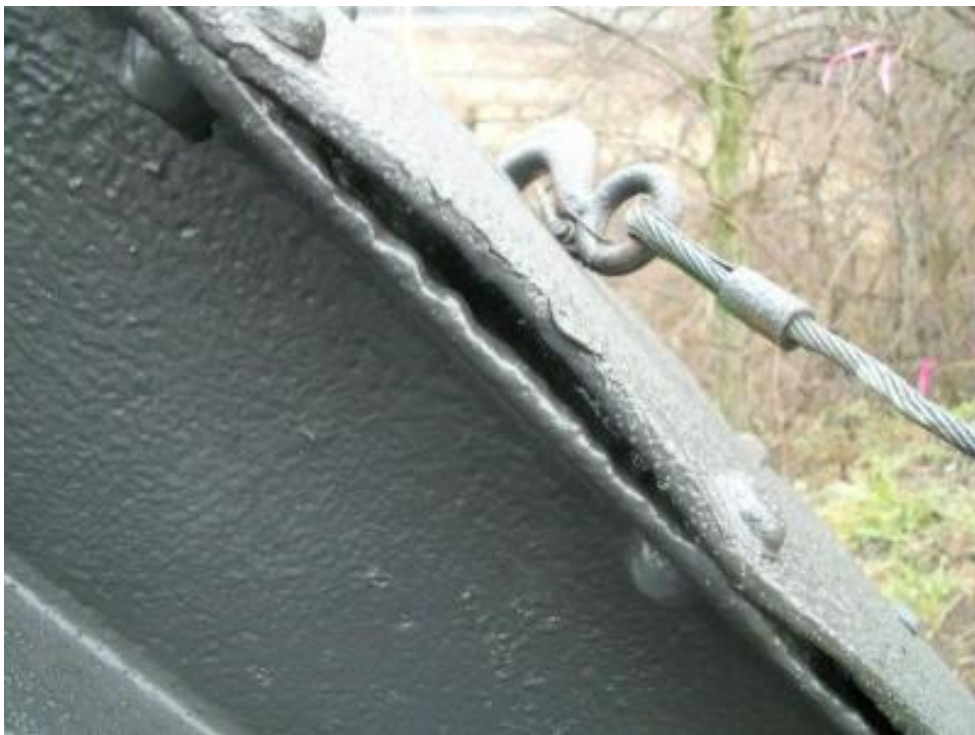
Photo 20 Close-up of connection with most of the pack rust removed before painting.

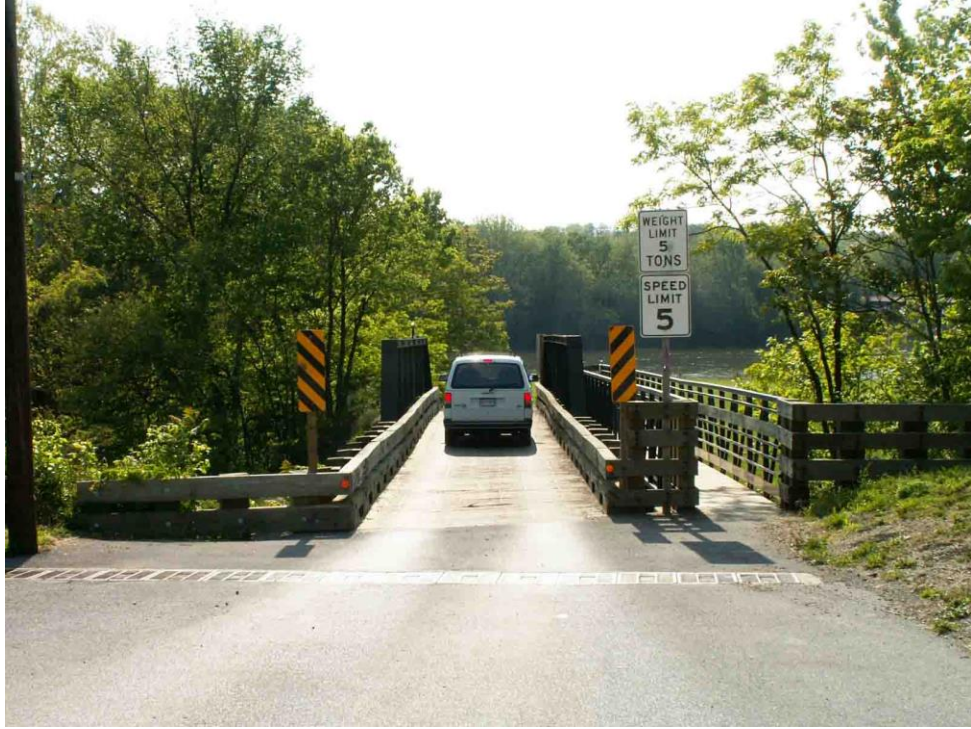
1. The Termarust coating appears to be in excellent condition no undercutting or delamination.
2. There were a few areas (not shown) where the Termarust coating had been scratched or marred during installation of the timber deck and rub-rails; however this damage to the surface of the coating has not (and will not) lead to failure of the coating; i.e. undercutting and delamination.
3. In summary, the Termarust coating is in excellent condition and crevice corrosion is stopped.

Photo 21 May 12, 2009 View of completed bridge work

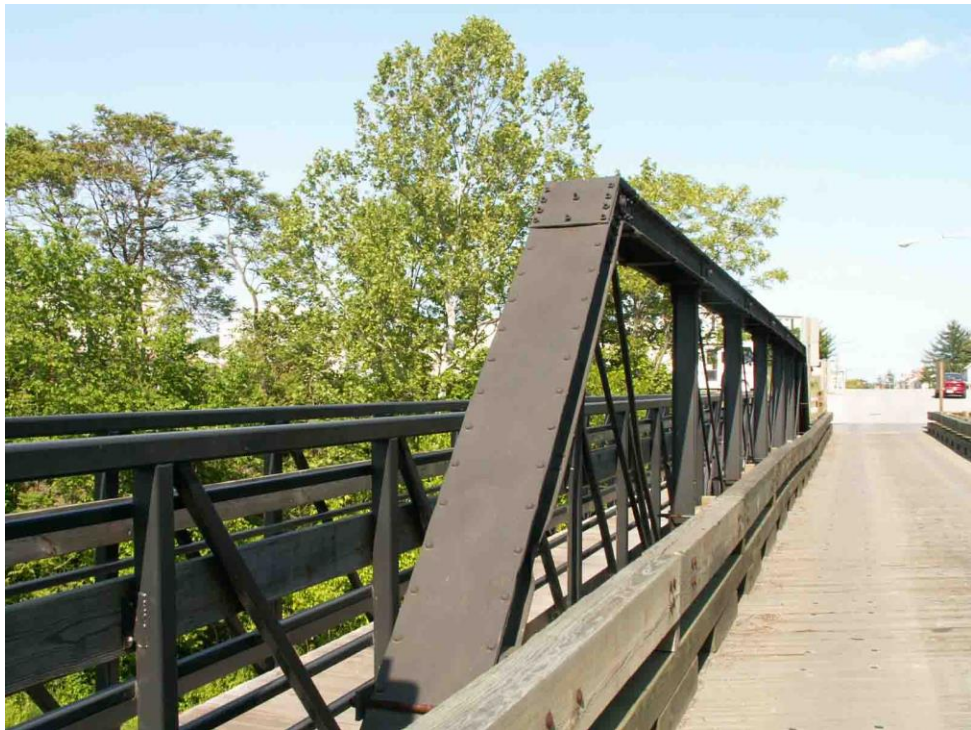
Photo 22 May 12, 2009 No coating or corrosion problems.

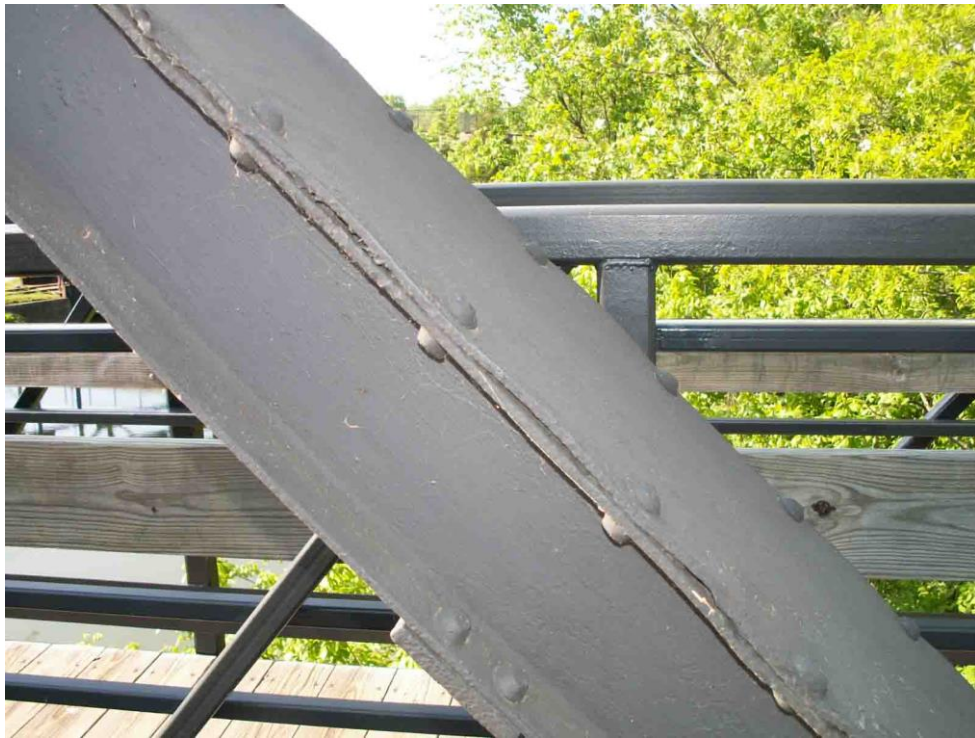
Photo 23 May 12, 2009 Crevice corrosion has been stopped.

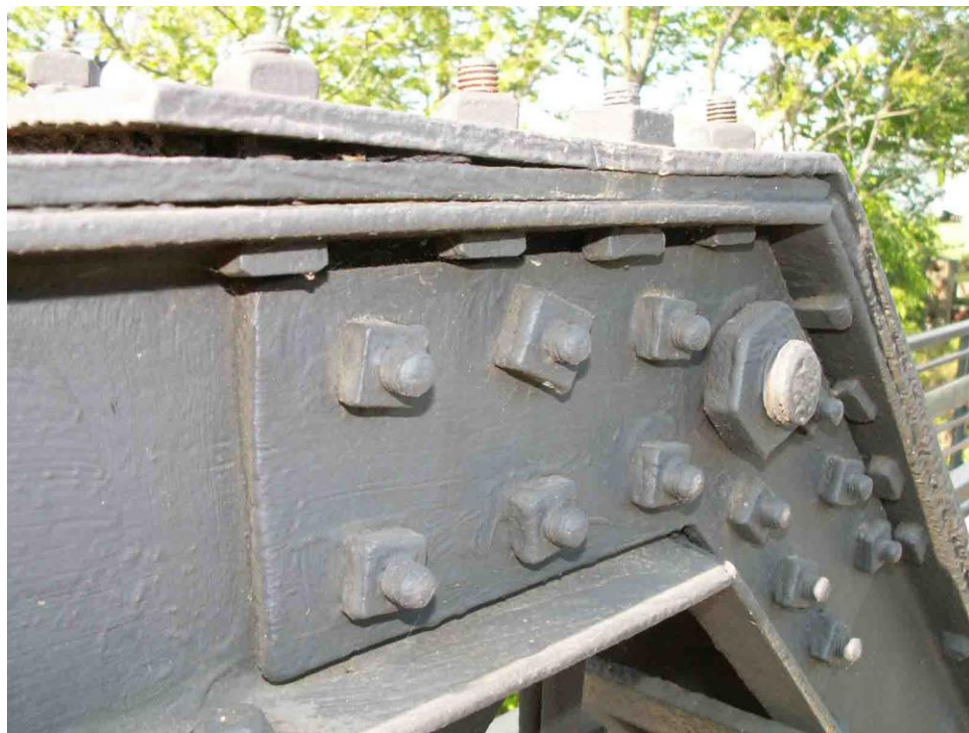
Photo 24 May 12, 2009 Corrosion has been stopped.

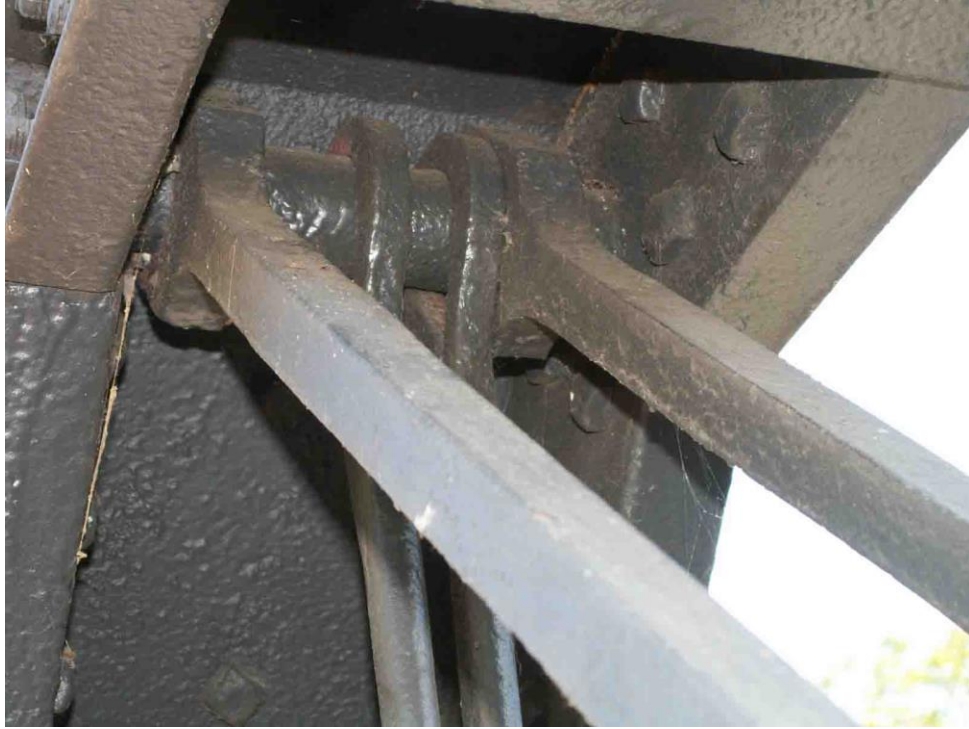
Photo 25 May 12, 2009 Corrosion has been stopped.

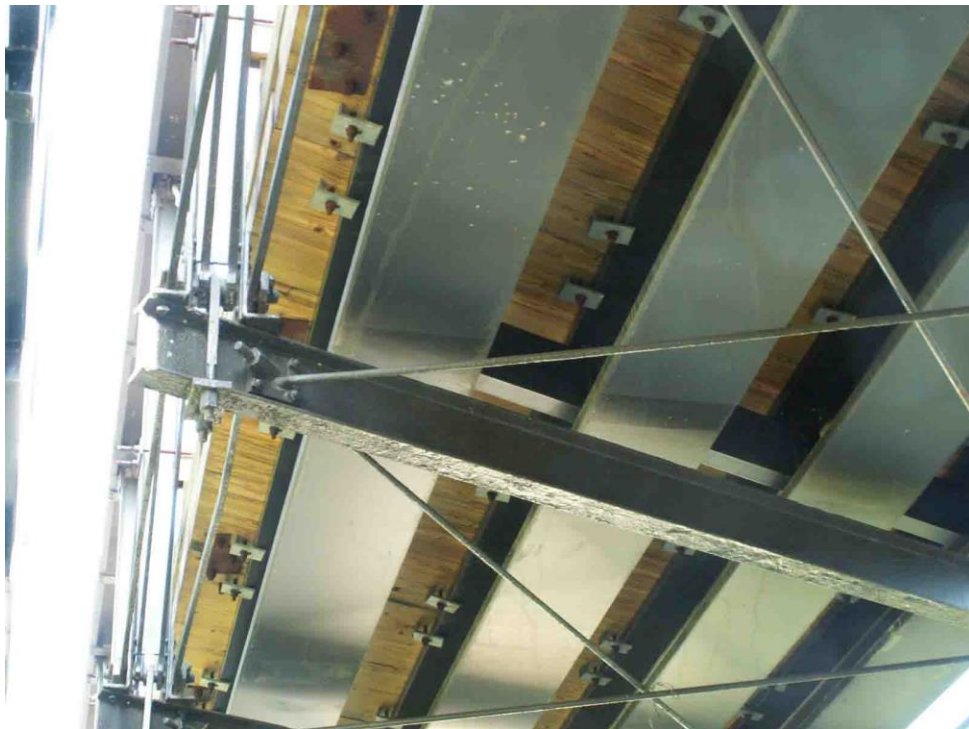
Photo 26 May 12, 2009 No coating or corrosion problems.

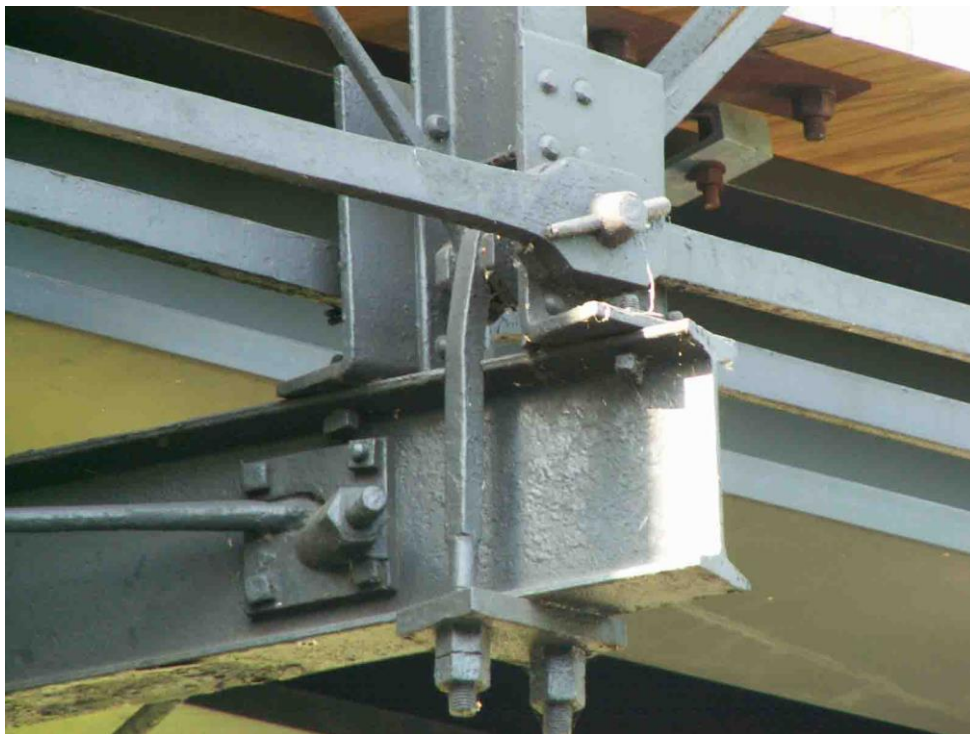
Photo 27 May 12, 2009 No coating or corrosion problems.

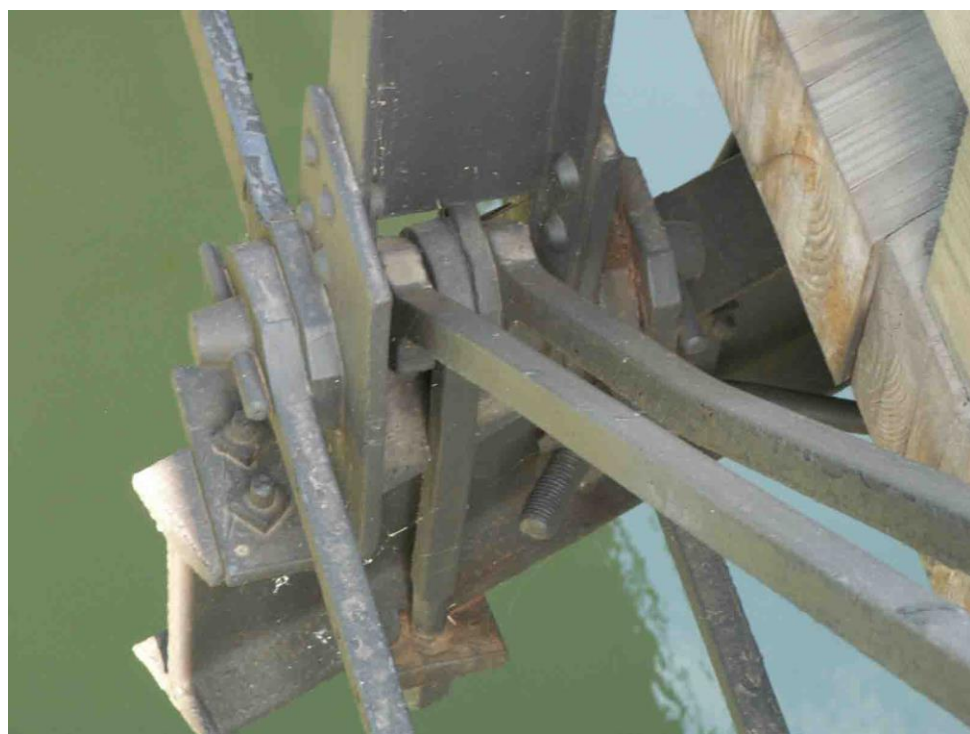
Photo 28 May 12, 2009 No coating or corrosion problems.
