FHWA BRIDGE COATING STUDY YIELDS PRELIMINARY TEST RESULTS

**By Pradeep Kodumuri,
SES Group & Associates; and
Seung-Kyoung Lee,
Federal Highway Administration,
Turner-Fairbank Highway
Research Center**

Initial Results from FHWA's Bridge Coating Study

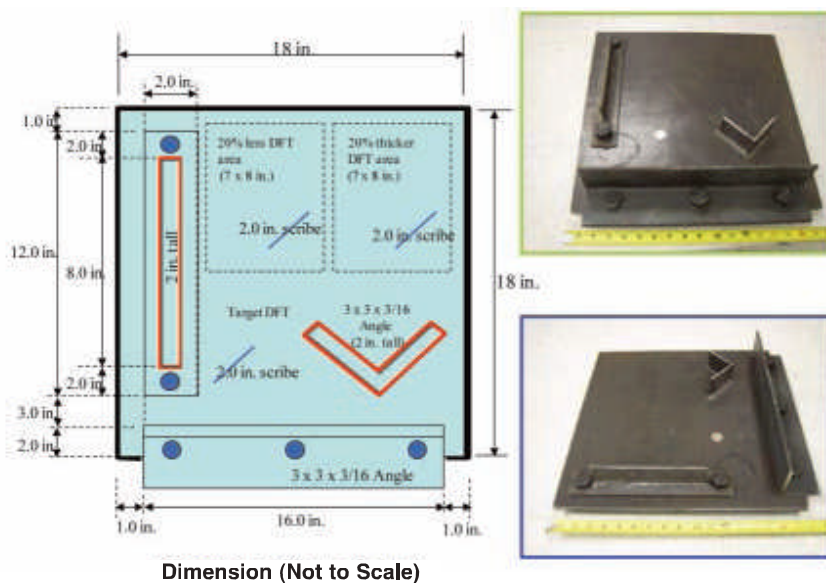
Fig. 1: Type II Test Panels

Typically, for its in-house coating studies, FHWA uses conventional, rectangular-shaped, 4-inch x 6-inch test panels. For this study, in addition to using conventional panels, FHWA adopted a new test panel design to closely simulate the steel coated on highway bridges. The new panels are 18 inches x 18 inches, with a welding joint and two angle attachments. All 4-inch x 6-inch panels will be referred to as Type I; 18-inch x 18-inch panels will be referred to as Type II panels. Figure 1 shows a typical Type II panel with a v-notch (welding joint), a T-shaped angle attachment and a wide-angle attachment.

The corresponding dimensions of each component are also shown.

All Type I test panels were coated according to each manufacturer's recommendations for dry film thickness (DFT). The test surface of a Type II panel consisted of three areas of varying DFT values:

- (a) Area 1—Target DFT
- (b) Area 2—DFT is 20% less than the target DFT
- (c) Area 3—DFT is 20% more than the target DFT

thicker than target DFT compare to the target DFT area for the coating systems tested. Figure 1 also shows the physical locations of these test areas on the surface of the Type II test panel.

All test areas of Type II test panels were scribed (Fig. 1). A mechanical scribing tool used for Type I panels was not suited for the large size test panels; hence, the Type II test areas were scribed using a high-speed Dremel tool with a rotary bit. C-clamps were used to support a metallic guide, along which the scribing was done using the Dremel bit.

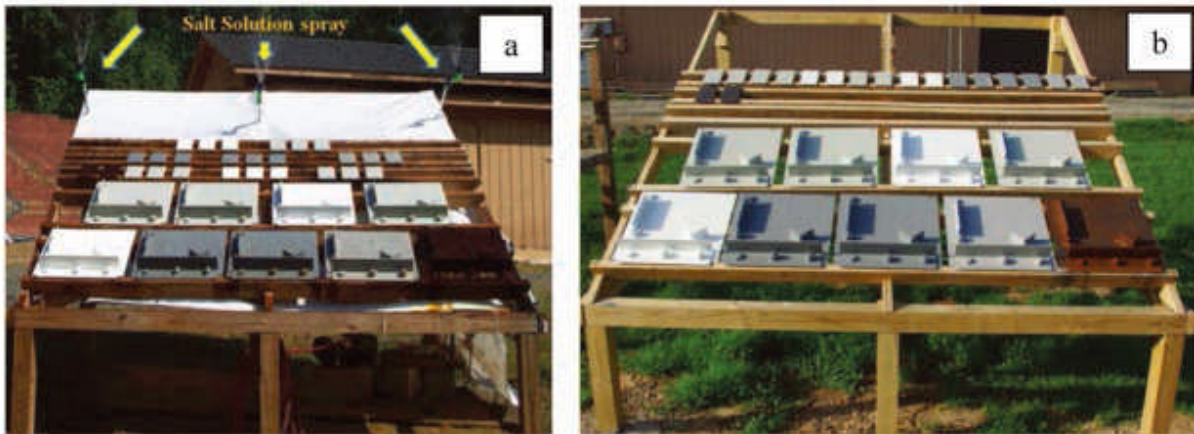
Fig. 2: (a) Natural weathering with salt rack and (b) natural weathering rack

Type I and Type II test panels were deployed on wooden racks inclined at 30 degrees facing south. Figures 2(a) and 2(b) show the test panels deployed initially in the back yard at Turner Fairbank Highway Research Center in Mclean, Virginia.

A 15 wt% sodium chloride solution was sprayed onto these test panels every 24 hours by an automatic salt spray system. This system was built in-house. It works with a timing switch turning on an electro-mechanical pump every 24 hours to spray these test panels for a short period (15 seconds) with the salt solution. After a week of salt spray, due to excessive salt deposit buildup, the

salt solution was changed from 15 wt% sodium chloride to the Harrison mixture (0.35 wt% ammonium sulfate and 0.5 wt% sodium chloride). Test panels are evaluated every 6 months for coating performance.

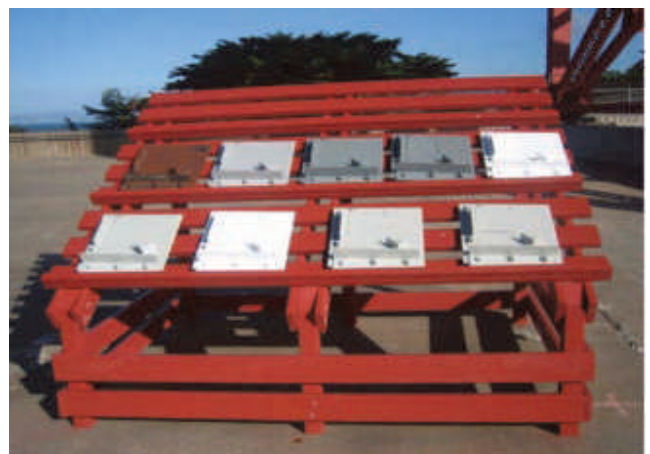
Fig. 3: Type II panels deployed at the Golden Gate Bridge

The outdoor exposure test conditions at Golden Gate Bridge can be considered harsh because of the severe fog, which also contains airborne chlorides. Figure 3 shows Type II panels deployed near the south abutment at the Golden Gate Bridge. Test panels are evaluated every 6 months for coating performance.

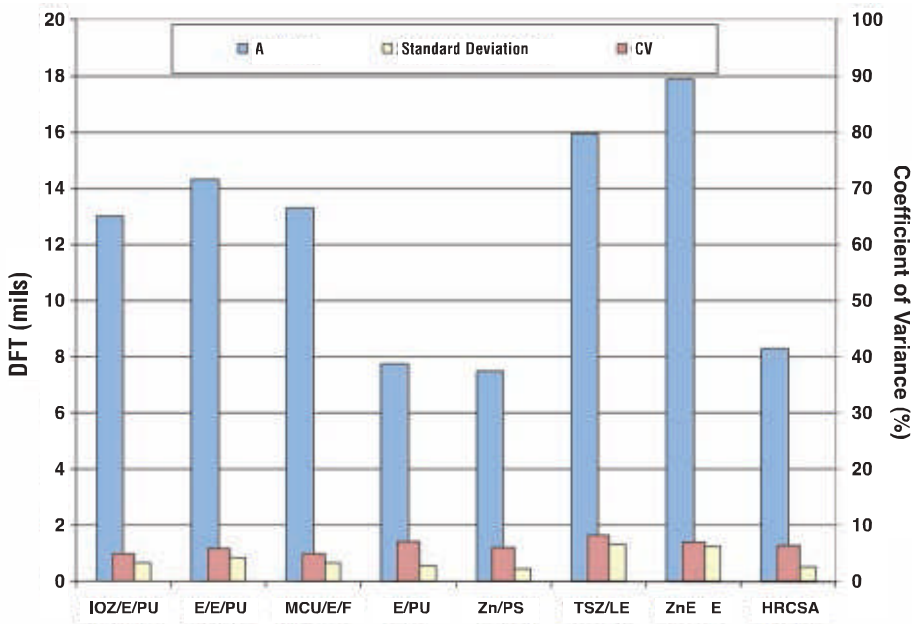
Fig. 4: Mean DFT values (Type I panels)

Figure 4 shows the mean DFT, standard deviation, and coefficient of variance (CV) of each coating system. DFT varied significantly, from 7.5 mils to 17.8 mils, depending on the coating system. None of the mean DFTs were less than 7 mils, and three systems (E/PU, Zn/PS, and HRCSA) were between 7 and 10 mils. All three-coat systems (IOZ/E/PU, E/E/PU, and MCU/E/F) had mean DFTs between 10 mils and 15 mils. The remaining two-coat systems (TSZ/LE and ZnE/LE) had DFTs exceeding 15 mils. Variation of DFT data, in terms of CV and standard deviation, was the highest for the last group of coating systems.

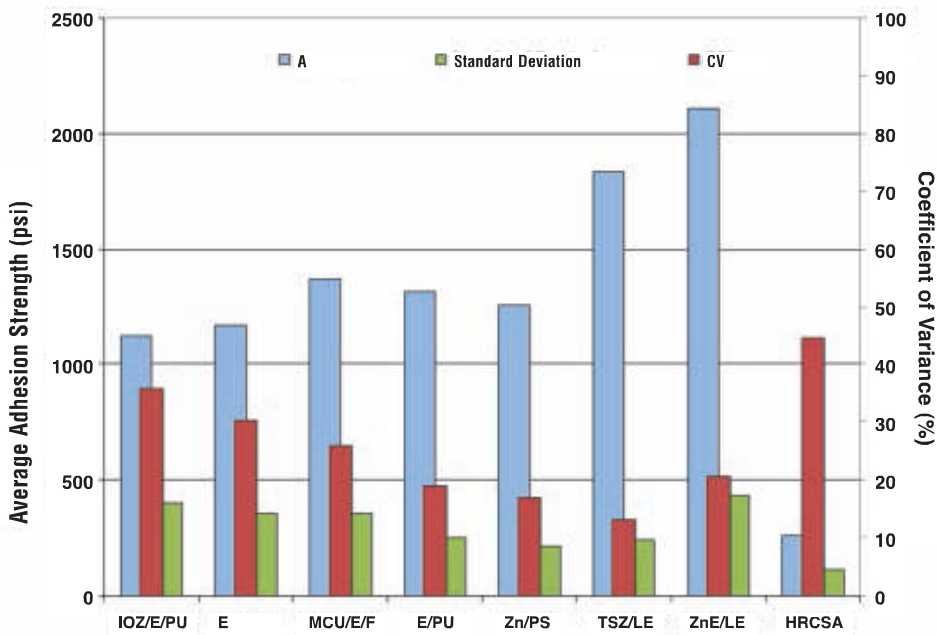
Fig. 5: Mean adhesion strength values (Type I panels)

Transform Infrared (FTIR) Spectroscopy and pull-off adhesion.⁷ The tests were performed on two extra panels for each coating system. The adhesion tests were conducted with a hydraulic pull-off adhesion tester, and the nominal adhesion strength of a coating system was calculated by averaging six readings from two panels.

Initial mean adhesion values and their variability are shown in Fig. 5. ZnE/LE exhibited the highest adhesion strength of 3160 psi (CV 20%) while HRCSA demonstrated the lowest adhesion strength of 259 psi (CV 44%). All remaining three-coat and two-coat systems except TSZ/LE showed adhesion strengths from 1,000 to 1,500 psi (CV 15–25%). TSZ/LE had the second highest adhesion strength of 1,834 psi (CV 13%). The two control coating systems had adhesion strengths of 1,119 and 1,173 psi respectively (CV 30 and 35%).

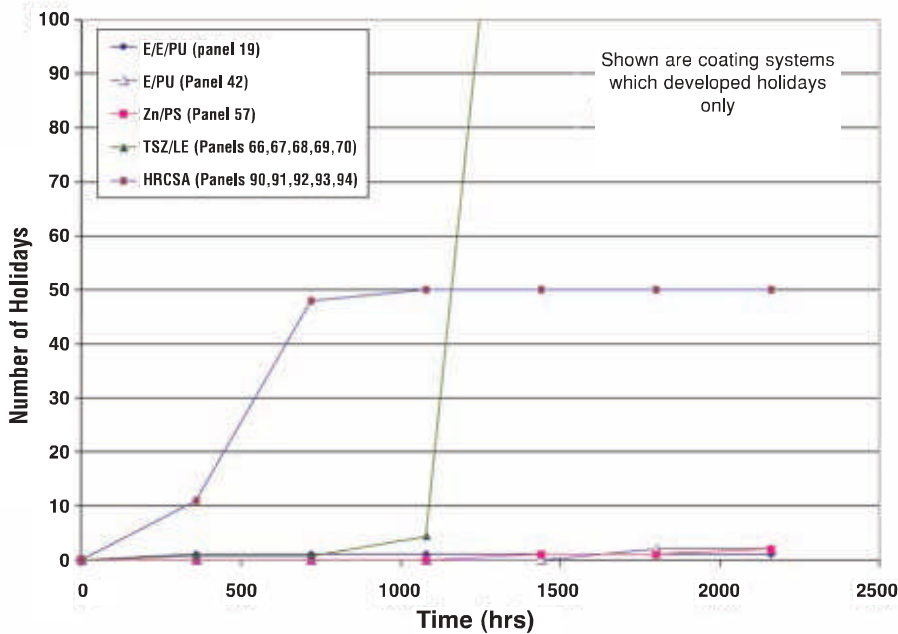
Fig. 6: Cumulative holiday development during accelerated testing

Figure 6 shows the cumulative (preliminary) number of holidays detected during the accelerated laboratory testing. When excessive holidays were detected, discrete defect spots could not be identified, and an arbitrary number of 100 was entered in the data sheet. Excessive numbers of holidays were observed on the surface of the TSZ/LE coating system. Initial assessment of this coating system showed no holidays on the surface. However, one of the panels demonstrated more than 20 holidays after 1,080 hours of testing, and the number of holidays increased excessively after two accelerated cycles that followed (after 1,440 and 1,800 hours of testing). These surface defects were then followed by excessive blistering and cracking of the surface of the coating system.

The rest of the three-coat, two-coat, and one-coat systems demonstrated either zero or minimal coating defects on the surface after 2,160 hours of accelerated testing.

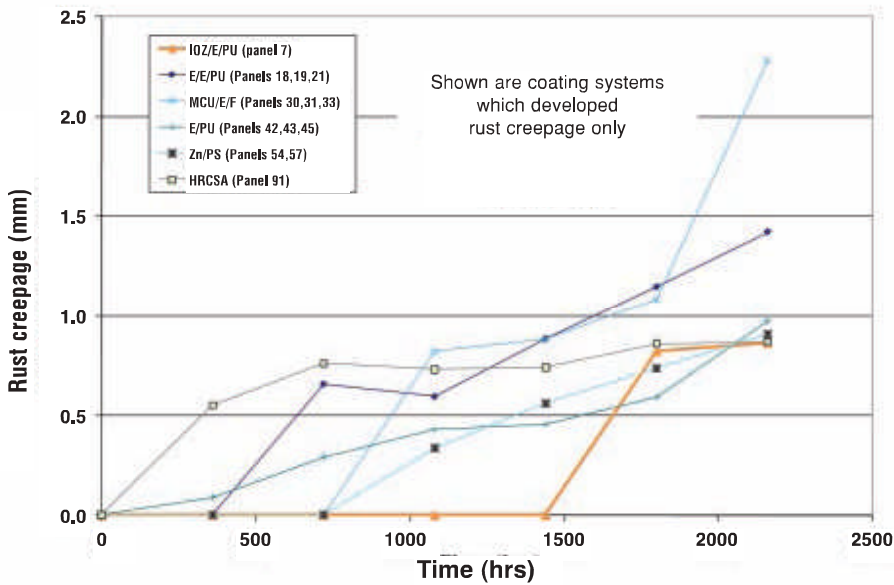
Fig. 7: Rust-creepage growth with time accelerated testing

Figure 7 shows rust creepage data for eight coating systems after 2,160 hours of accelerated testing. MCU/E/F (2.0

mm) and E/E/PU (1.42 mm) have shown more than 1.0 mm creepage at 2,160 hours. HRCSA, IOZ/E/PU, E/PU and Zn/PS showed creepage growth of less than 1 mm. Based on the creepage values at the end of 2,160 hours of accelerated testing; the coating systems can be ranked in the following order of highest to lowest rust creepage:

MCU/E/F > E/E/PU > E/PU > Zn/PS > HRCSA > IOZ/E/PU

It is interesting to note that the inorganic zinc three-coat control has the best per-

formance for rust creepage, followed by the HRCSA. The latter coating system has performed well in earlier studies,⁵ and a similar trend is being observed here up to 2,160 hours of accelerated testing.

4. MCU/E/F developed the highest amount of rust creepage (almost twice) in comparison to the rest of the coating systems in accelerated testing. As was expected, the inorganic three-coat control (IOZ/E/PU) had the lowest creepage, followed by the HRCSA.

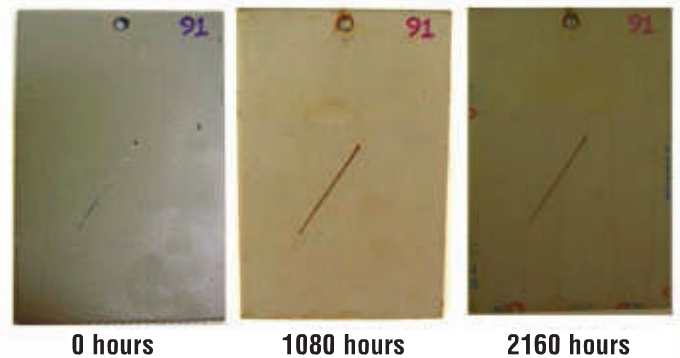
Fig. 8: Progressive changes of HRCSA (1-coat system)

Figures 8 through 10 show selected Type I test panels representing coating systems with the best (HRCSA), moderate (E/PU), and worst (TSZ/LE) performance during the accelerated laboratory testing at 0; 1,080; and 2,160 hours. Similarly, Figs. 11

The three-coat inorganic zinc control (IOZ/E/PU) had the best surface retention properties in terms of holidays, rusting, and blistering. However, this is expected of a control coating system. The next best performing coating system among the candidate coating systems was identified as the HRCSA. The E/PU had a moderate development of holidays and rust creepage growth. The

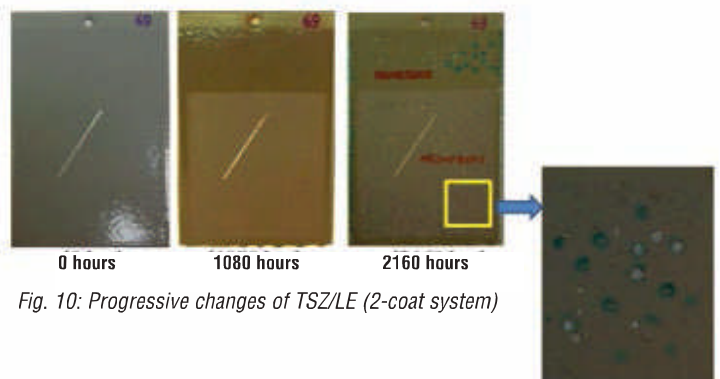
Fig. 10: Progressive changes of TSZ/LE (2-coat system)

- TSZ/LE coating system had the worst surface deterioration, as indicated by the development of holidays, surface blistering, and coating peel-off.

phases of its progressive deterioration. Certain areas still had blisters intact while some areas had half-peeled off coating or detachment of the coating from the surface. White residual zinc oxide was forming on the surface in the areas where coating had peeled off.

The surface of the TSZ/LE coating system at 2,160 hours of accelerated testing indicated surface blistering and peeling off of the coating system all over the surface for both scribed and unscribed panels.

3. The TSZ/LE coating system developed the highest number of defects during accelerated testing up to 2,160 hours, but no holidays developed on the surface after outdoor testing. The defect formation was progressively followed by blisters and by the coating peeling from the surface.

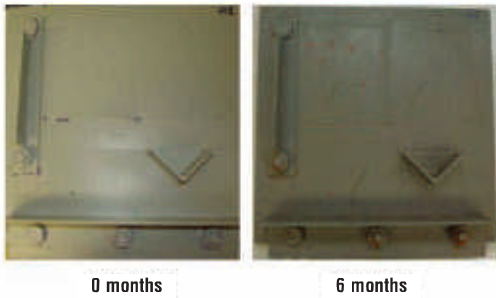
Fig. 11: Progressive changes of HRCSA

a
els that showed the best (HRCSA) and worst (ZnE/LE) surface deterioration after six months of exposure in natural weathering with salt spray.

appeared after accelerated testing. During outdoor exposure testing, except for ZnE/LE, none of the Type I panels and the Type II panel test areas developed holidays or rust creepage at the scribe. Figures 11 and 12 show the Type II test panels for the HRCSA and ZnE/LE coating systems.
