## **10-Yr report: Termarust\* stops severe crevice corrosion on a Pennsylvania Turnpike bridge**

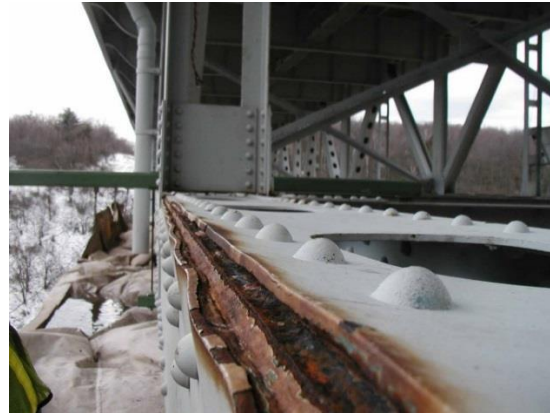
3” Pack rust bent steel plates and overstressed rivets – in all lower chord members

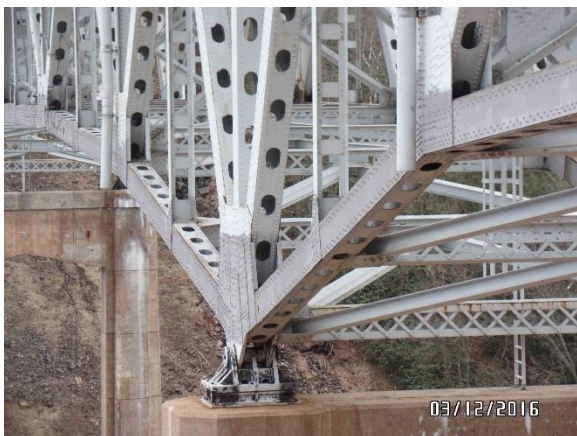
After 10 years – no active crevice corrosion

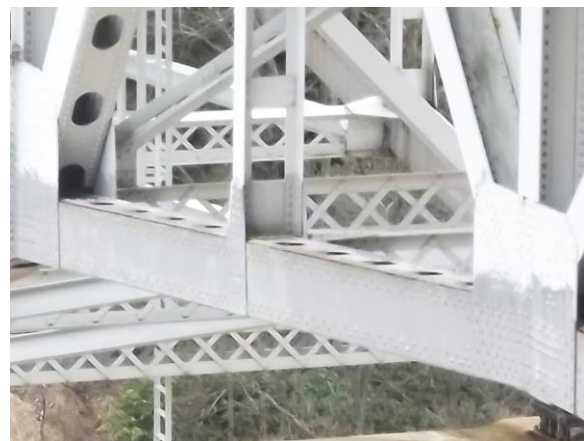
After 10 years – no active crevice corrosion
