Arlington Bridge Structure Critical Rehabilitation

Structural rehabilitation of truss bridge structure critical components with the application of a HRCSA rust mitigation coating system.

Arlington Bridge, located over CP Rail yard in Winnipeg, Manitoba, Canada

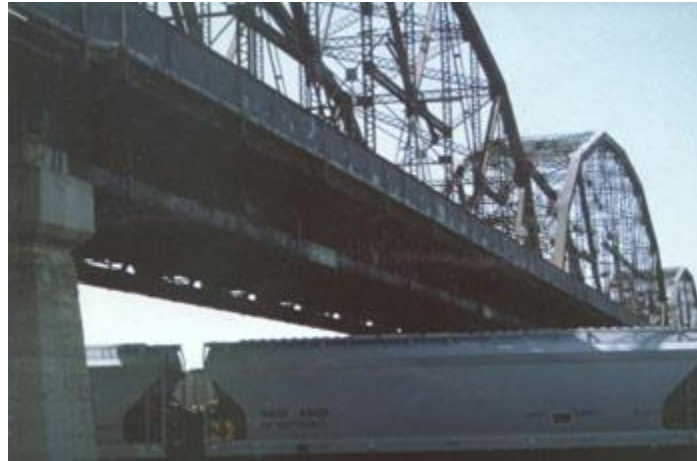
Repairs of all crevice corroded joints and connections on lower section of bridge, clean and apply HRCSA coating system.

To restore structural load capacity, stop crevice corrosion and pack rust, and apply long lasting protective coating to the steel.

Application of Termarust TR2200HS HRCSA Penetrant/Sealer to joints and connections followed immediately with an application of Termarust TR2100 HRCSA Primer/Topcoat, 10 mils DFT.
