# This Is What The Nation's Crumbling Infrastructure Really Looks Like (PHOTOS)

Artist and researcher Nickolay Lamm took photos of structurally deficient bridges in his hometown of Pittburgh to show what the problem really looks like. Severe rust, corrosion and structural defects may make you think twice about driving over structurally deficient bridges in your area (scroll down for a state-by-state map).

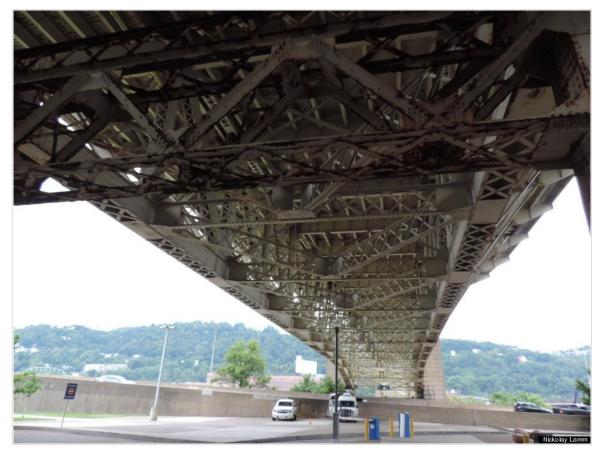
# Liberty Bridge (23.5 sufficiency rating)

This bridge is a multi-span continuous Riveted Steel Deck Truss Fracture Critical bridge type.

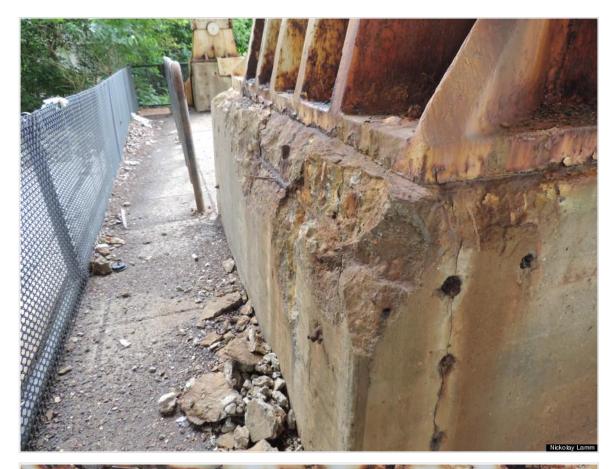
## Thompson Run Rd over Thompson Run (62.5 sufficiency rating)

This is a steel multi-beam bridge with advanced section loss due to corrosion.
